**Culvert Assessment
and Recommendations**

**Fish Passage Evaluation
Holgate Creek
Haines, Alaska**

April 2008

**Natural
Channel
Design, Inc.**

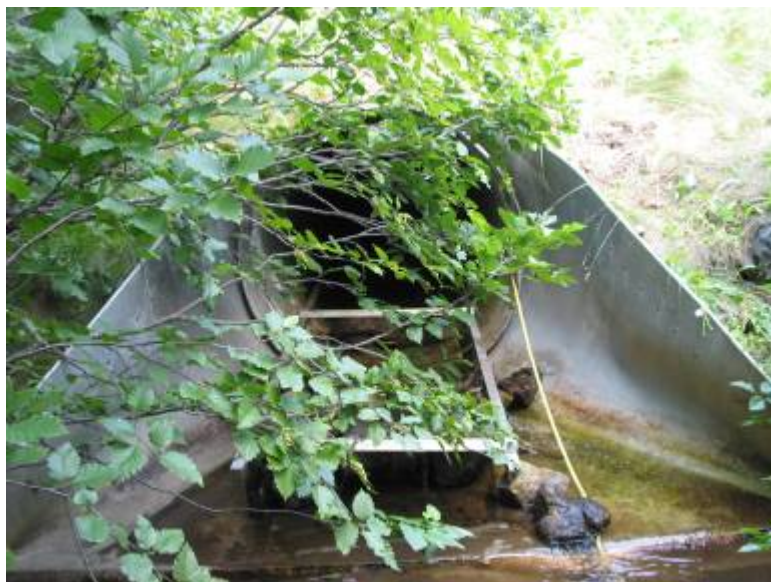
Figure 3. Existing culvert outfall at Holgate Creek below Mud Bay Road.

The physical components of stream and culvert were surveyed August 13, 2007. (See Appendix A Fish Passage Inventory Data Sheet and Survey Data) There is a single, 66-inch, round corrugated metal pipe passing under Mud Bay Road. The culvert length is 80 feet. The pipe is aluminum and the inlets and outlets have flared metal end sections (Figure 3).

Inlet and outlets are flared sheet metal. An in-culvert fishway was installed to collect and stabilize bedload material in a steep culvert (6.5%).

The existing culvert is rated RED due to excessive grade, lack of substrate coverage, low culvert span to bedwidth ratio, and potential for blockage.

The existing culvert **FAILS** to meet any of the four criteria for Tier 1 design. The culvert is installed at greater than two times the upstream grade and six times the downstream grade. Culvert diameter (66 inches or 5.5 feet) is only 57% of the upstream active channel width. The culvert is not set below channel grade and fails to maintain substrate even with the addition of the sediment rack. The lack of sediment suggests any sediment would not be dynamically stable in large floods.

Excessive culvert slope is the greatest limiting factor. As a result, it is not possible to retrofit the current culvert installation to provide adequate fish passage. Therefore installation of a larger arch culvert with a slope consistent with the channel bed is recommended. Installation of new culvert will require altering the existing channel bed elevations. It is recommended that the channel between Mud Bay Road and the Holgate estuary be raised and realigned to match the new culvert outlet invert elevation. These recommendations offer an effective approach for creating effective, reliable fish passage to Holgate Creek.

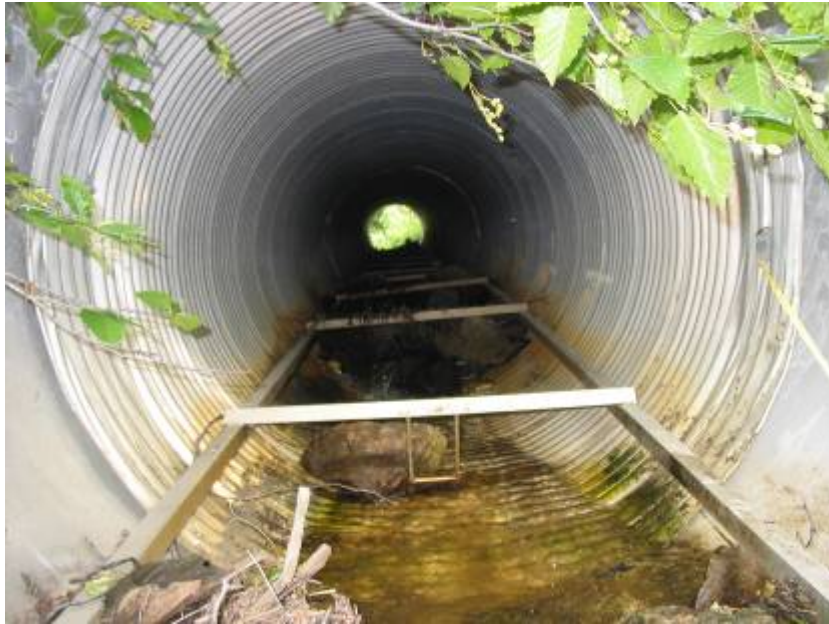
Figure 4. Metal detachable fishway.

A metal detachable fishway was placed in the culvert to hold and collect stream bedload material, providing extra roughness and slowing water velocities (Figure 4). The frame was retrofitted into the existing culvert around 1989 and originally stocked with cobble substrate. The height of the frame is 1.1 ft (0.2 times the pipe diameter), width is 3.5 ft, and cross members are every 6.6 ft (1.2 times the pipe diameter) with one centered retention grid. Frequent maintenance has been required to maintain sediment within the frame (Randy Ericsson, Cramer and Assoc., Inc., pers. comm.). At the time of the survey there was little sediment in the frame and did not appear to be enhancing fish passage. Local observations indicate passage through the culvert and lower portion of the stream may be of particular concern during dry years due to limited surface flow.

Frame was originally meant to capture and hold sediment, creating higher roughness and slower velocities. Currently, little sediment is being held in place.

Any bed material placed inside the culvert will not remain and upstream channel recruitment of larger material cannot be replaced. Therefore, the created roughened channel within the culvert will degrade. If the bedload collector was seeded no material will remain. Existing collector has one retention grid in center of frame and at 1 foot high the majority of channel bed material can move underneath the frame.

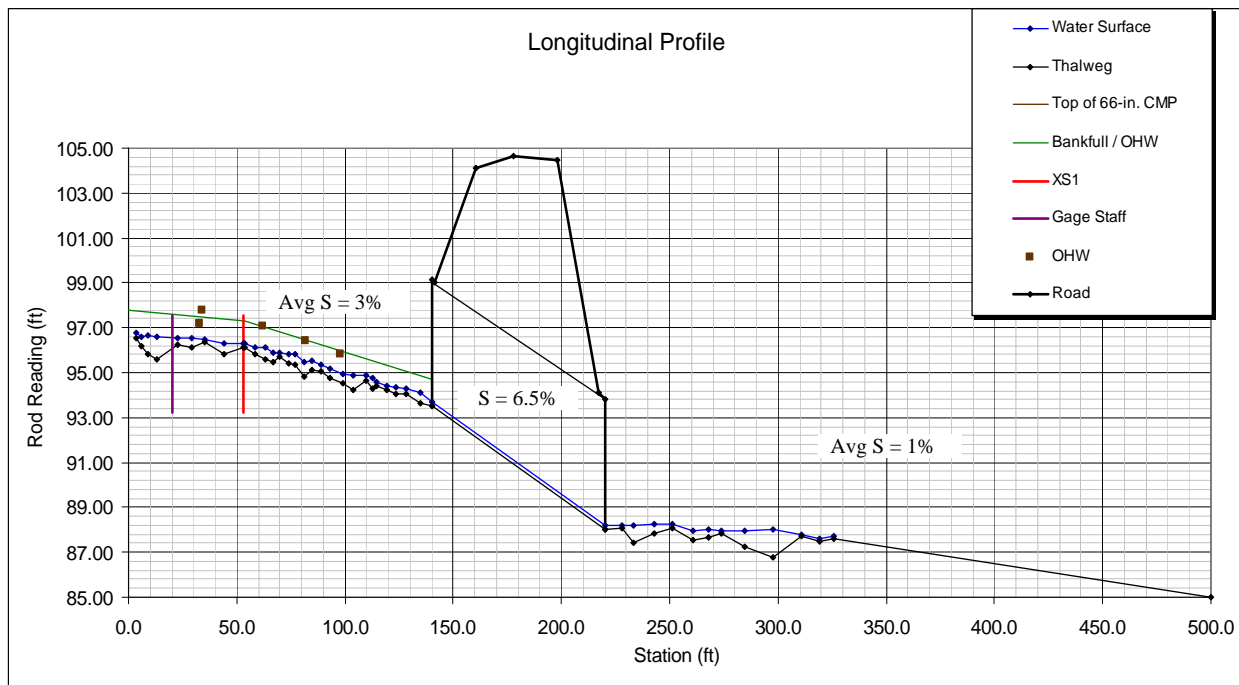
Figure 5. Longitudinal profile of Holgate Creek.

A longitudinal profile of the channel bed was surveyed above and below the culvert. The slope of the existing culvert is more than 2 times steeper than the channel bed above the culvert and nearly 6 times steeper than the downstream channel bed. The green represents the approximate elevation of OHW through the upstream project reach.

The slope of the culvert is twice that of the channel upstream and 6 times steeper than the downstream channel. The reason for this abrupt slope change is not clear. From study of recent aerial photography and maps, as well as site visits it appears likely that the stream was rerouted and shortened to pass directly under the road rather than follow an original course along Mud Bay Road. A direct route from upstream of the culvert, along Mud Bay Road to the current channel confluence with the Chilkat River would have a slope roughly equal to the upstream channel grade of 3%. While the slope change does not appear to affect stream function, it greatly increases velocities, shear stresses, and sediment transport all of which greatly affect fish passage.

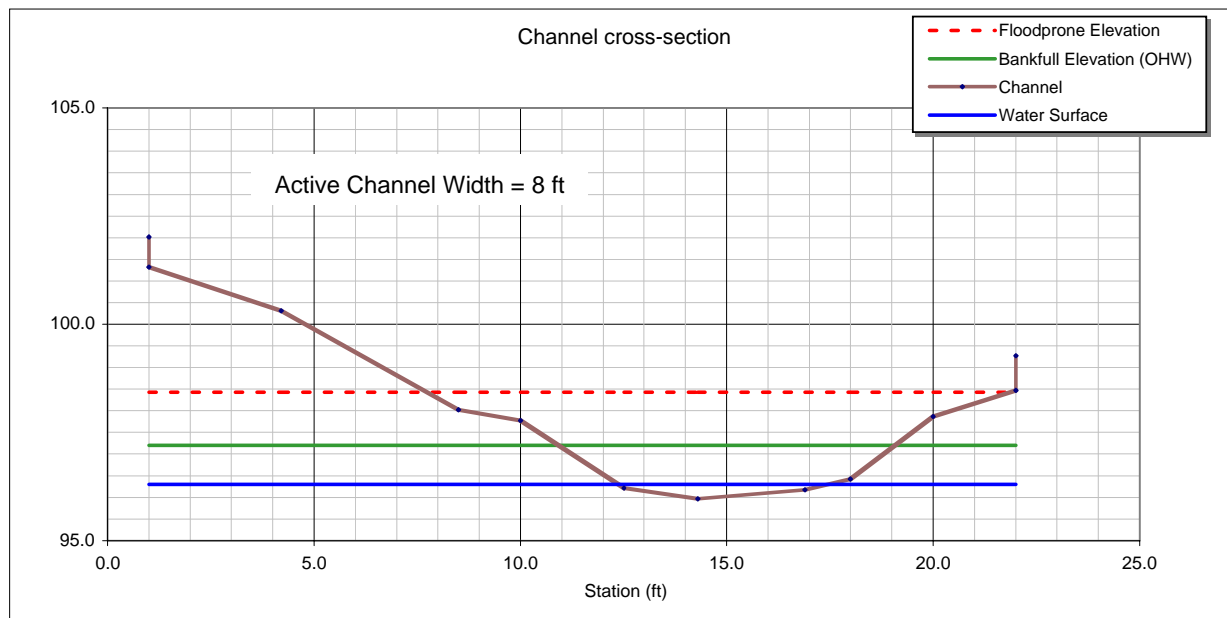
Figure 6. Typical cross-section

A single representative cross-section was surveyed upstream of the crossing (Figure 6). The average bankfull (active channel) width is 8 ft with a mean depth of 0.8 ft and cross-section area of 6.5 sq ft. Section 404 of the Clean Water Act regulates discharge into Waters of the United States below the Ordinary High Water (OHW). The delineation of OHW is somewhat subjective but in this region it is commonly consistent with erosion scour lines along one or both stream banks.

This cross-section was surveyed at Station 0+53 on the longitudinal profile upstream of the culvert. Ordinary High Water as defined in Section 404 of the Clean Water Act is shown in the solid green line.

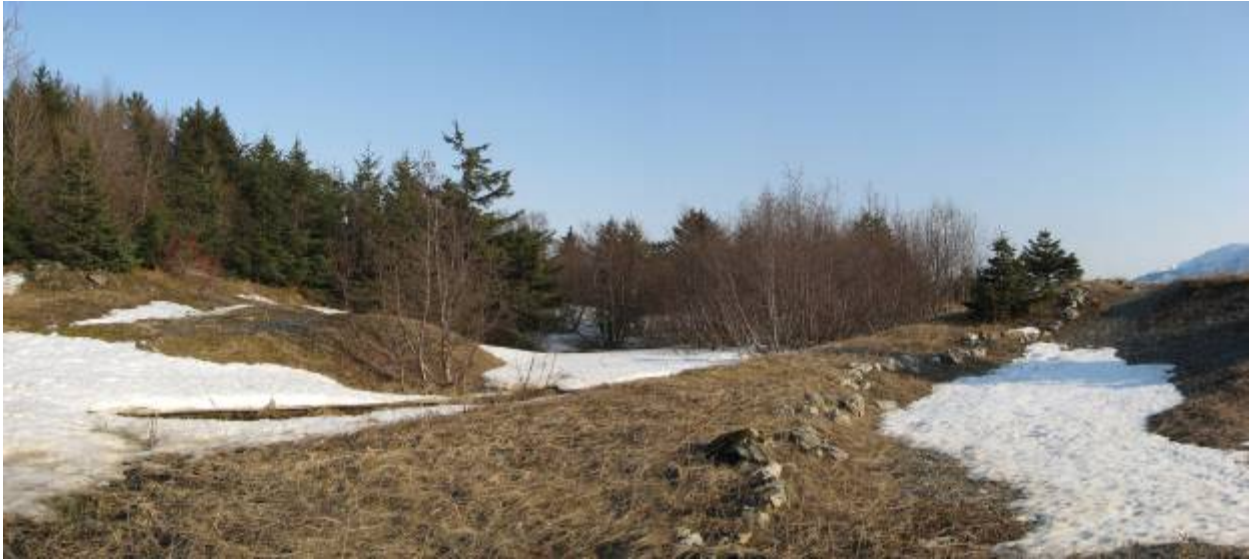
Figure 8. Holgate Creek looking upstream towards the culvert

Photo taken April 18, 2008 along the berm between Holgate Creek and the Chilkat Inlet. Proposed channel modification would take place in this location.
