# Taiya Inlet Stream Condition Assessment

July 2007

**The purpose of this assessment was to report and describe riparian disturbances, fish habitat impairments and obstructions, and to identify areas for future Taiya Inlet Watershed Council restoration efforts.**

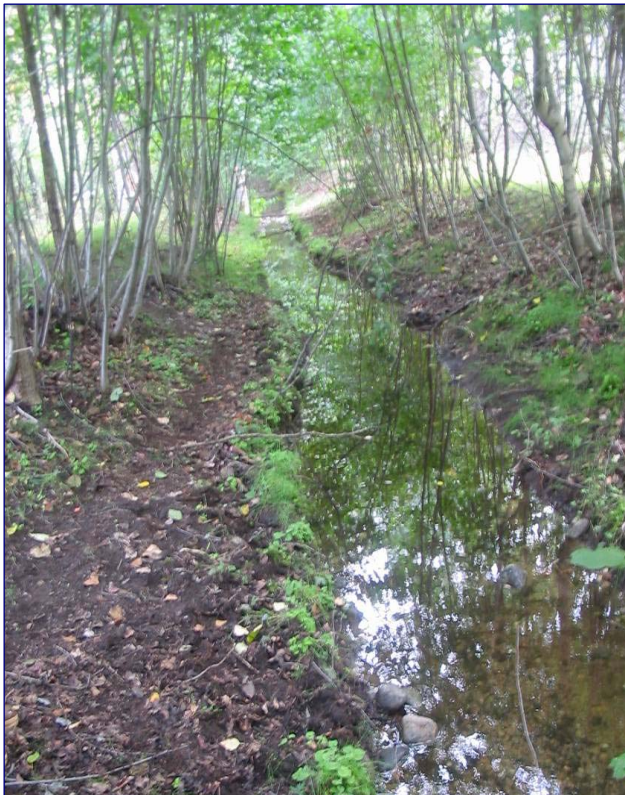
Sections of Dairy Creek were historically straightened. Restoration of these areas could include the reintroduction of stream meanders, revegetation of riparian areas, and construction of pool/riffle stream habitat.

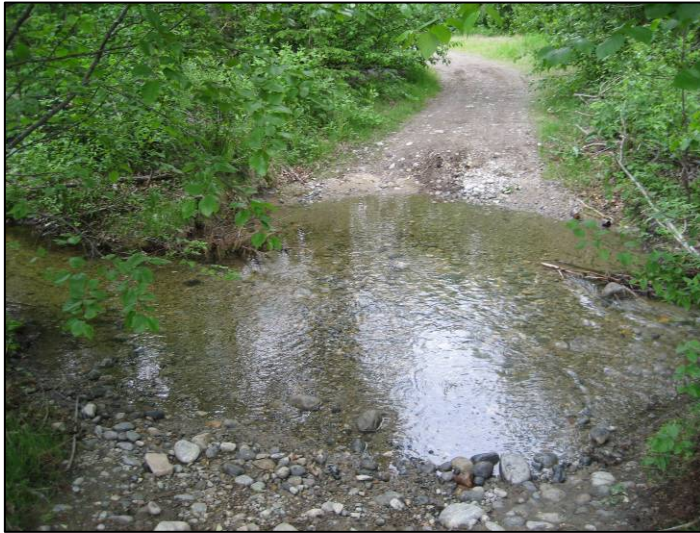
This ATV ford crossing, just upstream from the Klondike highway, degrades a stream reach densely populated by rearing juvenile salmon, Dolly Varden, and stickleback.

- Construction of a simple bridge for ATV use at the current ATV crossing site, along with some restoration work to reverse the impacts of past ATV traffic, will improve habitat and remove a source of sediment.
- Where feasible, reversing channel modification impacts by reintroducing channel meanders may improve fish habitat complexity and slow water velocities during periods of high flow.
- Re-vegetation of riparian zones throughout the length of the creek will provide shade and habitat for fish, stabilize banks to combat erosion at higher flows, and reduce sediment and debris inputs from adjacent roads.

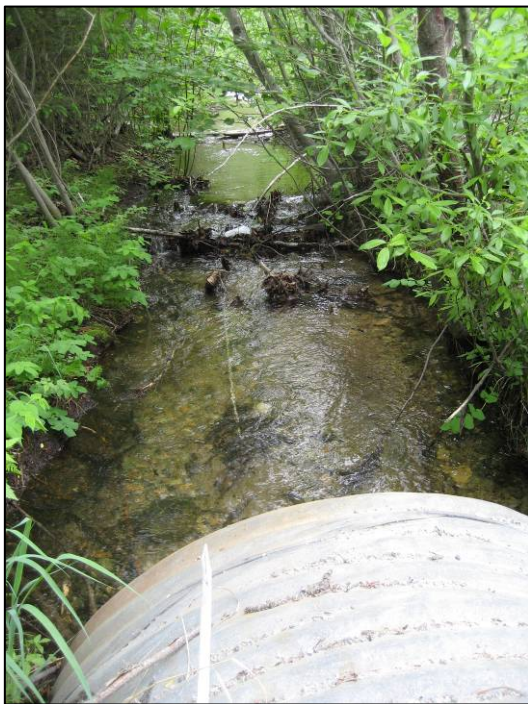
View looking upstream from Klondike Highway culvert inlet. Some debris and trash are present in a small woody debris pile. Note road gravels atop the culvert.  
*Image: S. Seifert, USFWS, June 2007.*

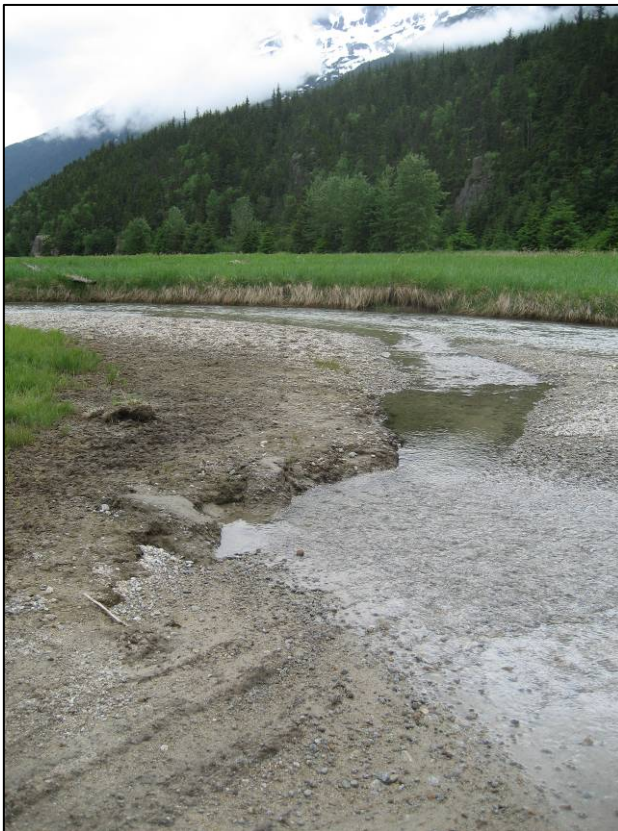
Nelson Creek Reach 3. View looking downstream; erosion at ford crossing location. It is common for commercial tours on horseback and in large passenger vehicles to ford the creek at this site.

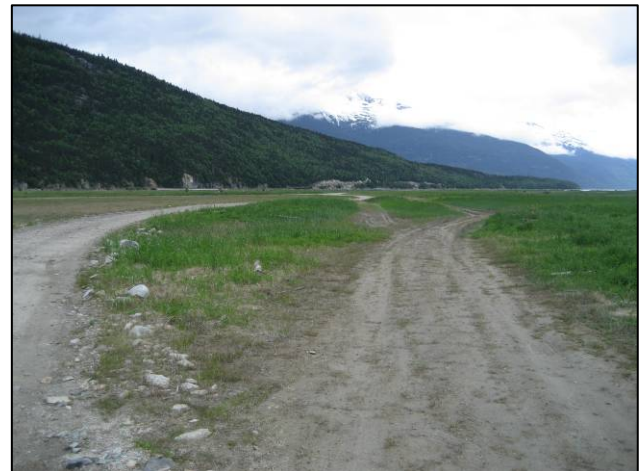
Multiple parallel roads and trails located in and around riparian areas on the Dyea Flats (view looking south). It is recommended that these trails are inventoried, that necessary existing trails are marked, and unnecessary trails are reclaimed and revegetated.

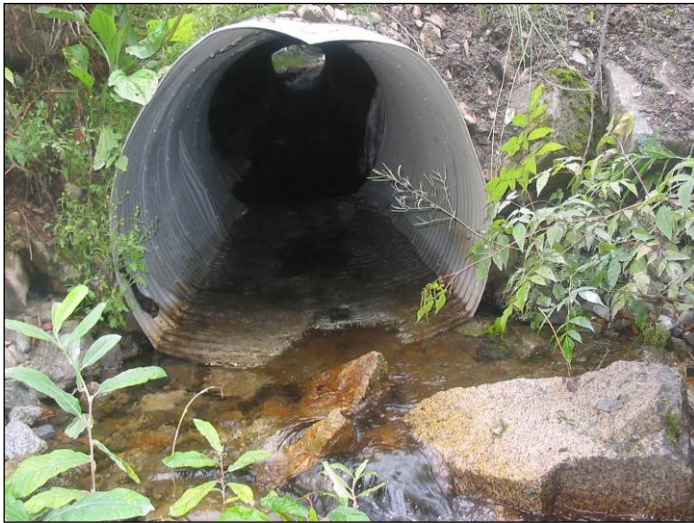
There are two parallel culverts at the crossing under Dyea Road. These culverts are installed at 4% gradient, potentially creating a partial or full creating a fish passage barrier. When these culverts are blocked by debris, flooding occurs over the road and backwaters inundate upstream private property. Pet waste seems to be a minor issue along the beach access trail. Refuse and debris are found in the lower reaches of the creek, probably remnant from beach camp and picnic sites.

One of two culverts under Dyea Road at Matthews Creek. Note the steep grade. These culverts likely present a sediment transport and fish passage problem.  
*Image: A. Bethe, TIWC, August 2005.*

- Culverts running under the Dyea Road crossing should be quantitatively evaluated for potential fish passage and sediment transport improvements.
- The driftwood dam at the mouth of the creek should be dismantled or modified to ensure fish passage.
- Relatively minor riparian area disturbances just upstream of the culverts could be addressed by revegetating the area and constructing stairs for water access.
- Pet waste may be controlled by providing biodegradable pet waste bags at the trailhead along with a small dumpster.
- A beach cleanup effort to remove trash and debris would improve area aesthetic values.
- Commence monitoring to add Matthews Creek as a pink salmon spawning waterbody in the ADFG anadromous waterbody catalog.

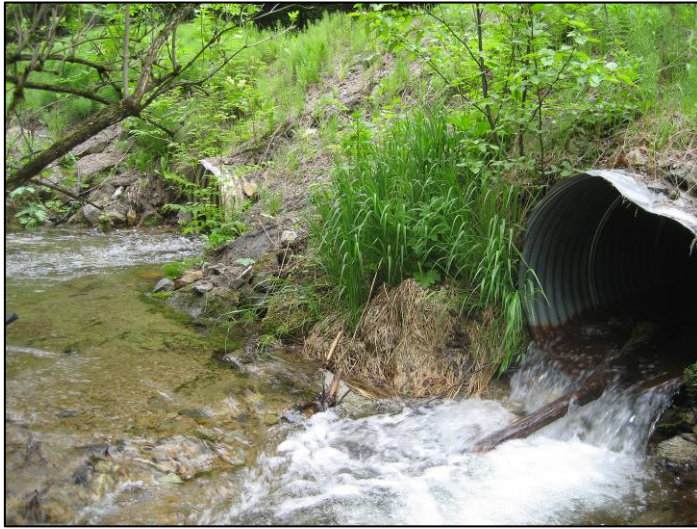
Culvert outlets downstream of Dyea Road. Note: Culvert pictured at right is perched (~12" above grade).

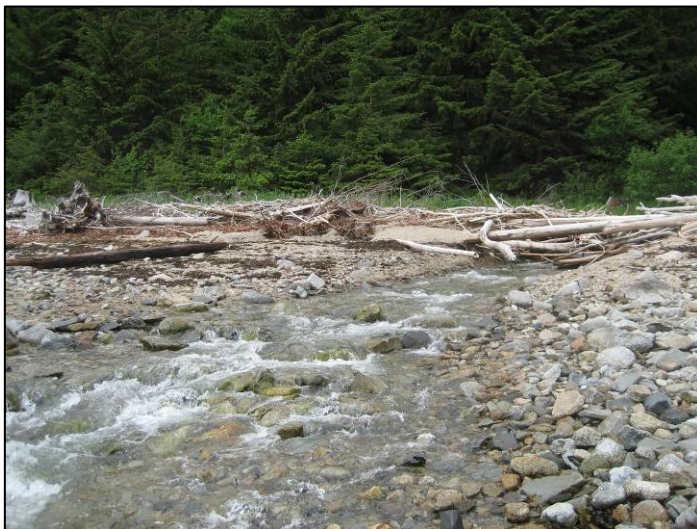
Mouth of Matthews Creek at beach (looking upstream). The stranded driftwood pictured has formed a small dam at the mouth of the creek which may present a barrier to fish passage.

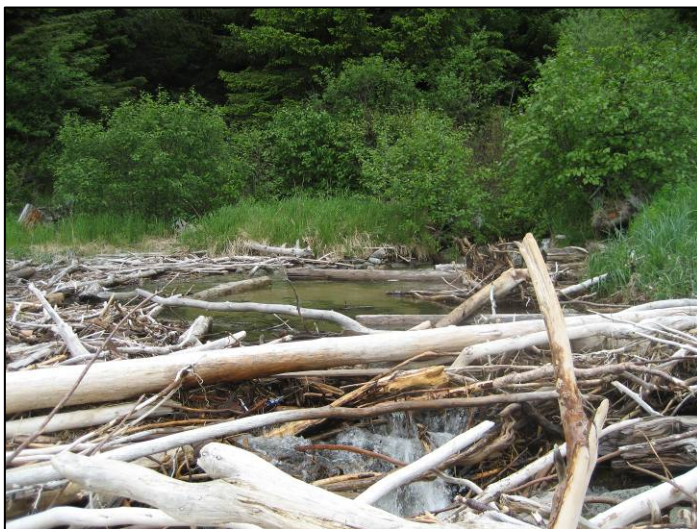
Driftwood dam at mouth of Matthews Creek (looking upstream).

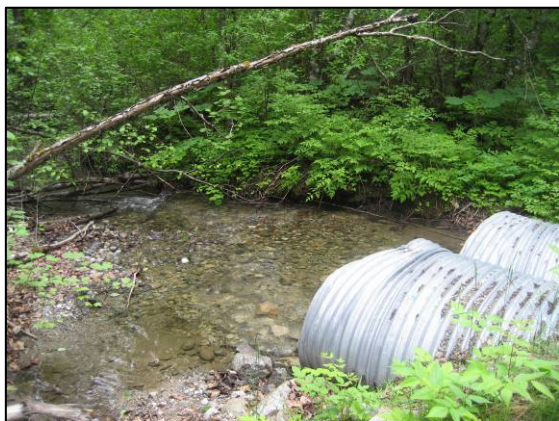
Reach 1: This Dyea Road 2 x 60" culvert crossing is prone to blockage by downed wood.

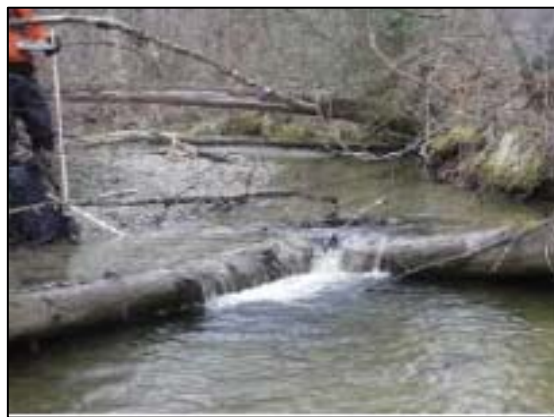
An old “V” log structure (see image) located 100’ above the confluence with West Creek may have been installed historically to create a scour pool. However, this structure was undermined by upstream erosion of bed material, a classic failure of this type of structure, and is probably not a barrier to fish passage. Two 60” culverts at the only Dyea Road crossing appear to be in good condition, but are reportedly prone to blockage by downed wood and thereby present a fish passage and flooding risk if not properly maintained. The unimproved road crossing the creek at the culvert site may contribute fine sediment during heavy rainfall or snowmelt events.

Reach 1: This old "V" log structure has failed, but likely passes fish at all flows.
