# Klawock Watershed Condition Assessment

Central Council Tlingit and Haida Tribes of Alaska  
and  
USDA Forest Service  
Tongass National Forest  
Craig Ranger District

March 2002

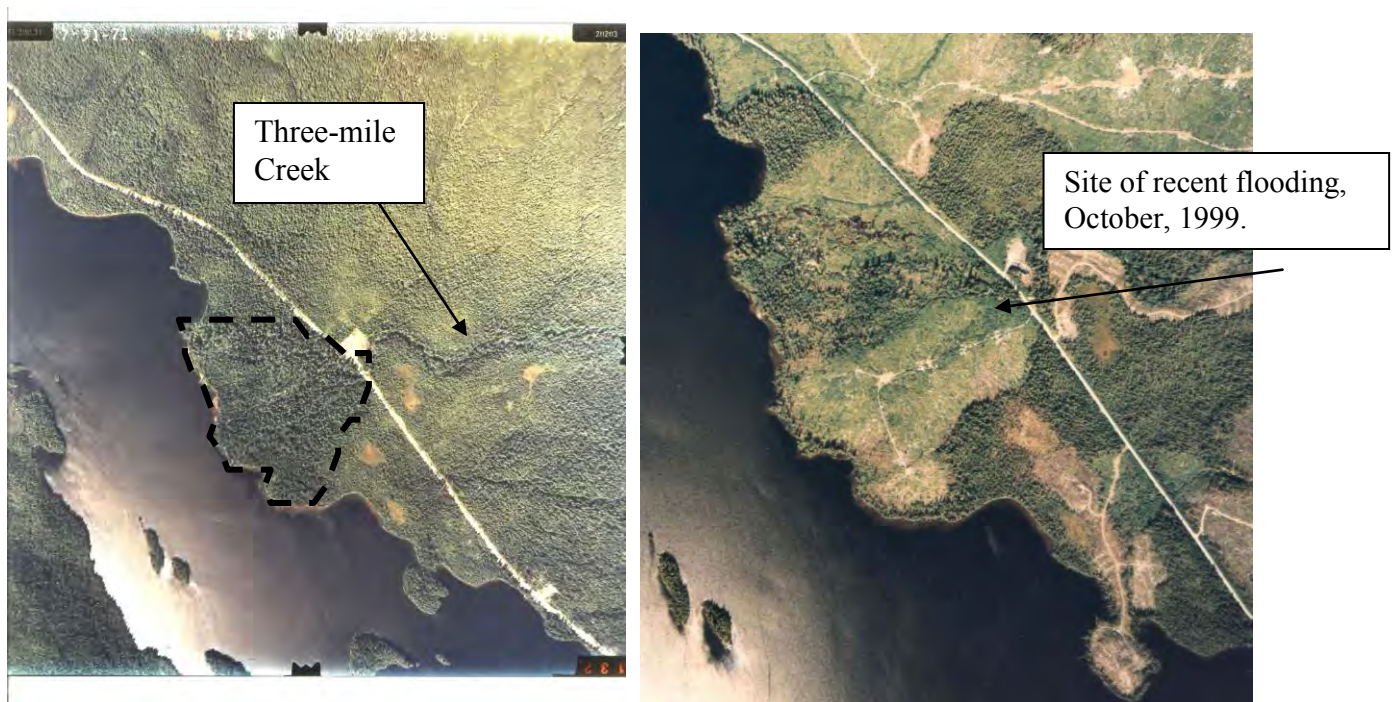
*Photo 1. Three-mile Creek alluvial fan, pre-harvest 1971. Photo 2. Three-mile Creek alluvial fan, post-harvest 1991. Notice extensive ponding on the north side of the alluvial fan.*

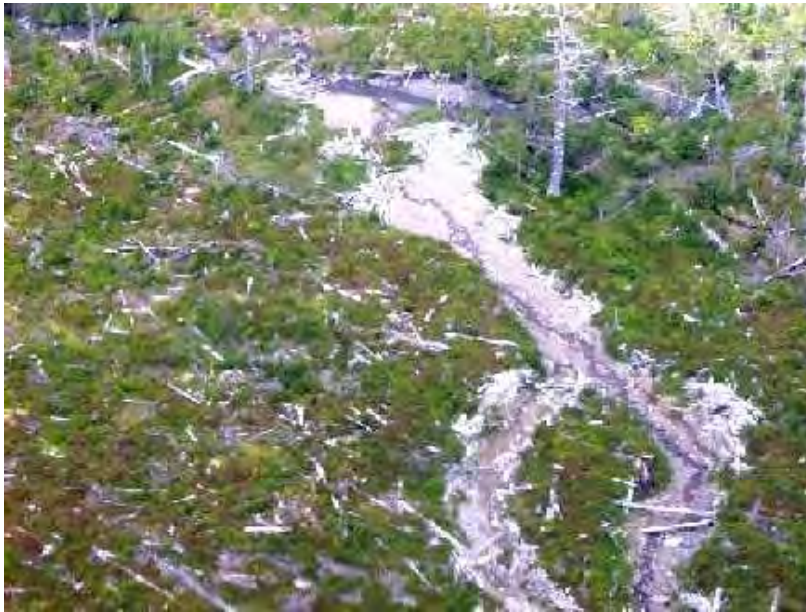
*Photo 3. Debris torrent, upper Three-mile Creek.*

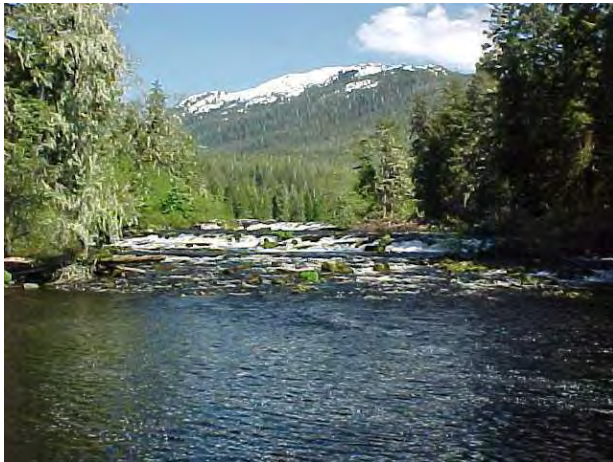
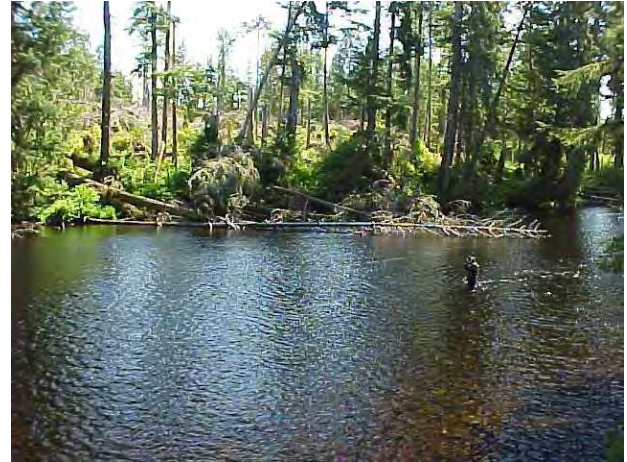
Photo 4. Klawock River near Prince of Wales Hatchery. Photo 5. Klawock River downstream of hatchery looking south, stream buffer blowdown visible.

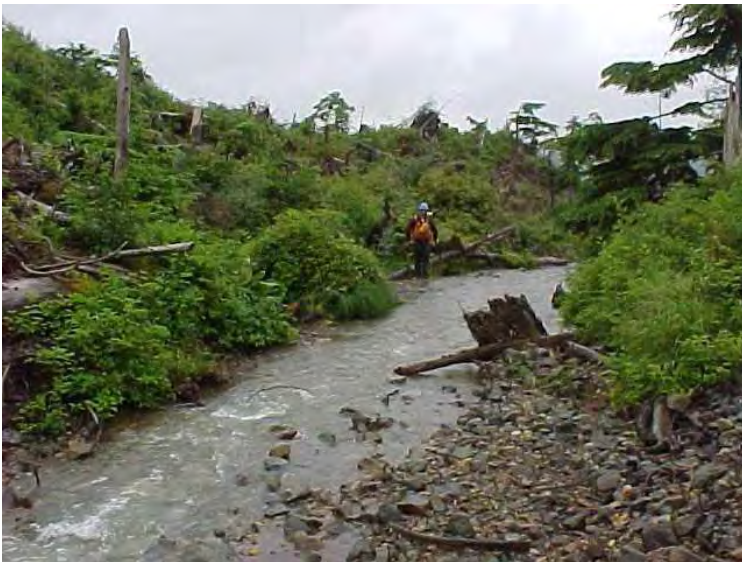
**Reach B3 was rated Non-Functional.** The reach contains insufficient amount of LWD. Plant communities are not an adequate source of coarse and/or LWD for maintenance and recovery (Prichard, Tech. Ref. 1737-15 1999). There are no large trees adjacent to the stream for LWD recruitment in the future—no diverse age classes, and the upland watershed is contributing to riparian degradation. The roads and landslides are leaching material into the stream. The road directly south of the stream has re-routed several small Class IV/V channels and needs maintenance. There is not adequate riparian vegetative cover to protect banks and dissipate energy during high flows. Floodplain and channel characteristics are not adequate to dissipate energy. The stream is not in balance with the water and sediment supplied by the watershed. Excessive erosion was documented.

Photo 6. Upper Bluewater Creek, reach B3.

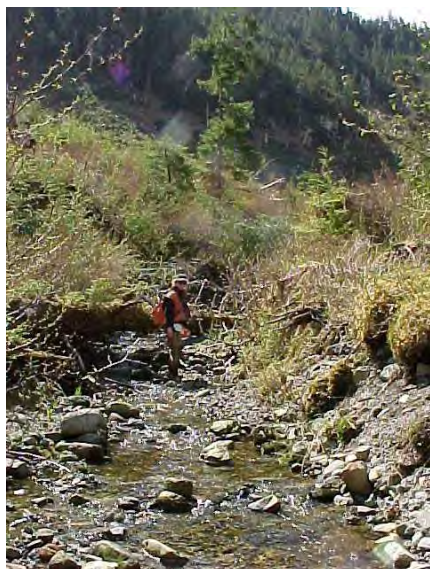
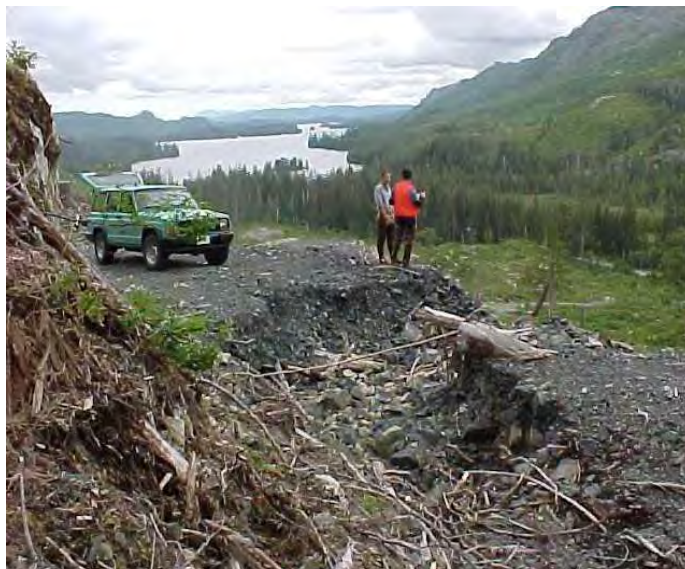
**Reach IT3&4(south side)** was rated **Functional at Risk—Downward Trend**. The reach contains an insufficient amount of LWD; removal of LWD may have increased W/D ratios. The upland watershed is contributing to riparian degradation; the upper stream crossing is blown out and contributing sediment. There are no large trees adjacent to the stream for LWD recruitment in the future—no diverse age classes. Plant communities were not an adequate source of coarse and/or LWD for maintenance and recovery. The stream is not in balance with the water and sediment being supplied by the watershed. Predominant seral stage for the reach is early.

Photo 7. Lower Trib 4 of Inlet Creek, reach IT3&4 Photo 8. Road washout upper Trib 4, reach IT3&4.

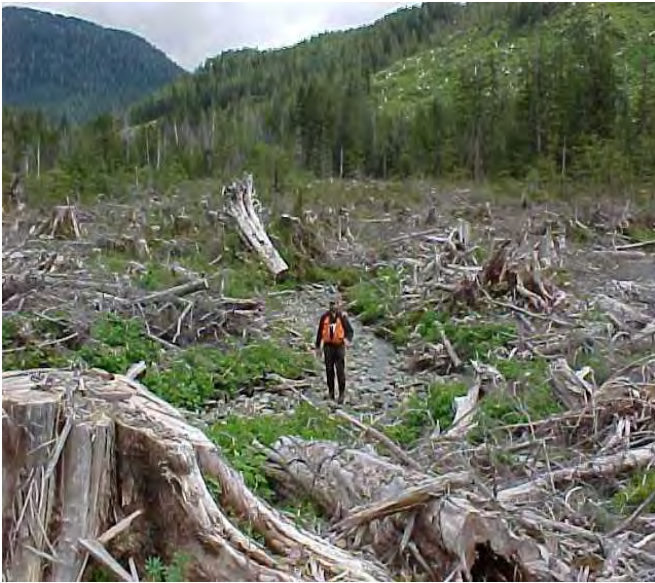
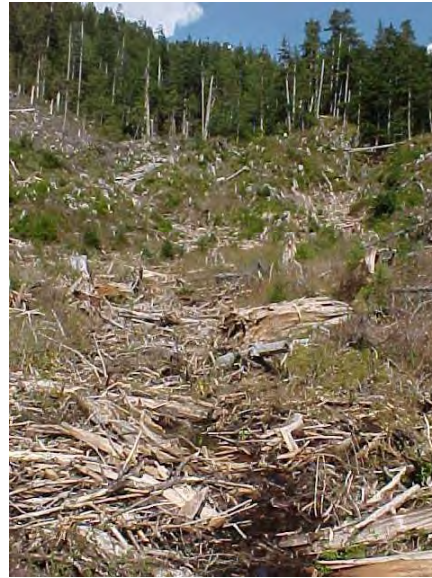
Photo 9. Trib 7, reach ITNorth at first road crossing. Photo 10. Trib 6, upper WA, reach ITNorth.

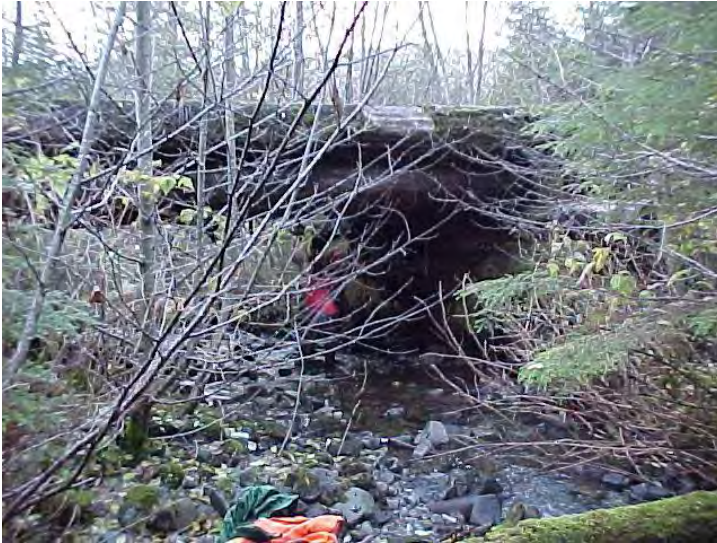
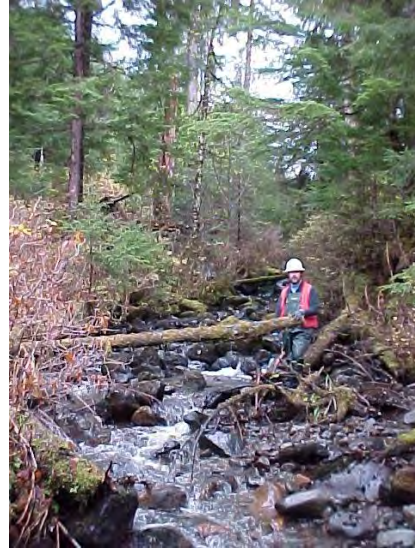
Reach A1 has lost a significant amount of a functional riparian area in approximately 45 percent of the lineal reach. This leave buffer approaches the minimum amount required to maintain a PFC rating. A significant amount of blowdown has occurred compromising the already “thin” hemlock dominated leave buffer. Plant communities were determined to be an adequate source of coarse and/or LWD for maintenance and recovery (Prichard, Tech. Ref. 1737-15 1999). Some localized channel disturbance was noted in the lower section of the channel next to the salvage patch. An adequate supply of large wood adjacent to the stream is currently available; however, this may be decreased by future storm events. Stream banks appear to be relatively stable

*Photo 11. Alder Creek, Reach A1, at main road crossing. Photo 12. Reach A1 of Alder Creek upstream of bridge crossing. Note presence of LWD and stream bank stability.*

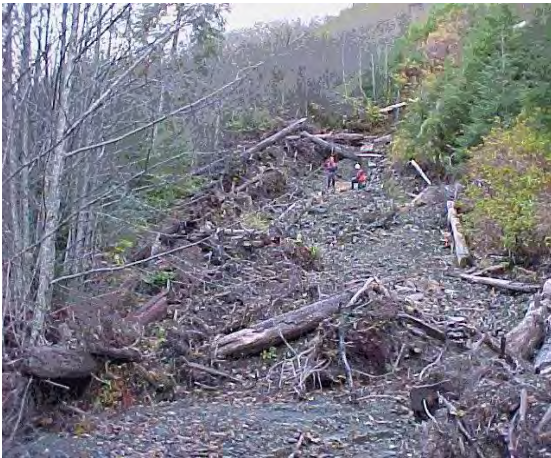
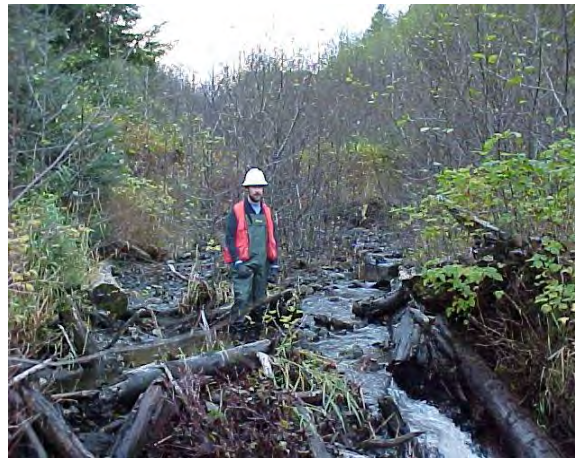
*Photo 13. Landslide intersects Alder Creek Reach A2. Photo 14. Reach A2 of Alder Creek.*

**Reach A2** encompasses the remaining more impacted upstream portion of Alder Creek above the steep cascades. Reach A2 extends 3,500 feet beyond the extent of anadromous habitat. The stream is small, approximately 20 feet in bankfull width. The reach is predominantly HC2 channel type and habitat for resident trout. The stream is a small mountain footslope channel that functions to transport sediment at high flows and deposit sediment at low flows. Harvest adjacent to the stream occurred in the early 1990s, resulting in a predominance of disturbance species throughout the reach. Alders proliferate between the cascades and the tributary junction. Larger High Gradient Contained streams need a moderate amount of LWD to function properly. These streams were not buffered nor do they currently contain adequate LWD. It appears in-channel LWD was removed during logging. Logging debris and debris from slides was observed in the reach. There is a high frequency of small debris jams in the upper reach as is expected in this type of channel and landform, but the team agrees that the amount of material exceeds the natural range of variability. A steep full-bench road

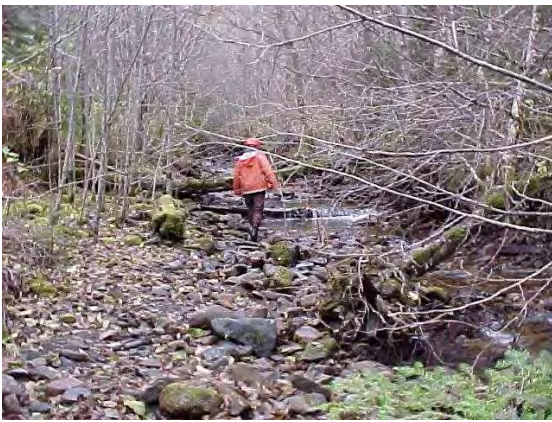
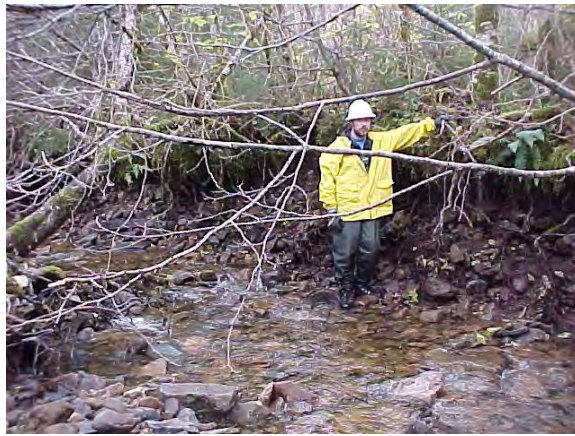
**Reach CL2 was rated Functional at Risk—Downward Trend.** The reach has been significantly impacted. The reach has no functional conifer buffer. There are no large trees adjacent the stream for LWD recruitment now and in the future. Alders and disturbance species do not constitute an adequate source of coarse and/or LWD for maintenance and recovery. Adequate riparian vegetation was not present to protect banks and dissipate flows; plant communities were not an adequate source of LWD. Floodplain and channel characteristics were determined inadequate to dissipate energy. Effects of harvest may not yet be completely visible. It is highly possible that the downcut reach could grow. Minimal recent beaver activity was noted, as well as excessive erosion from old beaver ponds. Recovery of the reach is dependent upon the emergence of stable riparian vegetation.

*Photo 15. Reach CL2 of Chutes and Ladders Creek. Photo 16. Reach CL2 below main road.*

**Both photographs depict FP transitioning to MM channel types. Note riparian composition, lack of LWD and cut banks.**

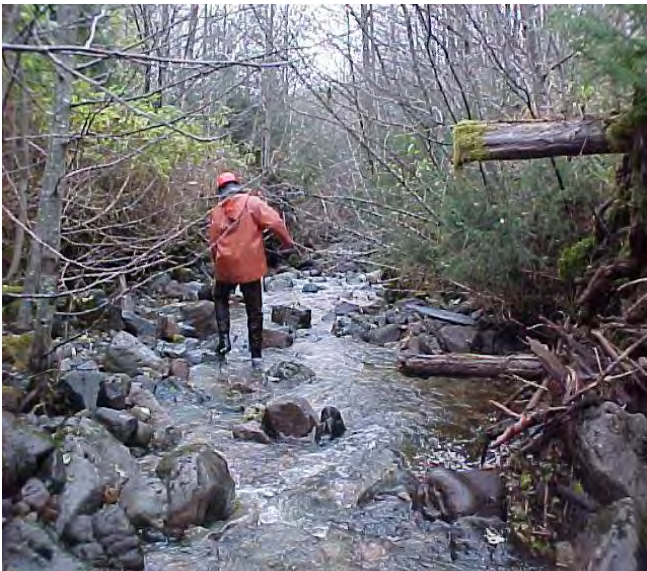
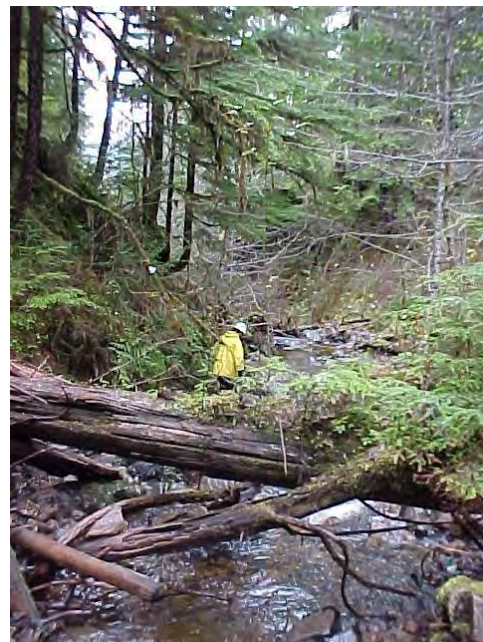
*Photo 17. Reach CL2, channel type MM1. Photo 18. Reach CL2 above channel type MM1 transitioning to HC 2. Note composition of riparian area and decrease in LWD between photos.*

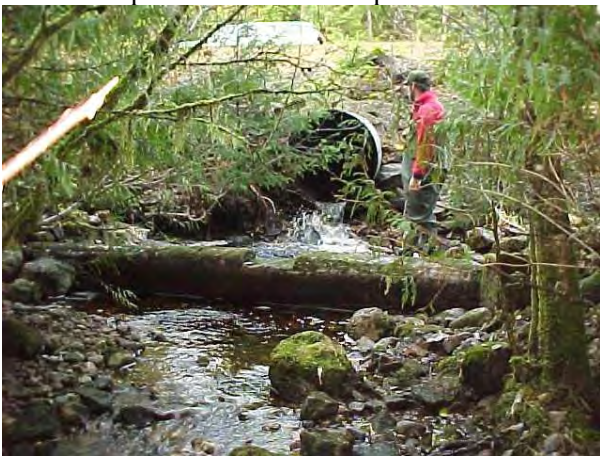
Photo 19. Reach KT5 (Trib 5) below highway crossing.

- Restore passage of approximately 500 feet of anadromous habitat and 1000 feet of resident habitat.
- Improve condition of riparian habitat.

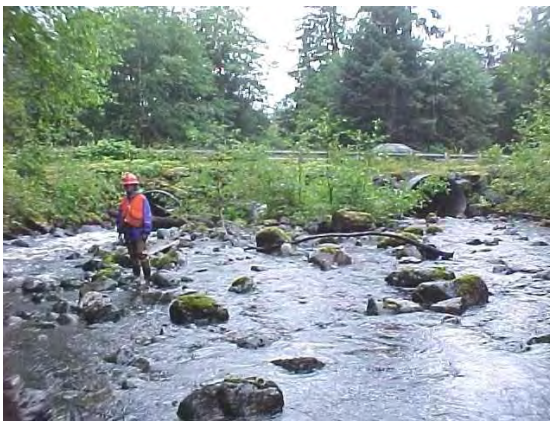
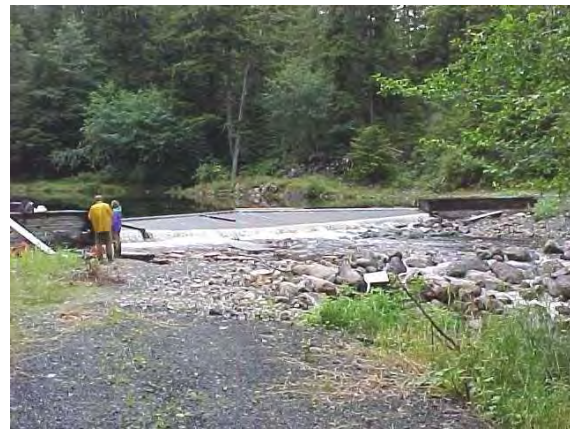
Photo 20. Klawock-Hollis road crossing at Half-mile Creek, reach HM1. Photo 21. City of Klawock municipal water supply reservoir on Half-mile Creek.

- Improve fish passage by increasing the size of the outlet pool, reducing stream flows and 'jump height'.
- Reduce flow and gradient inside the culvert.
- Decrease chances of failure, flooding, and damage to road.

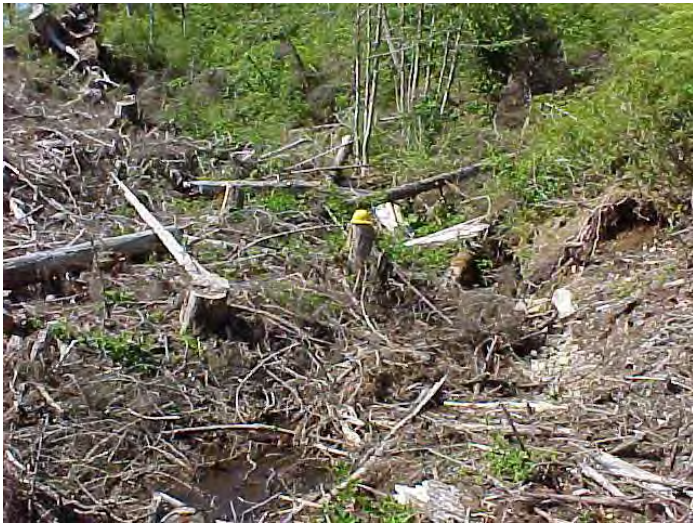
Photo 22. Tributary 2, lower Three-mile Creek, below road crossing.

- Remove the log culvert on the spur road and remove excess logging debris from about 1,200 feet of stream.

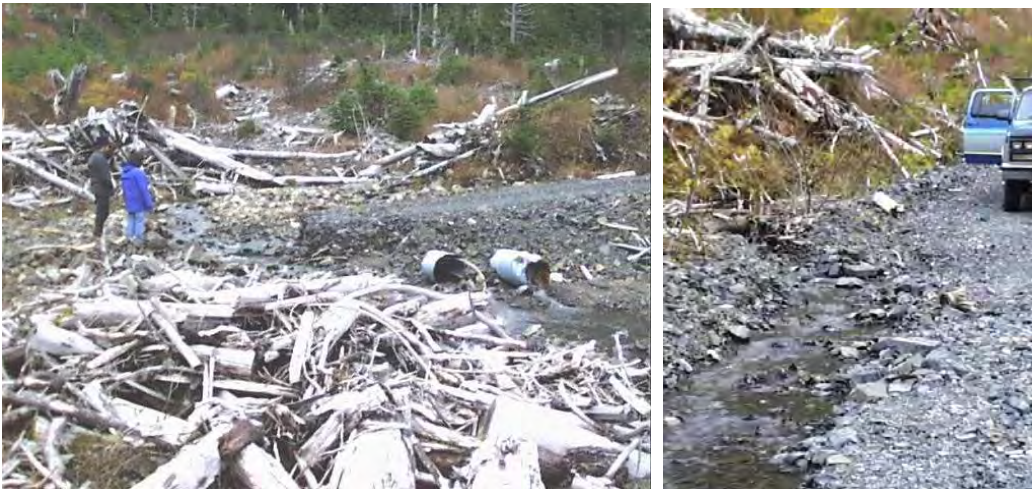
- The road crossing the South Fork is impeding resident fish passage to about 1,600 feet of high quality resident fish habitat. Adjacent culverts are also not functioning and these culverts are diverting water out of their natural stream channels into others. Water diversion is causing excessive erosion and increases the chances of the downstream culverts plugging and the stream overtopping the road. Culverts blocked by debris, rocks, and/or sediment can cause significant damage to the road and/or the stream. Recent flood flows (October, 1999) have caused the stream to overtop the road, causing erosion of the road prism (Photo 23).

*Photo 23. Relief culvert plugged and subsequent stream crossing failure. Photo 24. Relief culvert failure.*

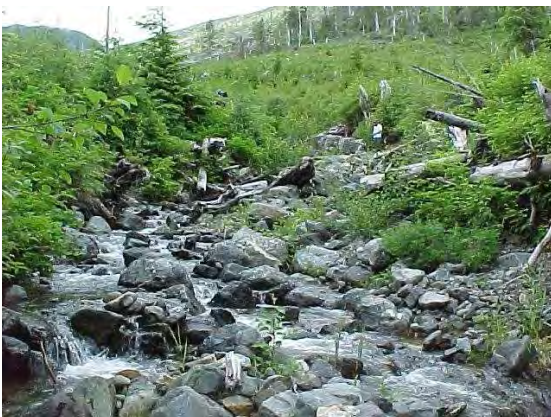
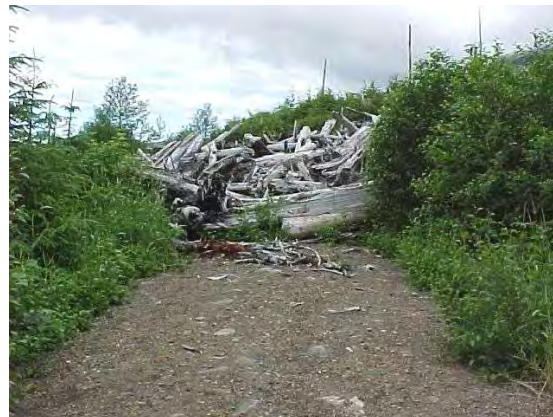
Photo 25. Three-mile Creek, Trib 11, riparian harvest, little LWD present. Photo 26. Debris torrent on roadway Trib 11).

- Improve stream network drainage.
- Reduce stream erosion and input of fine sediments.
- Improve resident fish habitat.
- Maintain natural hillslope hydrology.

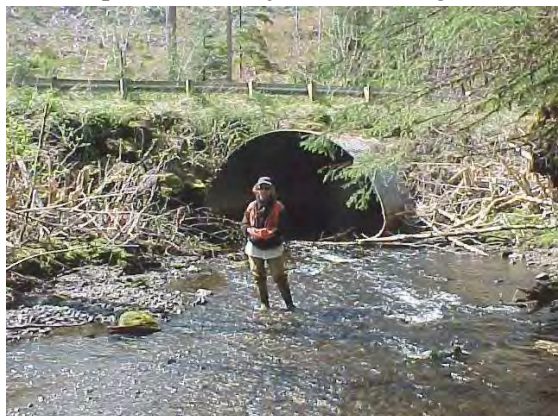
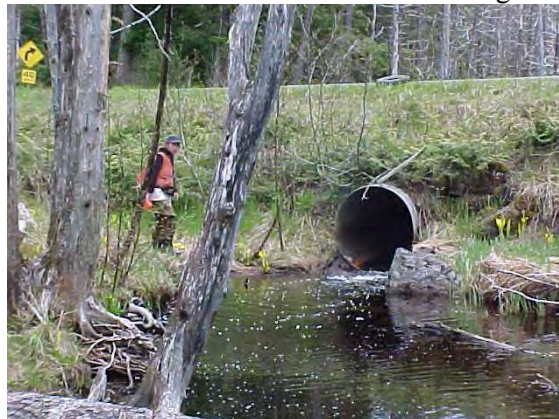
- Main stem Inlet Creek has two stream crossings on the Klawock-Hollis Highway. Both culverts currently pass fish but likely do not meet current ADFG fish passage standards for juvenile fish and resident trout. The culvert at the lower crossing may not pass juvenile salmon at higher flows. This culvert was a study site for a broader project that involved fish passage through culverts completed by the University of Alaska—Fairbanks (Kane et al, 2000). The upper culvert (resident habitat) may not pass adults or juveniles at high flows. More information is needed at these crossings.

Photo 27. Lower culvert main stem Inlet Creek. Photo 28. Upper stream crossing, main stem Inlet Creek.

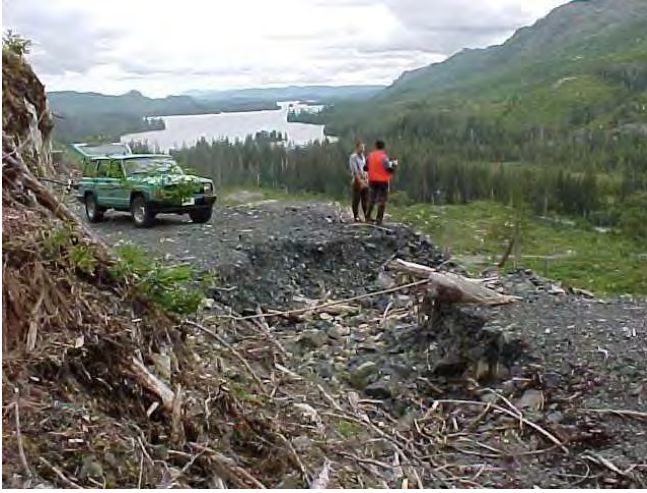
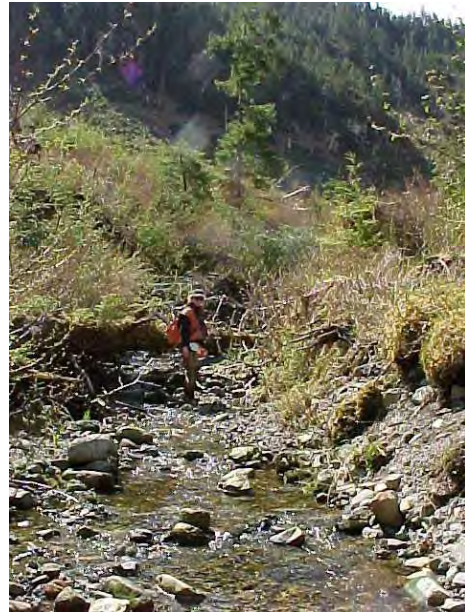
- Two culverts impede access to 2,000 feet of total stream habitat and 1,000 feet of anadromous habitat. Neither culverts meet ADFG fish passage standards.
- Opportunity to place LWD in Trib 4 in the lower MM1 reaches to improve fish habitat.
- Clean up blown-out crossing on Trib 3 (Photo 29).

Photo 29. Stream crossing failure on Trib 3 of Inlet Creek. Photo 30. Lower reach of Trib 4, Inlet Creek.

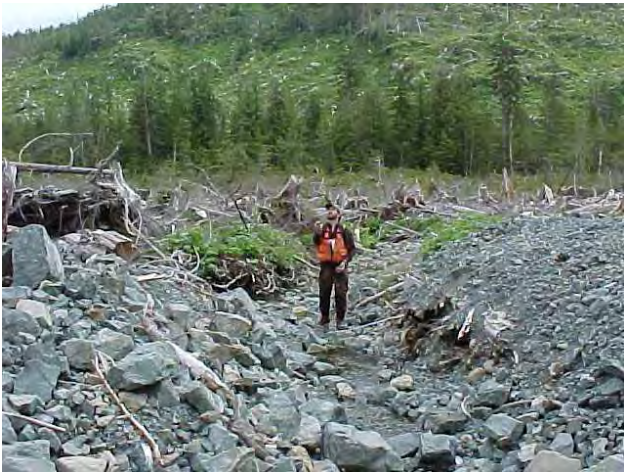
- Road is encroaching on floodplain.
- Stream habitat is degraded, LWD removed from stream.

Photo 31. Inlet Creek, tributary 7.

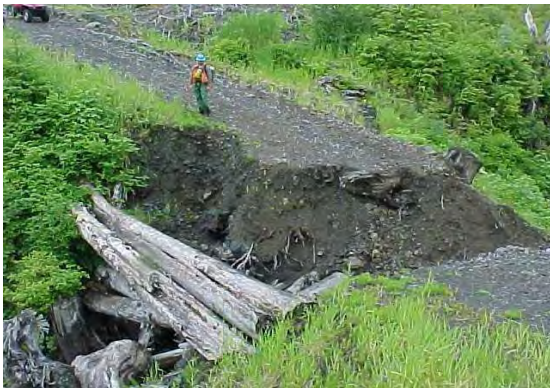
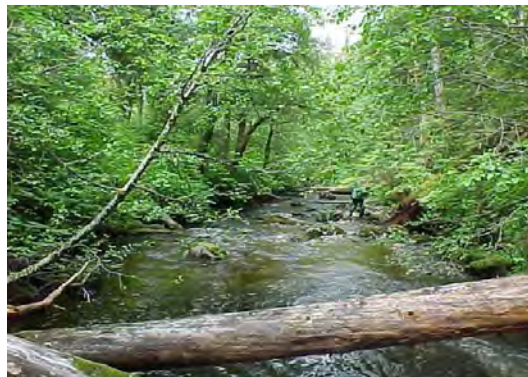
A CMP culvert plugged and failed on a large Class III tributary flowing into upper Tributary 2. This crossing failure is actively eroding and contributing fine sediment into reach HT2C (Photo 32). Tributary may be resident fish habitat.

*Photo 32. Blown stream crossing on small stream draining in to Trib 2 upper Hatchery Creek. Photo 33. Hatchery Creek, reach HT2C.*

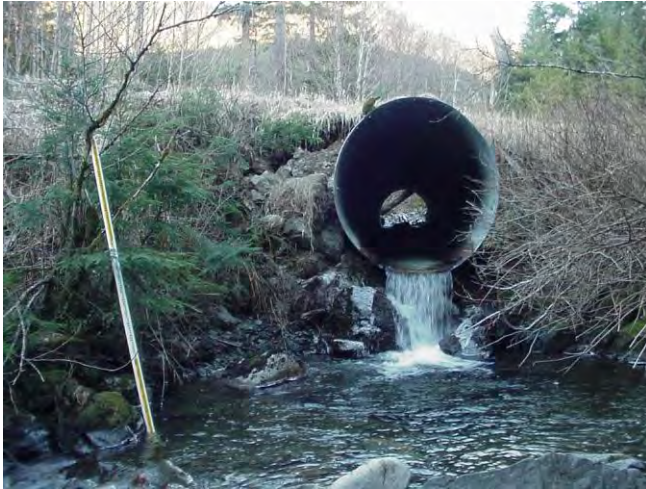
*Photo 34. 7-mile Creek culvert along Klawock Hollis Highway Crossing.*

- Allow fish access to 700 feet of habitat and improve movement of LWD downstream.

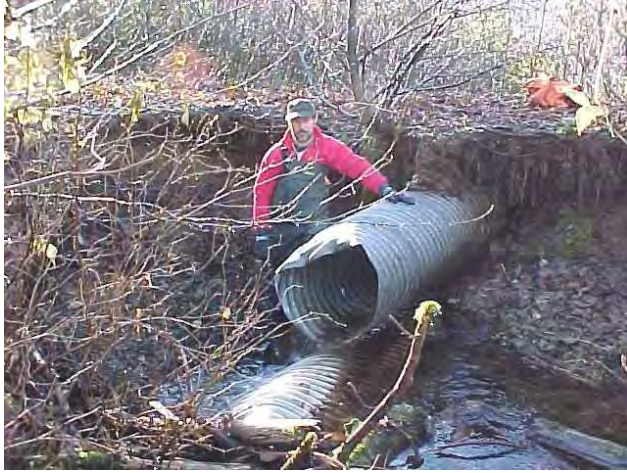
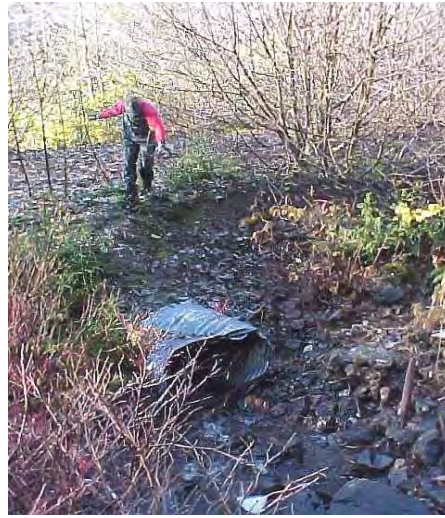
Photo 35 and 36. Non-functional culverts upper Arrow Creek, reach A2.

- Improve fish passage.
- Reduce erosion and habitat alteration.

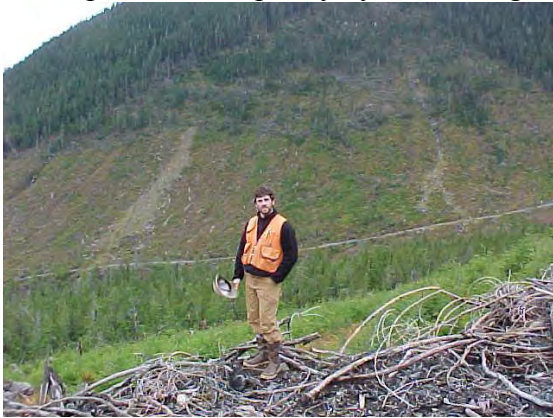
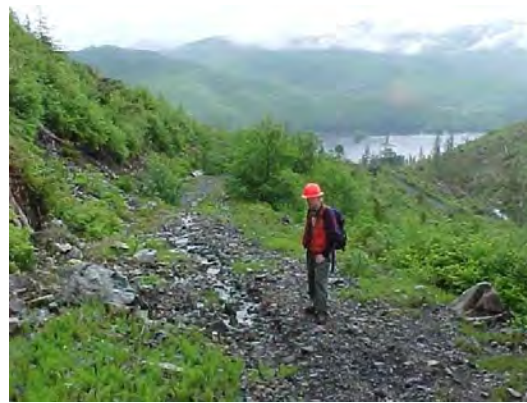
Photo 37. Landslides visible from Upper Bluewater Creek. Photo 38. Water on road surface from failed cross drain, upper Bluewater road system.

- Improve water quality by controlling erosion from roads, landslides and disturbed areas.

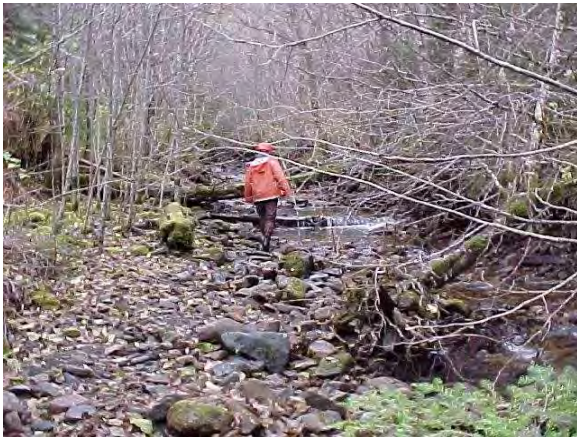
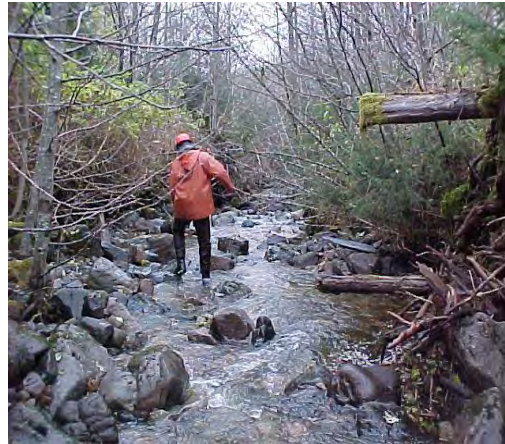
*Photo 39. Reach CL2 below main road, FP channel type transitioning to MM channel type. Note riparian composition and lack of LWD. Photo 40. Reach CL2, channel type MM1.*

- Improve stream channel stability and riparian condition.
- Evaluate condition of roads.
