Little Gunnuk Creek Site Visit

Date: 9/09/08 – 9/11/08

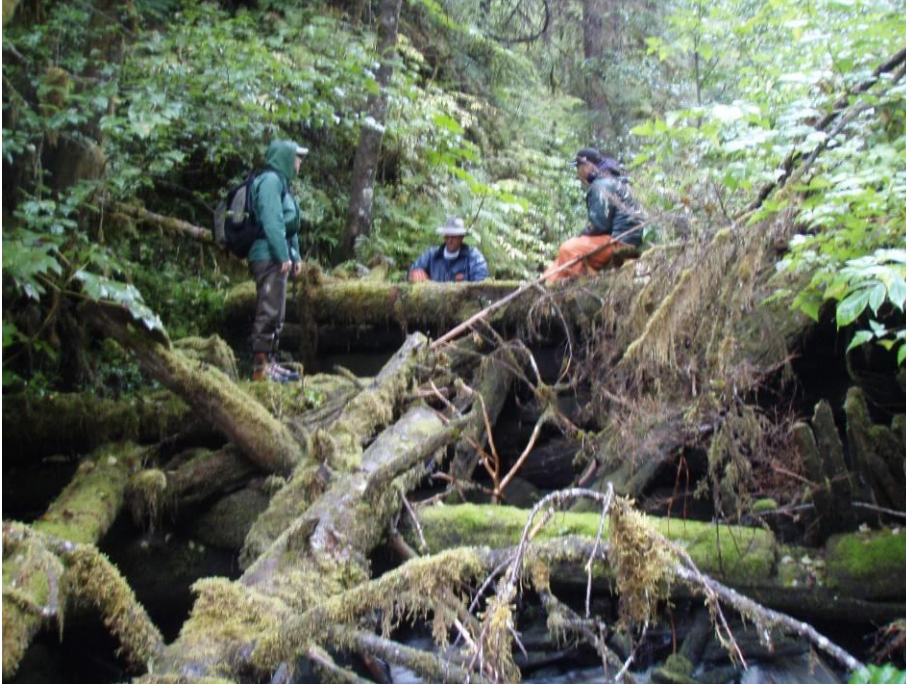
An old check dam approximately 0.25 miles upstream of the mouth was assessed for upstream passage. The dam is approximately 3m high, 5m across, and has withstood many years of flow without failure (according to Mike Jackson this dam supplied water to the old cannery near the turn of the century). Water flows under and through the structure, with a large space below the lowest log providing sufficient passage upstream (Photo 1).

Photo 1. Upstream view of old check dam on Little Gunnuk Creek.

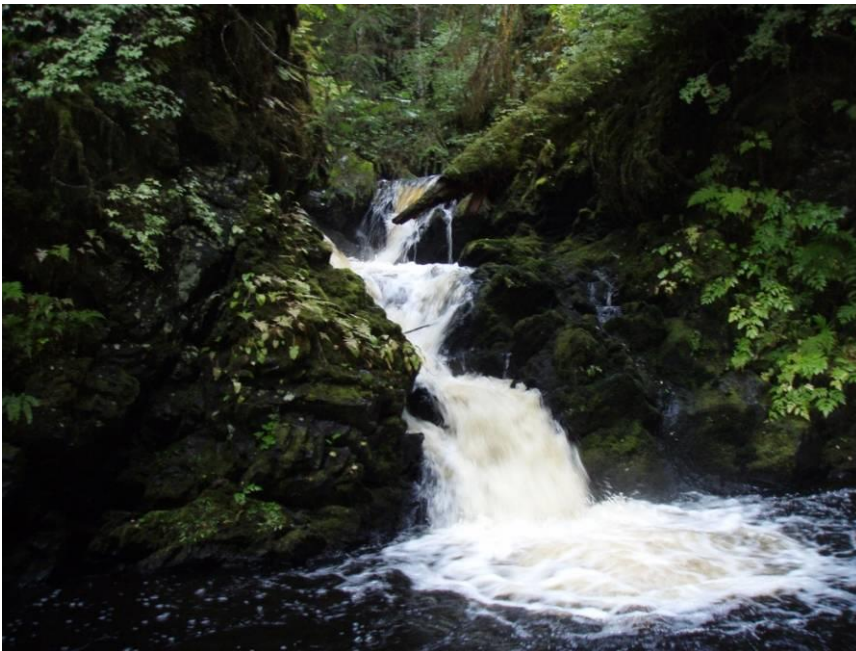
Approximately 100m upstream from the dam, a series of cascades was encountered. The first was a triple drop with a large pool at the bottom and was likely passable for adult coho (Photo 2).

Photo 2. First cascade upstream of dam.

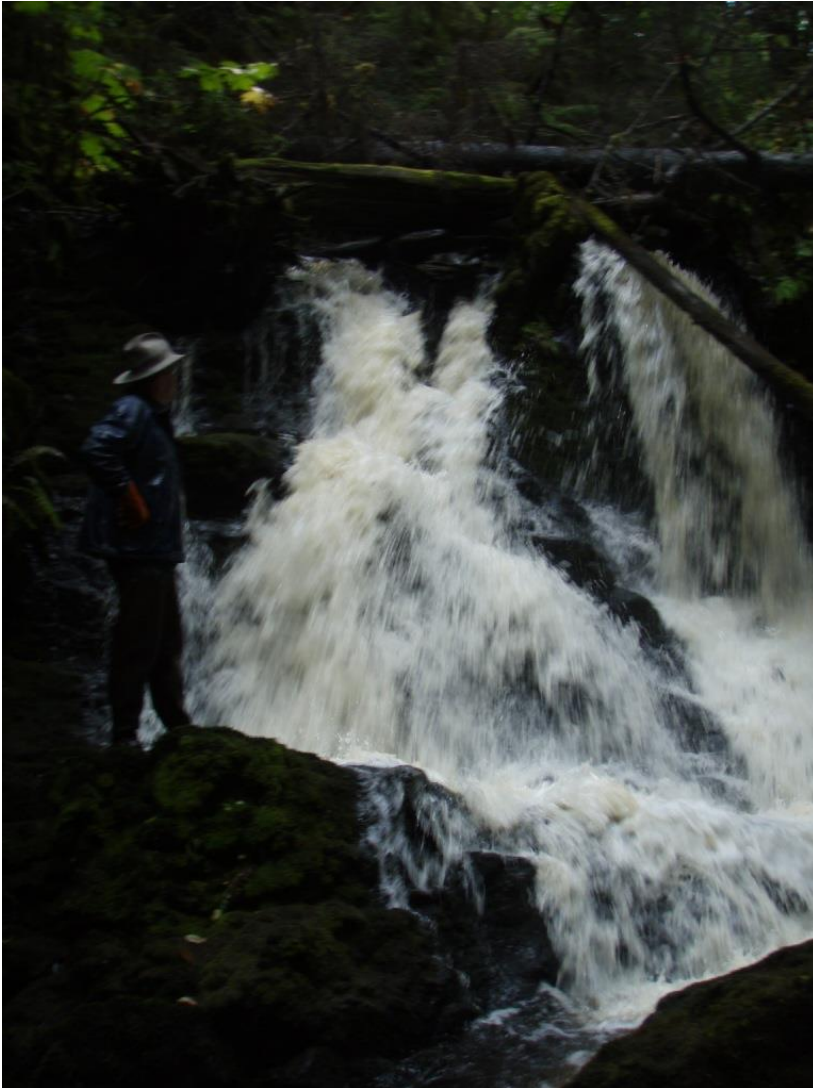
The second cascade was encountered shortly after the first. This barrier was approximately 4m high, and is likely a barrier to fish migrating upstream (Photo 3).

Photo 3. Second cascade encountered after dam. Likely a barrier to upstream migrating fish. Note Zack on the left for scale.

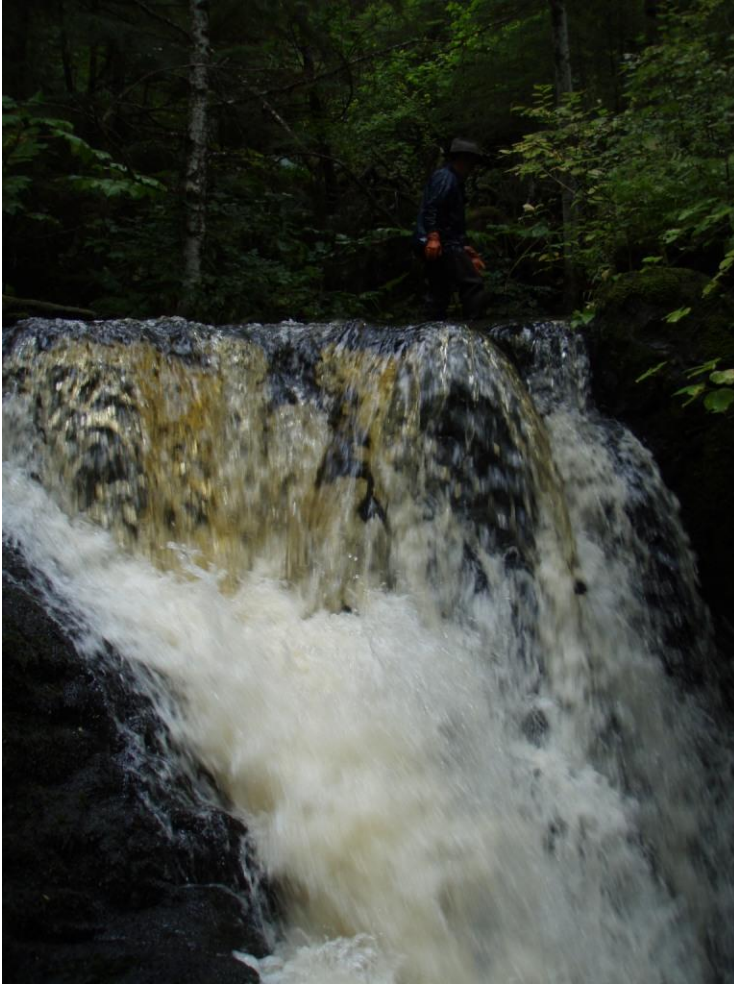
The third cascade was approximately 3m high and was encountered just upstream of the second. It appeared passable on the downstream right portion of the feature (Photo 4).

Photo 4. Third cascade. Note Zack upstream with orange gloves.

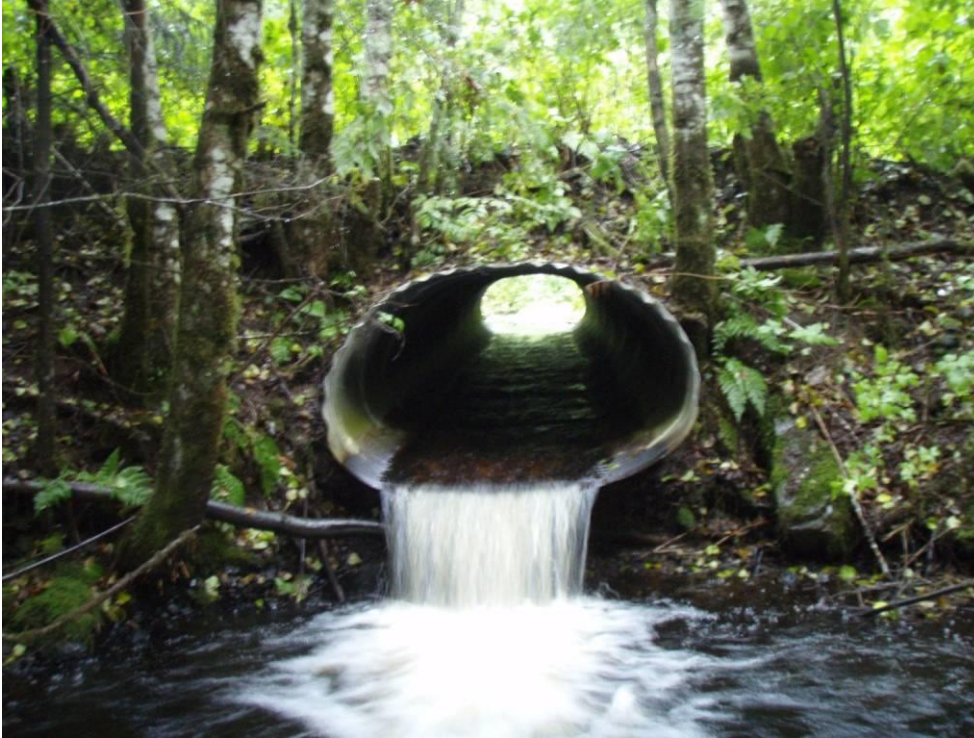
USFS personnel assessed the culvert at the Road 6308 crossing and conducted a Tier 2 stream survey on 9/9/08 and 9/11/08. Fish crossings on the Tongass National Forest are categorized red, gray, or green according to passage conditions. The Road 6308 culvert met Tongass criteria for a red fish crossing; those having a high certainty of not providing juvenile fish passage at all desired flow levels (Photo 5).

Photo 5. Culvert crossing on Road 6308 is likely juvenile fish barrier.

1. Replacement of the red fish culvert on Road 6308.
2. Radio tagging adult coho near the estuary to assess passage up the natural barriers and the extent of stream utilization beyond.
3. Environmental education in the form of a “watershed watch” modeled program with the Kake High School.

The fish culvert on Road 6308 falls under the ownership of Sealaska Regional Corporation and its replacement will depend on interest levels and potential funding sources, most of whom will receive copies of this report. There is a relatively high amount of quality spawning and rearing habitat upstream of the crossing, and replacement would be beneficial for resident populations. We will continue to work closely with the Gunnuk Hatchery on the possible tagging of adult coho in the fall of 2009. While we believe the second cascade is a barrier to upstream migrating adults, this could be validated with careful field observation and radio tagging. Several original stakeholders in this assessment effort have expressed interest in an environmental education component involving Kake Public Schools. Perhaps the tagging and subsequent tracking could be integrated into such a program. Details about what the environmental education will entail will depend on coordination with interested parties.

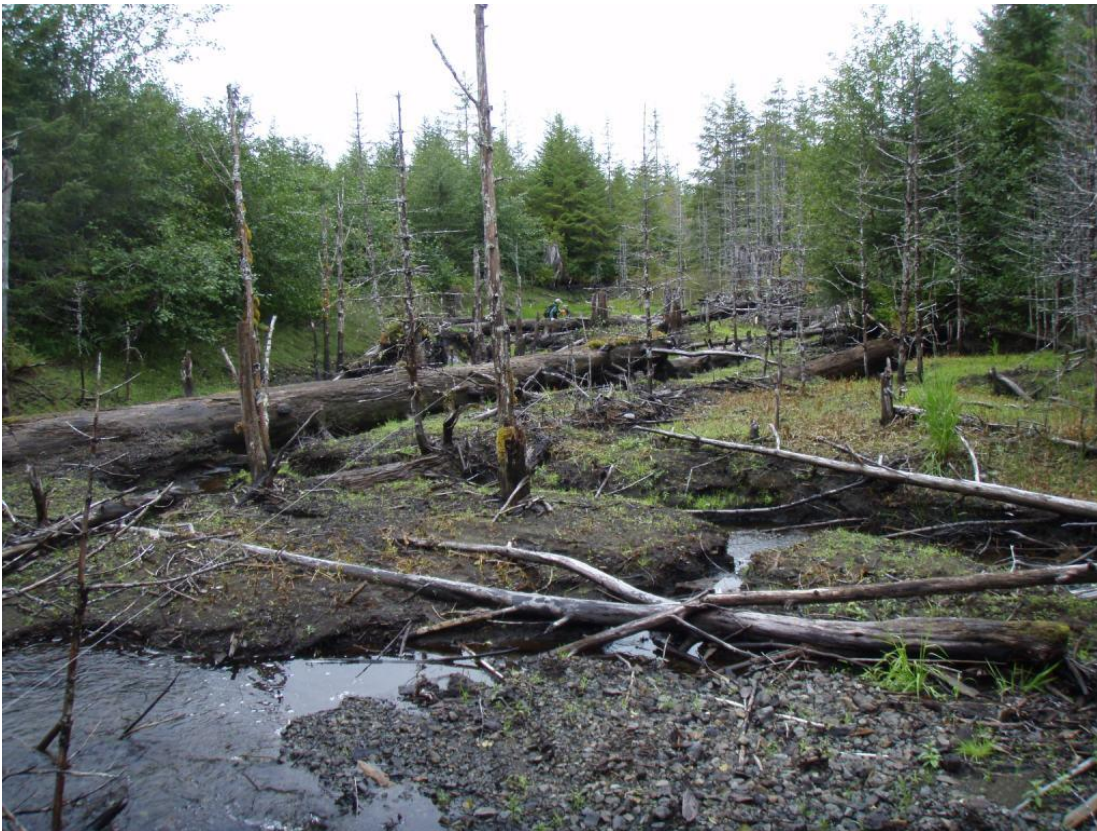
Three blown-out beaver dams were encountered hiking to the Tier 2 survey site, upstream of the culvert on Road 6308. The beaver pond furthest upstream was approximately 67m long, averaged 20m wide, and was 0.8m deep. The dams were breached recently based on vegetation regrowth within the “pool” footprint, and the stream was actively scouring through the sediment, creating a new channel (Photo 6). Approximately 1000 cubic meters of sediment remained at the time of the survey and will likely be transported downstream as the channel migrates with natural flow fluctuations (Photo 7; Photo 8). Fine sediment was observed in the stream from these dams to the large beaver complex below the road crossing.

Photo 6. Recently breached beaver pond near stream survey site.

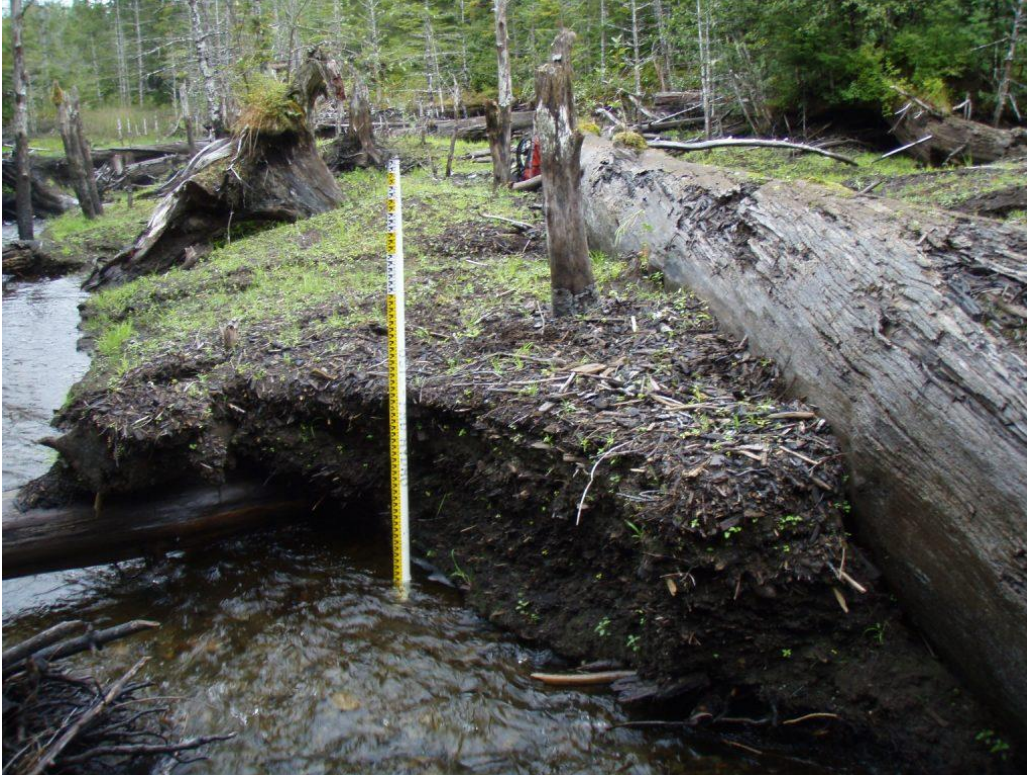
Photo 7. Fine sediment deposited in beaver pond.

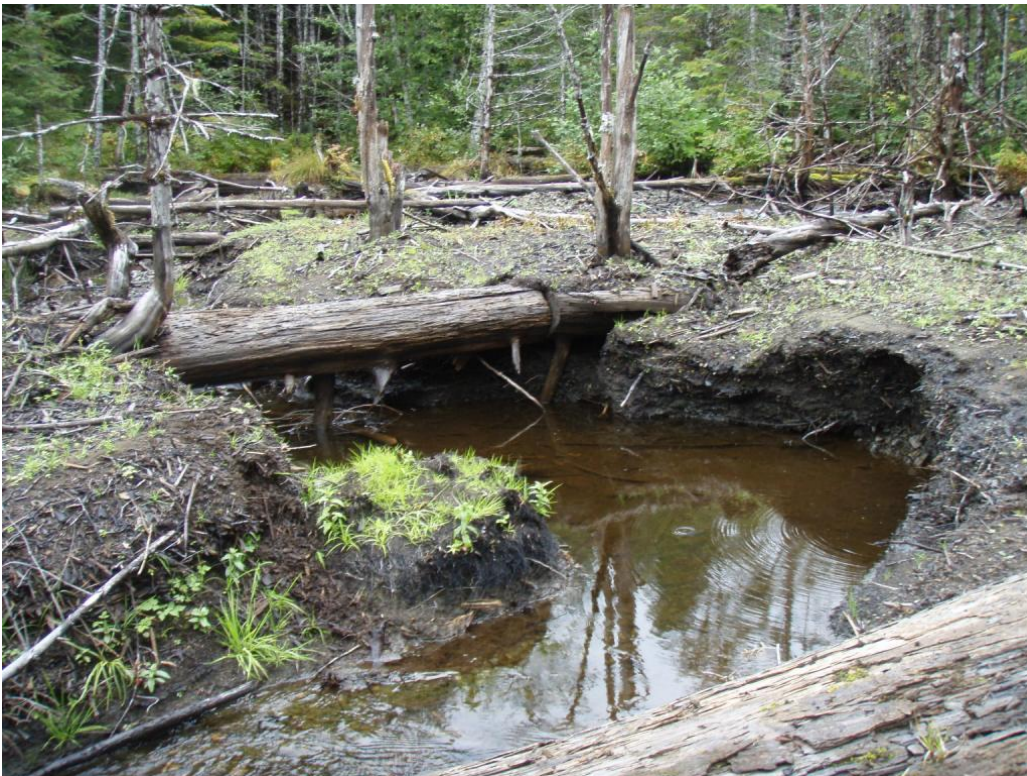
Photo 8. Active channel migration through beaver pond sediments.
