# Twelvemile Creek

## Mainstem Instream Restoration

### Monitoring Summary

Tongass National Forest, Craig Ranger District

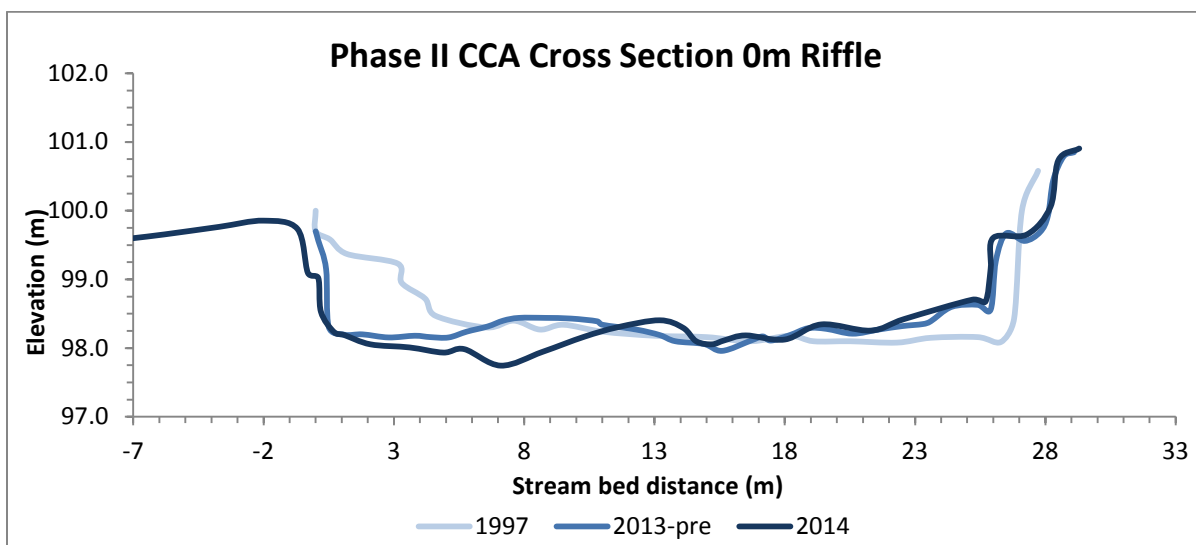
**Figure 5: Cross section profile of the 0m riffle, looking downstream.**

The riffle at 0 meters appears to have shifted thalweg locations from 1997 (thalweg on the right) to 2013/2014 (thalweg on left) (Figure 5). This would not be out of the ordinary considering the elapsed time and the nature of floodplain channels. Despite shifting, the width/depth ratio has remained fairly consistent through time. Immediately post restoration there was a decrease in depth and an increase in W/D ratio, possibly reflecting the presence of wood from Treatment site 18 which is in the immediate vicinity. These numbers returned to pre-project conditions in 2014.

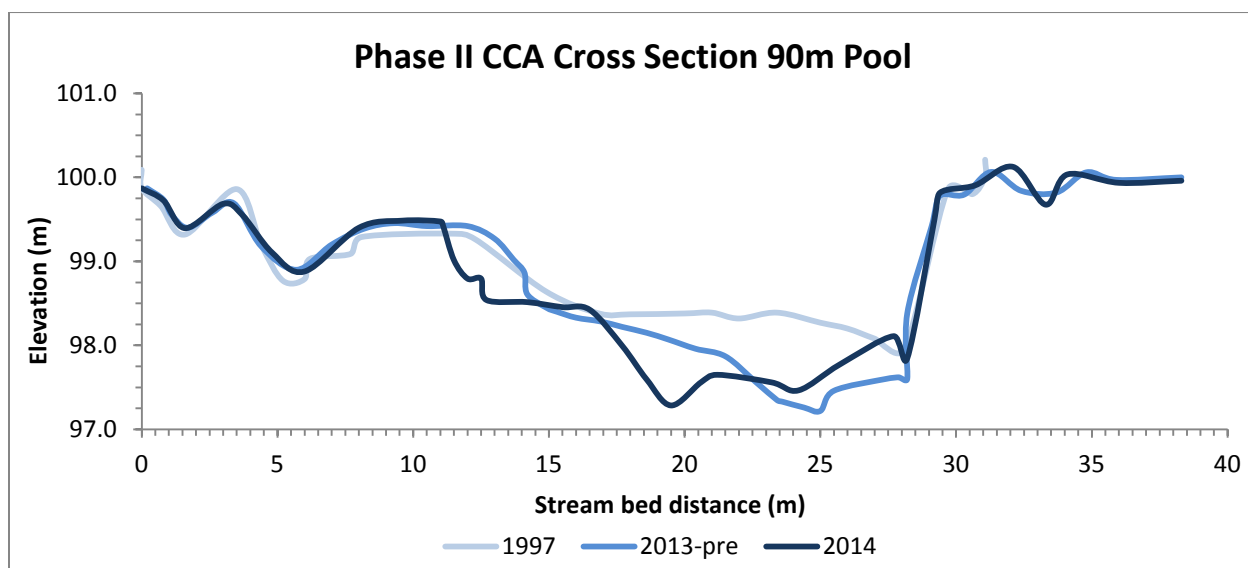
Figure 6. Cross section profile of the 90m pool, looking downstream.

The 90m pool showed little change between pre and post 2013; however a slight increase in both width and depth in 2014. There was also a decrease in W/D ratio in 2014. This is the same pool shown in the photos of Treatment site 17 in Figure 13. Observations during photo point and structure objective monitoring have also indicated expansion of the pool and slight widening on the left bank in 2014, possibly due to the wood placement and/or the high flow events of 2013.

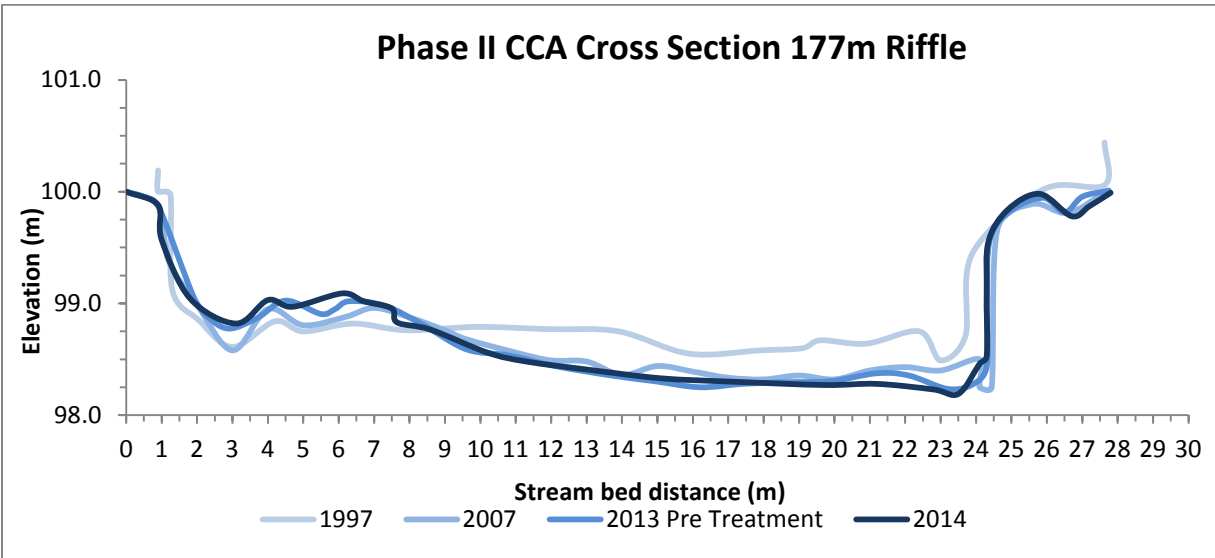
Figure 7. Cross section profile of the 177m riffle, looking downstream.

The 177m riffle has had consistent depths, but has changed in width, W/D ratio, and particle size over time (Figure 7). The left bank here was affected by a large legacy piece of wood present from prior to 1997 to 2013, which made discerning bankfull widths difficult. During implementation in July of 2013 the piece was shifted into the channel and subsequently mobilized downstream during a flow event in September 2013, where it remains, acting as a key piece forming a large channel spanning structure. This shift in wood may explain the increased width, increased W/D ratio, and decreased particle size at cross section 177m in 2014. Additional surveys will better show how this site adjusts to both the increased wood from restoration and the annual channel forming floods.

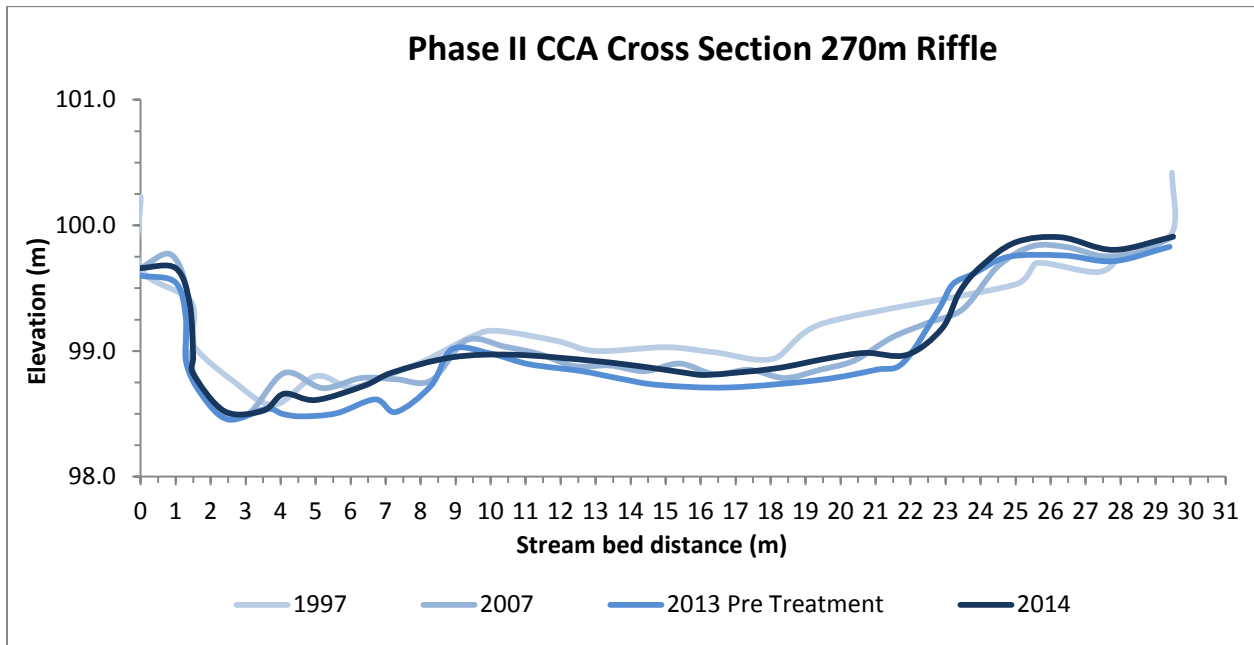
Figure 8. Cross section profile of the 270m riffle, looking downstream.

There is little consistency in the data from the 270m riffle (Figure 8). Overall, the W/D ratio has decreased through time and the D50 has remained relatively stable.

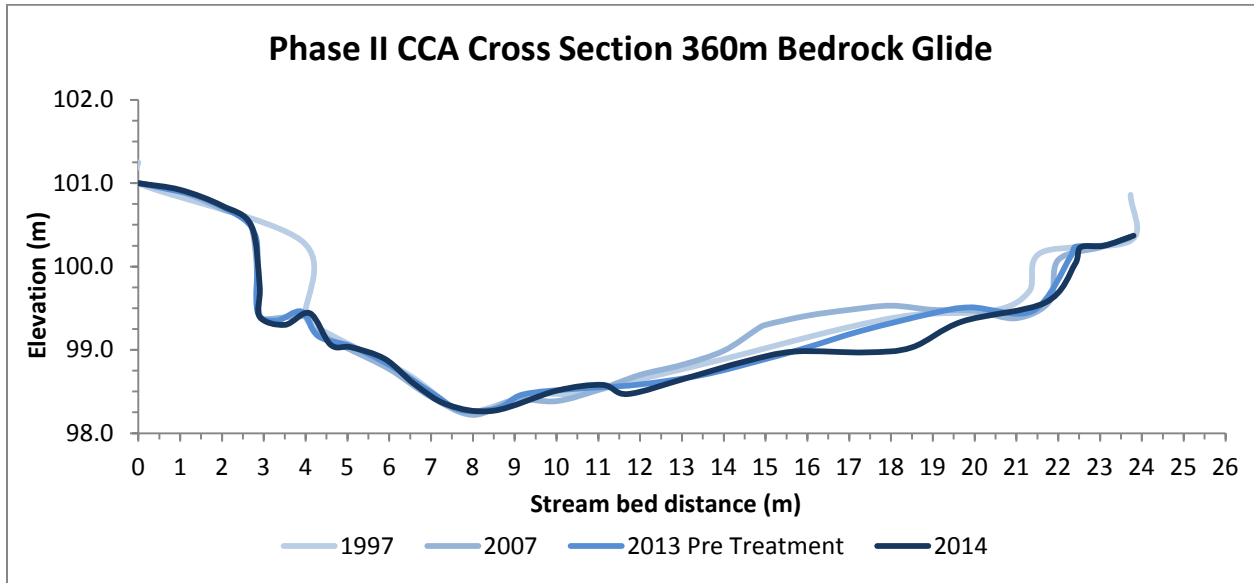
Figure 9. Cross section profile of the 360m glide, looking downstream.

The 360m glide cross section is in a bedrock reach (Figure 9). The widths are fairly consistent but depth and subsequently W/D ratio were different immediately post-project than all other surveys. The site has returned to pre-project conditions. Bankfull heights are difficult to determine on the left bank.

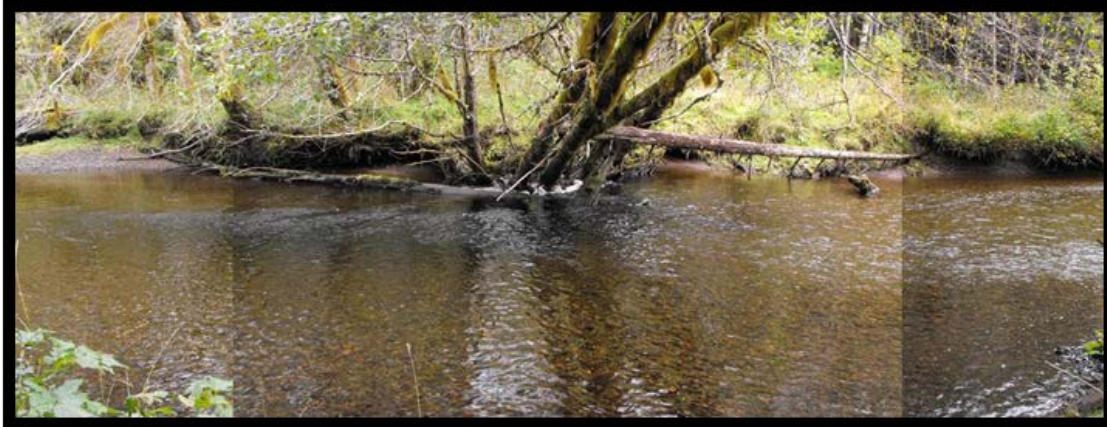
Pre- Project

- shallow pool
- little complexity
- alder at risk

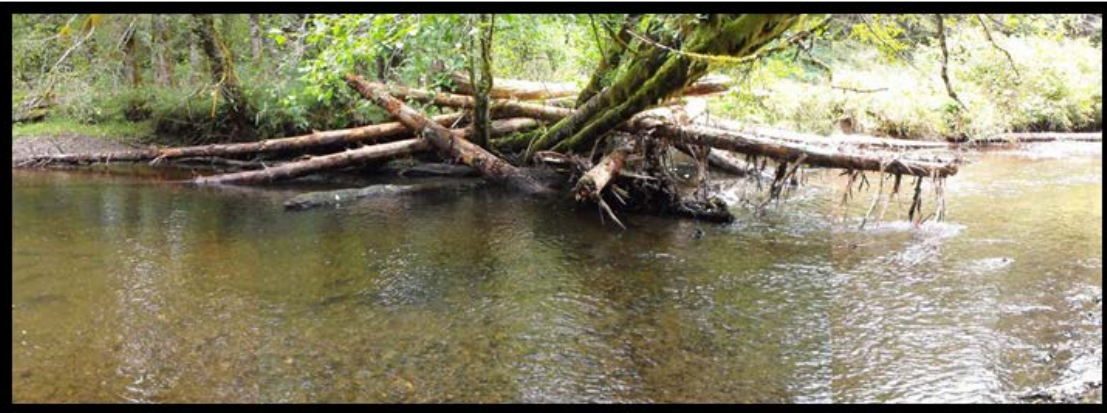
Post- Project

- increased wood
- more complex
- alder retained

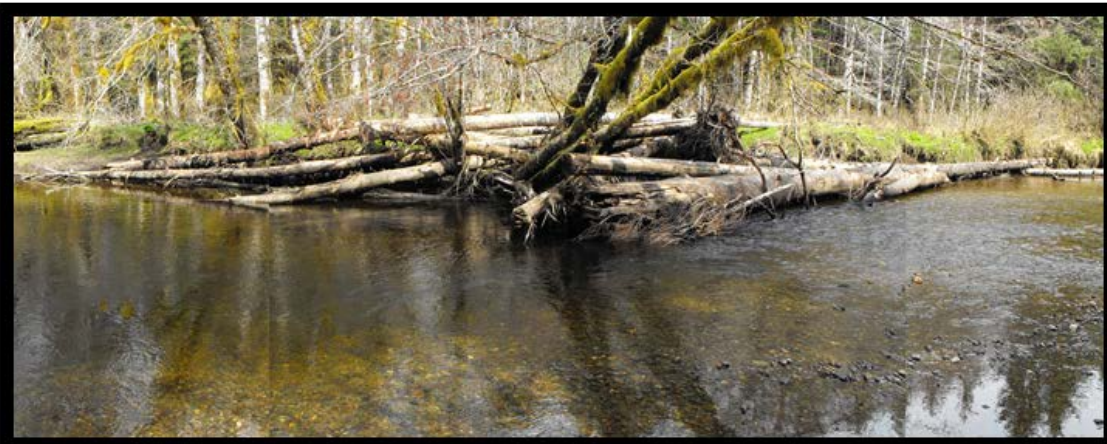
Spring 2014

- developed pool
- complex cover
- some wood lost
- some wood gained
- alder retained

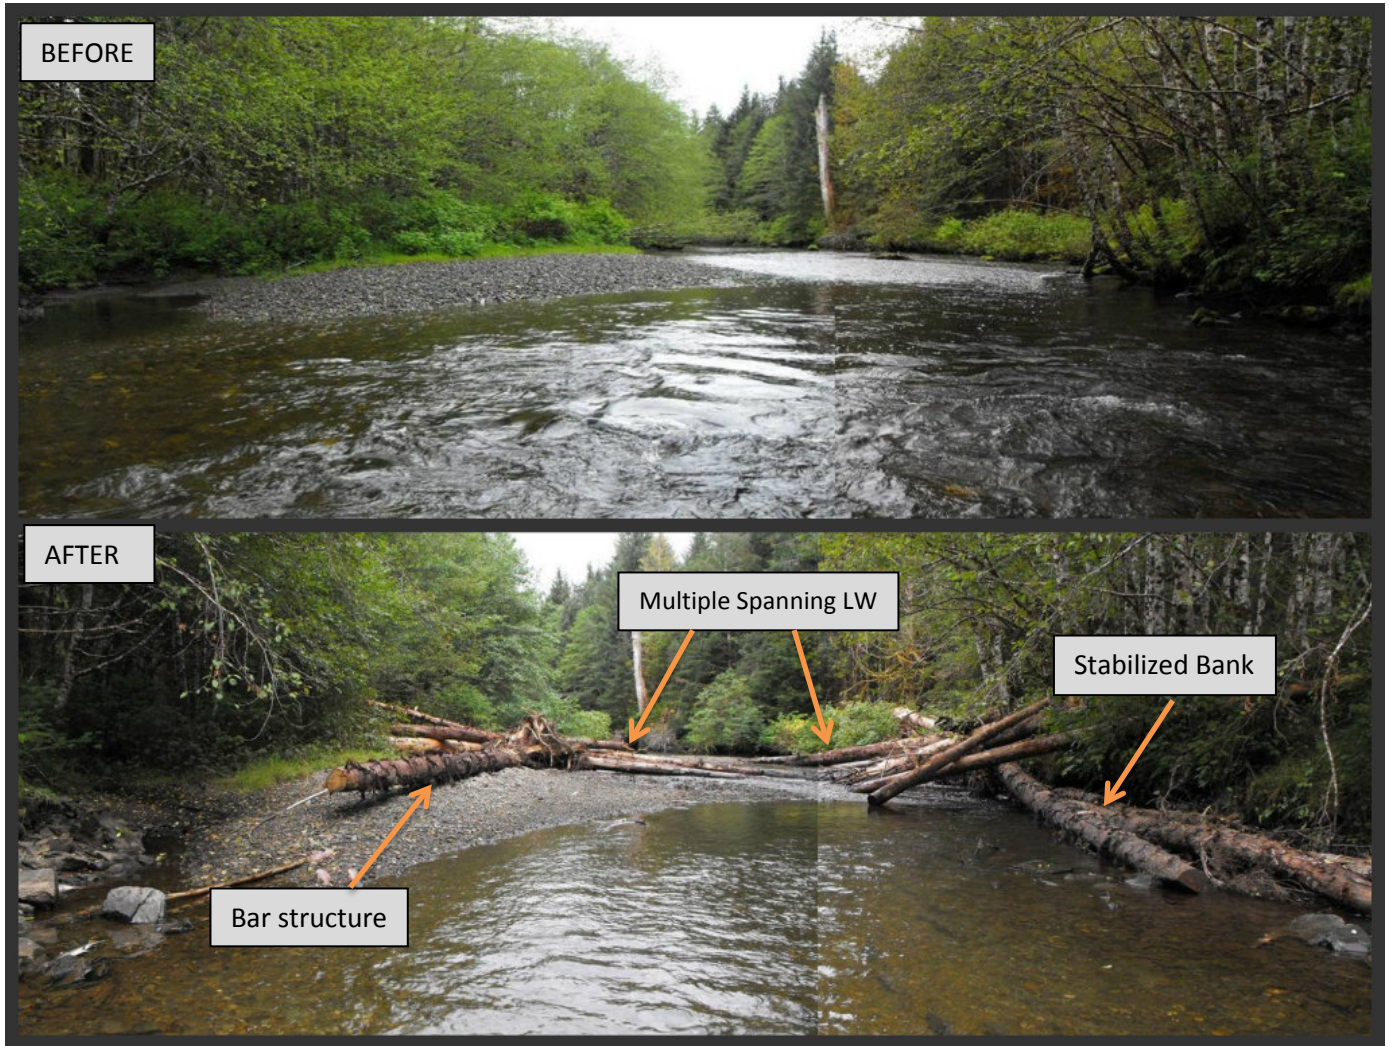
**Photo set 1 – Phase II, Structure Number 16, looking downstream right bank before and after LW placement.**

This photo is looking downstream at an example of a multifaceted structure with multiple objectives. This structure will stabilize a rapidly eroding bank, improve the quality of the pools along the bank, and improve surface water connection of side channel beaver habitat immediately upstream of the structure. The three facets of this structure (the bar structure, the channel spanning members, and the stabilized bank) will work together to achieve these objectives. The bar structure will encourage deposition on the bar to reduce the width/depth ratio and focus flow through the pool, the spanning members will encourage scour, and the stabilized bank will provide a hard, stable bank to scour against.

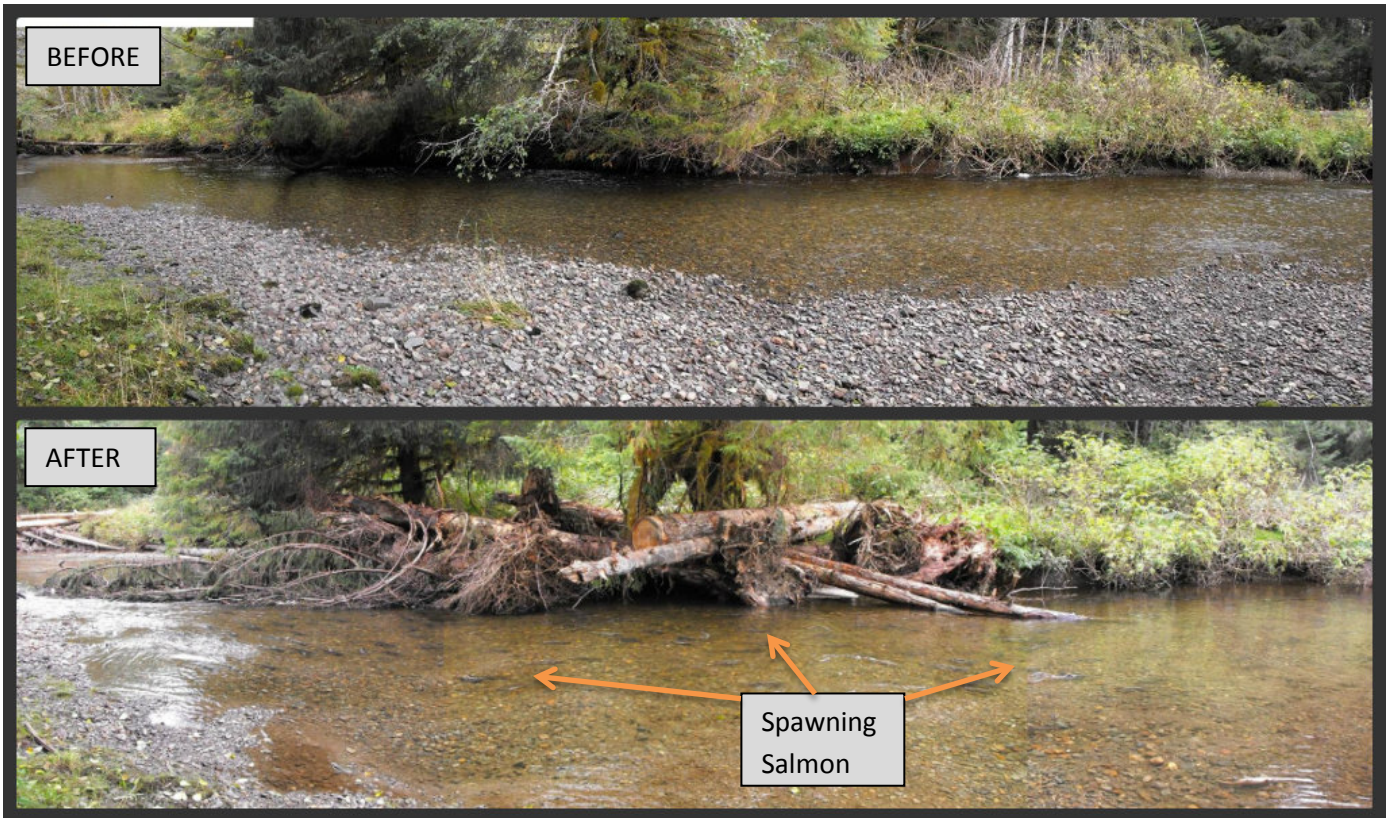
**Photo set 2 – Phase II, Structure Number 16.5, looking downstream right bank before and after LW placement.**

The objective of this multifaceted LW placement is to protect the bank from further erosion and provide cover for fish. In addition, there is a row of conifers on the downstream right bank which the stream was undercutting. These conifers were at risk of being undercut before they were mature and could become future, naturally occurring, LW in the stream system. Fish can be seen in the bottom photo.

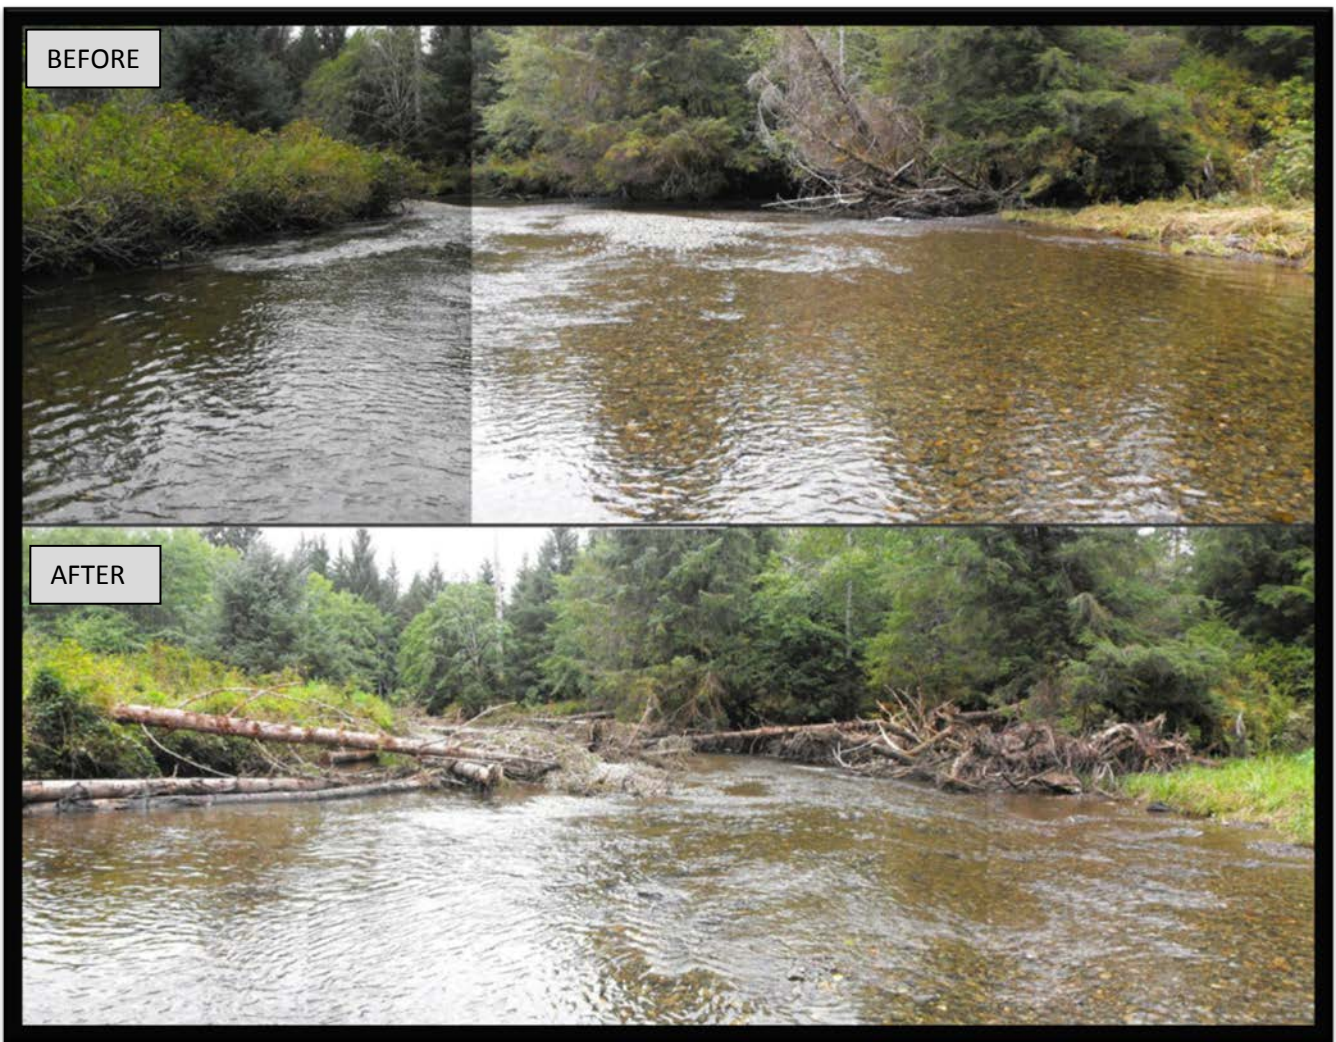
**Photo set 3 – Phase II, Structure Number 18, looking downstream before and after LW placement.**

This site had small remnant wood within the reach and a mid-channel bar. The objectives are to maintain and enhance the existing small jam, build scour and cover for the downstream right bank pool, construct an apex jam to maintain split flow, protect the left bank along the riffle, add floodplain wood to the left bank, construct a bar on left bank and place a formidable multi-faceted structure on the right bank.

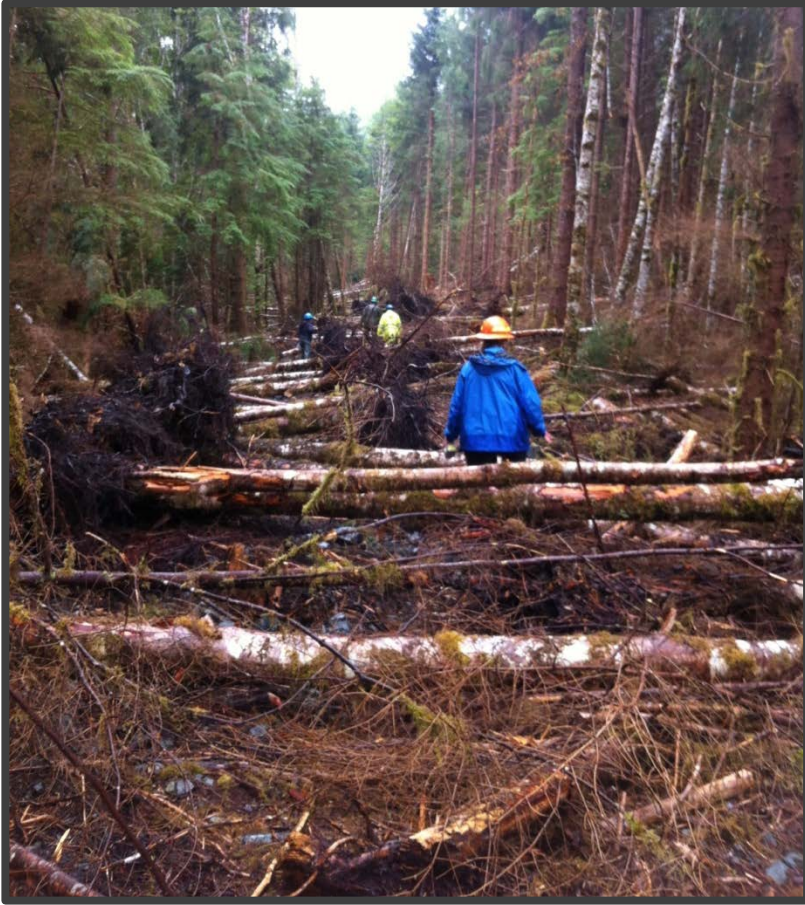
**Photo 4 - Road decommission.**

This photo is of a road that was decommissioned in the Twelvemile watershed. Fallen trees help reduce erosion and sediment loads to nearby waterways. All structures on this road were removed using heavy equipment. Downed alders were placed to prevent motor vehicle access, and seed was applied at the disturbed ground sites to further reduce erosion.

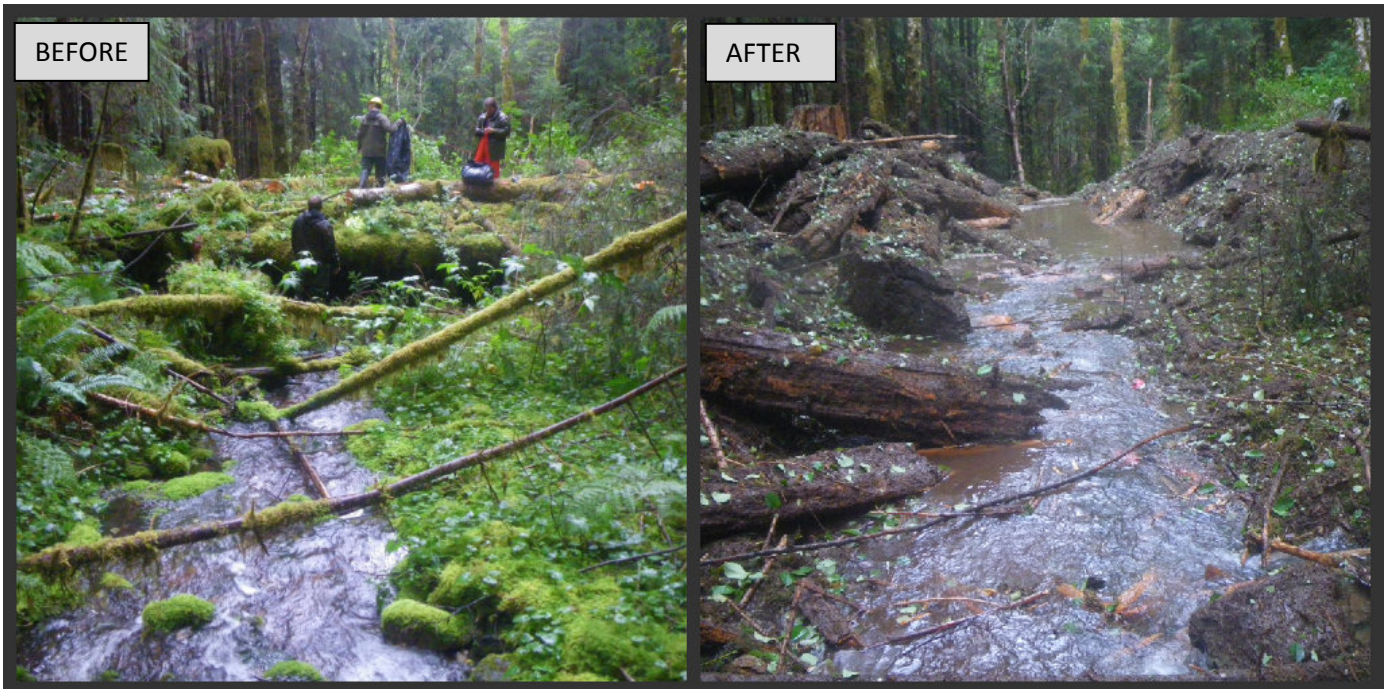
**Photo set 5 – Road decommissioning before and after treatment.**

The Twelvemile watershed improvement included the storage and decommissioning of abandoned, or ‘legacy’, logging roads. This photo displays a bridge that was removed with explosives because it was not easily accessible with heavy equipment, the typical method for removing such structures. This technique is utilized to treat specific sites that pose resource risk on roads with limited access, without creating the disturbance and expense of heavy equipment operation. The use of explosives is an effective way to remove log culverts and log bridges and create waterbars. Turbidity--seen in the post-treatment photo on the right—is a temporary, localized effect of instream restoration and subsides to clear water baseline conditions within a few hours. The long term intent of these actions is to reduce the erosion and the transport of road fill into streams, restore hydrologic connectivity, and improve aquatic species migration where possible.
