ALPINE PIPELINE RIVER CROSSINGS 2009 MONITORING REPORT

ConocoPhillips
Alaska

Michael Baker, Jr., Inc.

September 2009
117009-MBJ-RPT-001

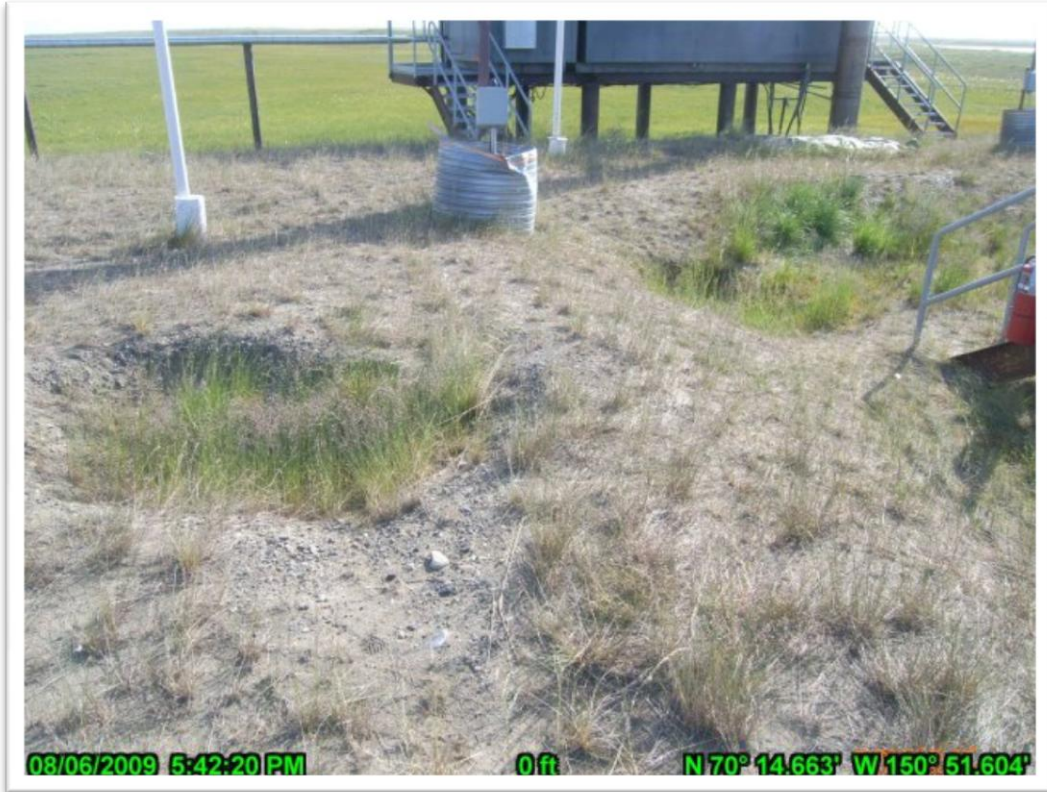
Several “pits” were noted in the gravel pads near the buildings at HDD West. These are shown in Photo A.5 and Photo A.6 in Appendix A. All three pits are located west of the large propane tanks, and generally east of the two CP Module buildings. The origin of these pits is not known.

Pit #1 is the northernmost pit, located north of both CP Module buildings, but south of the 2-inch diesel line. This pit is 5 ½' x 8 ½' x 3 ½' deep.

Based on visual observations, measurements, and survey results, there appeared to be no settling, or jacking of VSM or foundation piles. The HDD west bank gravel pad is largely free from erosion, although three large pits are present on the pad. The origin of the pits is not known. The pipelines appeared to be in good, stable condition with no leaks. No ponding, cracks, depressions, or pressure ridges were evident over the pipeline axis.

PHOTO A.5 HDD WEST, AUGUST 6, 2009. VIEW OF PITS IN GRAVEL PAD BETWEEN CP MODULE BUILDINGS.

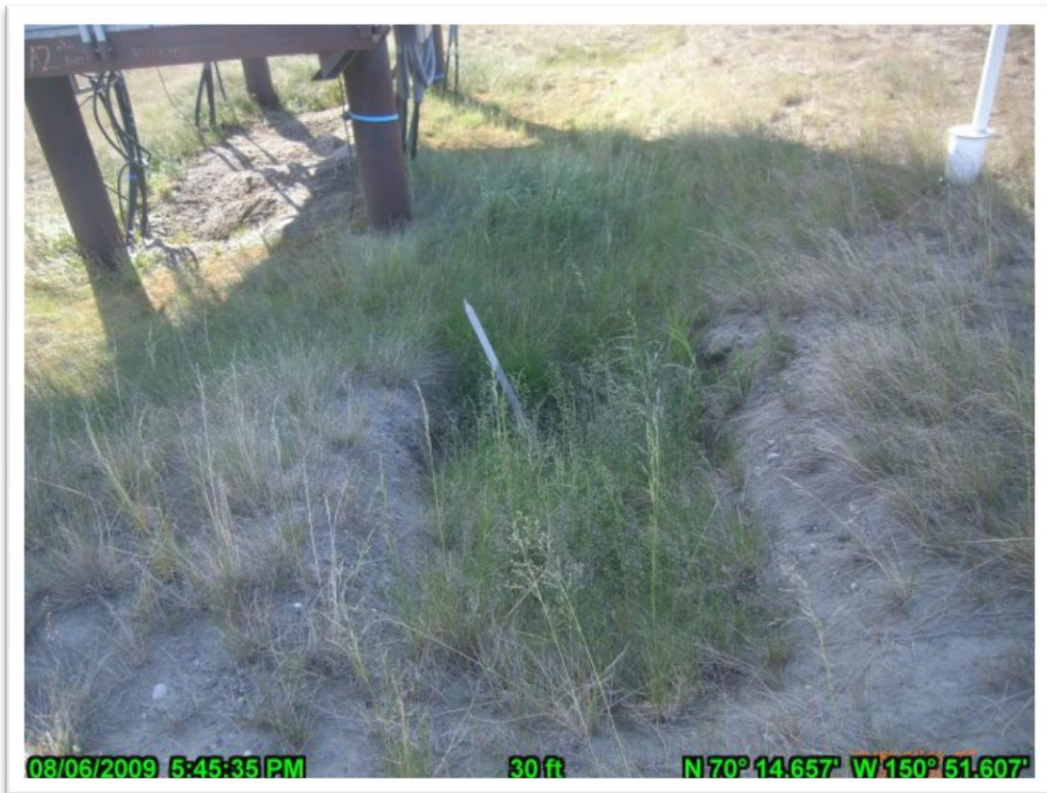
PHOTO A.6 HDD WEST, AUGUST 6, 2009. VIEW OF PIT IN GRAVEL PAD NEAR PROPANE TANKS.

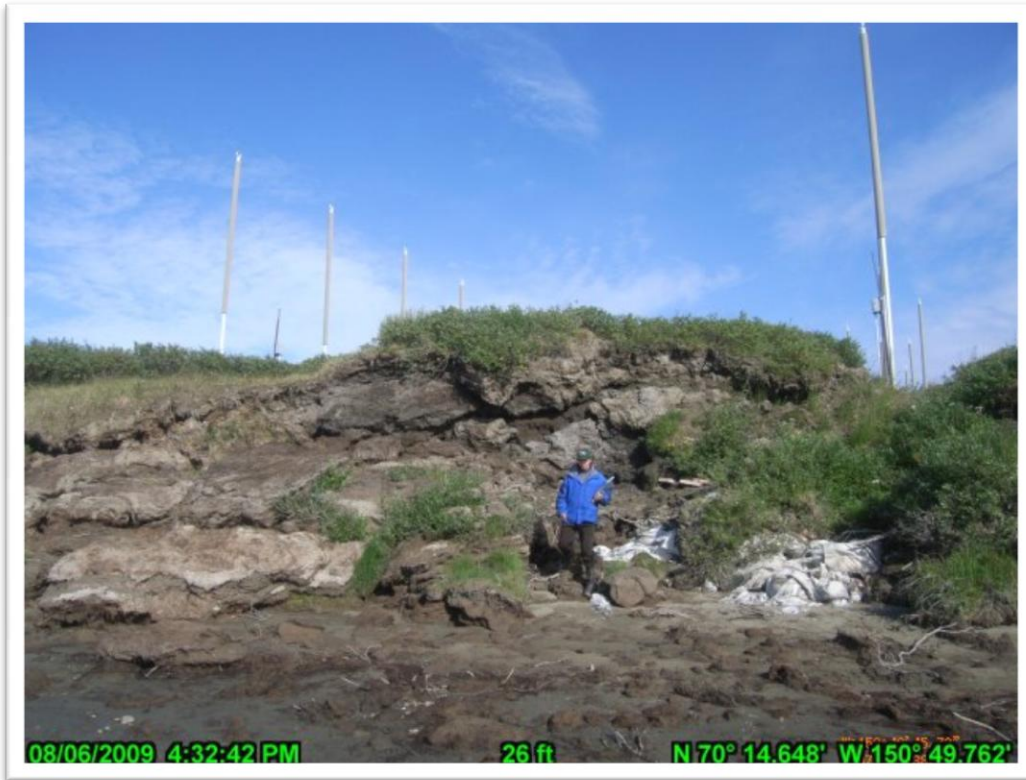
Visually, some erosion and sloughing has occurred along the east bank, with exposed sandbags and Styrofoam evident. It is our understanding that the sandbags and Styrofoam were placed in the bank to combat further erosion. The date of that placement is not known. As noted during the field visit, some large shrubs have fallen down the embankment into the channel. (Photo A.9 and Photo A.10 in Appendix A).

PHOTO A.9 HDD EAST, AUGUST 6, 2009. VIEW OF EAST BANK FROM CHANNEL.

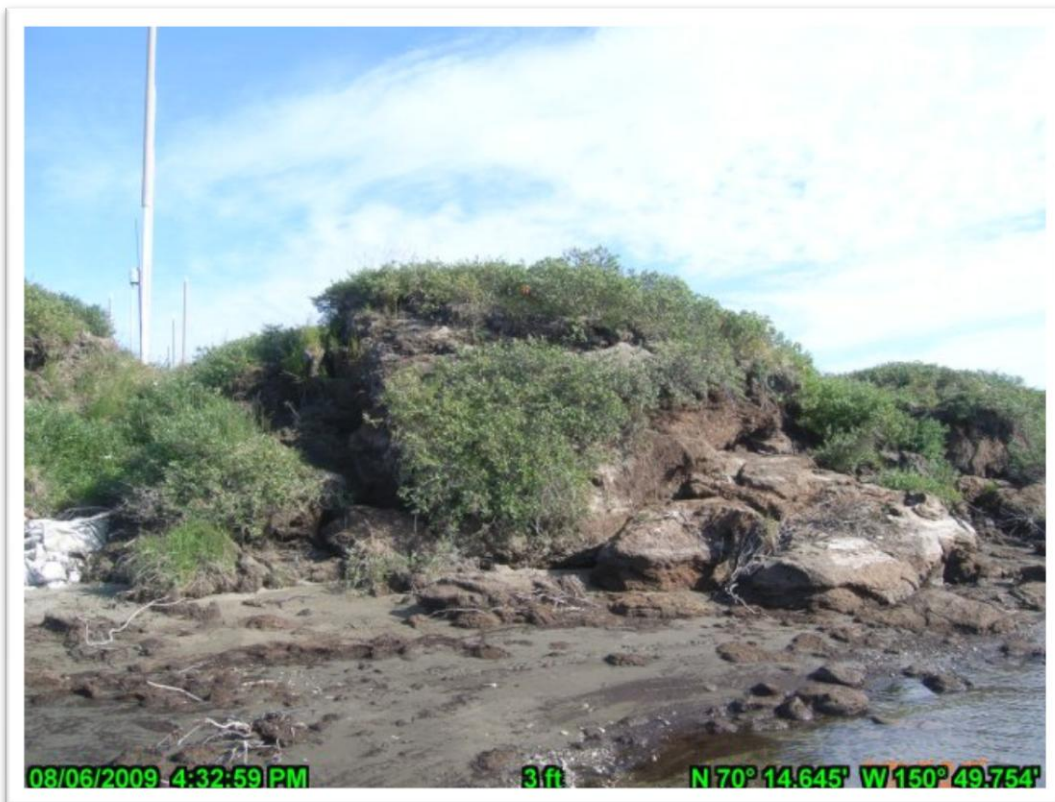
PHOTO A.10 HDD EAST, AUGUST 6, 2009. VIEW OF EAST BANK FROM CHANNEL, LOOKING SOUTHEAST.

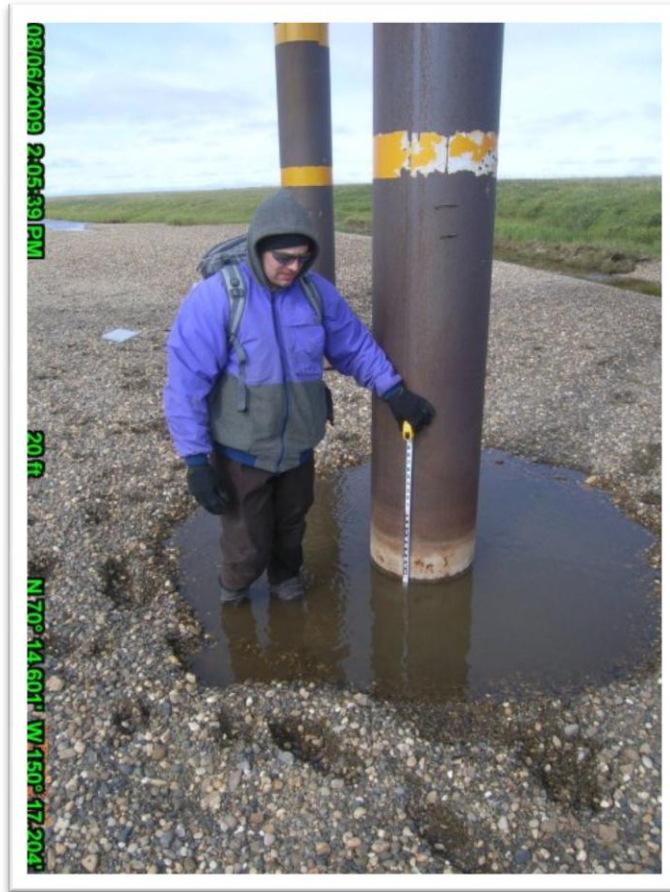
Visual observations and measurements were collected to evaluate pier scour for those VSM located within the active Miluveach River channel. No excessive scour was observed at the base of any VSM located within the channel or floodplain. The design scour limit for the main channel of the Miluveach River is 35.1 feet BPMSL; however, no topographic survey was conducted this monitoring cycle. Table 3.10 illustrates the field scour measurements.

PHOTO A.27 MILUVEACH RIVER CROSSING, AUGUST 6, 2009. VIEW OF VSM SCOUR HOLE.

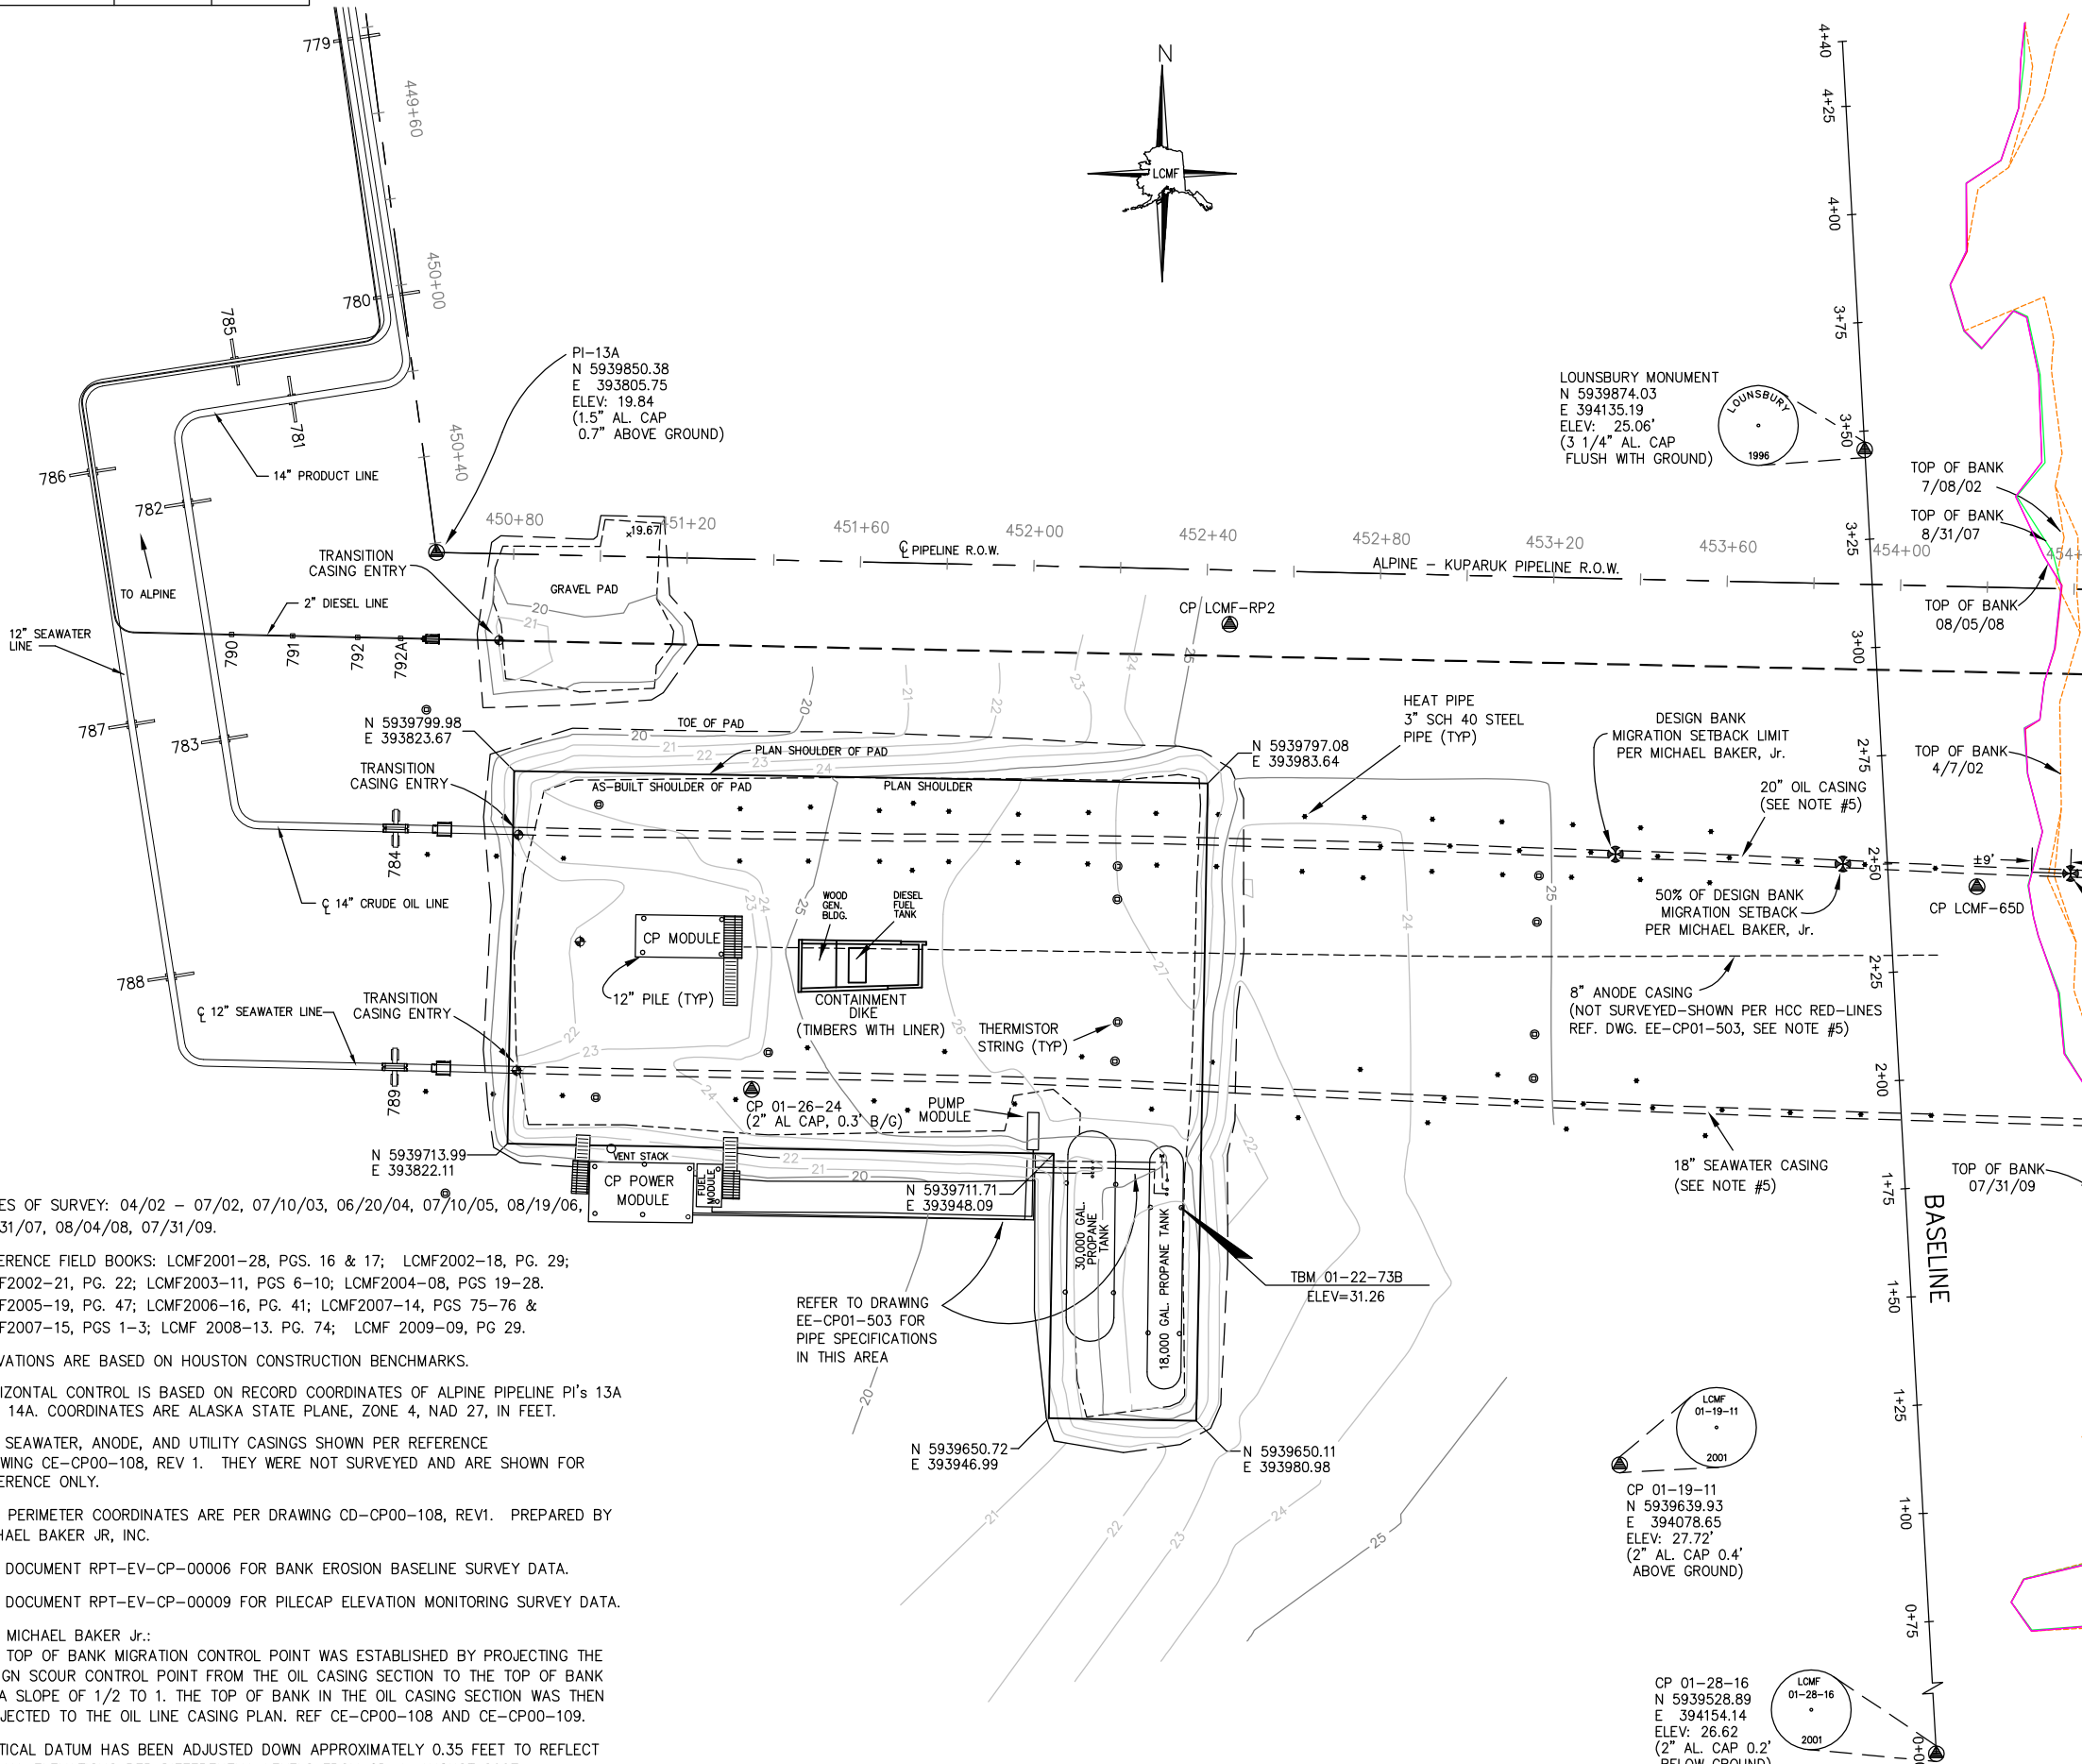
The greatest bank erosion observed between the 2008 and 2009 monitoring events was 2.0 feet, occurring at Station 0+20, approximately 230 feet upstream (south) of the oil pipeline centerline, as identified on the LCMF topographic survey. The oil pipeline centerline is located at Station 2+50 on the topographic survey (Appendix B).

A maximum erosion of 18.7 feet, between April 2002 and August 2009, was measured along the top of bank at Station 3+70, located 120 feet north of the oil pipeline centerline (STA 2+50). This erosion value is unchanged from 2008. This value yields a maximum average rate of 2.6 feet/year at this location over the monitoring period. The average rate of erosion for 2009 along the 440-foot top of bank was measured to be 0.14 feet/year. This is less than the observed historic average rate of 0.46 feet/year, and less than the estimated maximum erosion rate used for design of 2.3 feet/year (Baker 1997). A summary of the LCMF surveying results for the HDD West Bank crossing is presented in Appendix B.

In 1997 Baker established a scour control point at the centerline of the NPS 14 oil pipeline, as shown on HDD Bank Monitoring HDD Site-West, as provided in Appendix B. Comparing the location of the 1997 scour control point to the 2009 LCMF survey data, approximately 9.0 feet of bank erosion has occurred over the 12 year period since 1997 (0.75 feet/year). This rate equals approximately 9% of the design setback of 105 feet. The west bank erosion has not yet reached the 50% design setback. If at some point in the future the bank “migrates 50% of the design setback, erosion rates or possible mitigation measures will be evaluated” (Baker 1999).

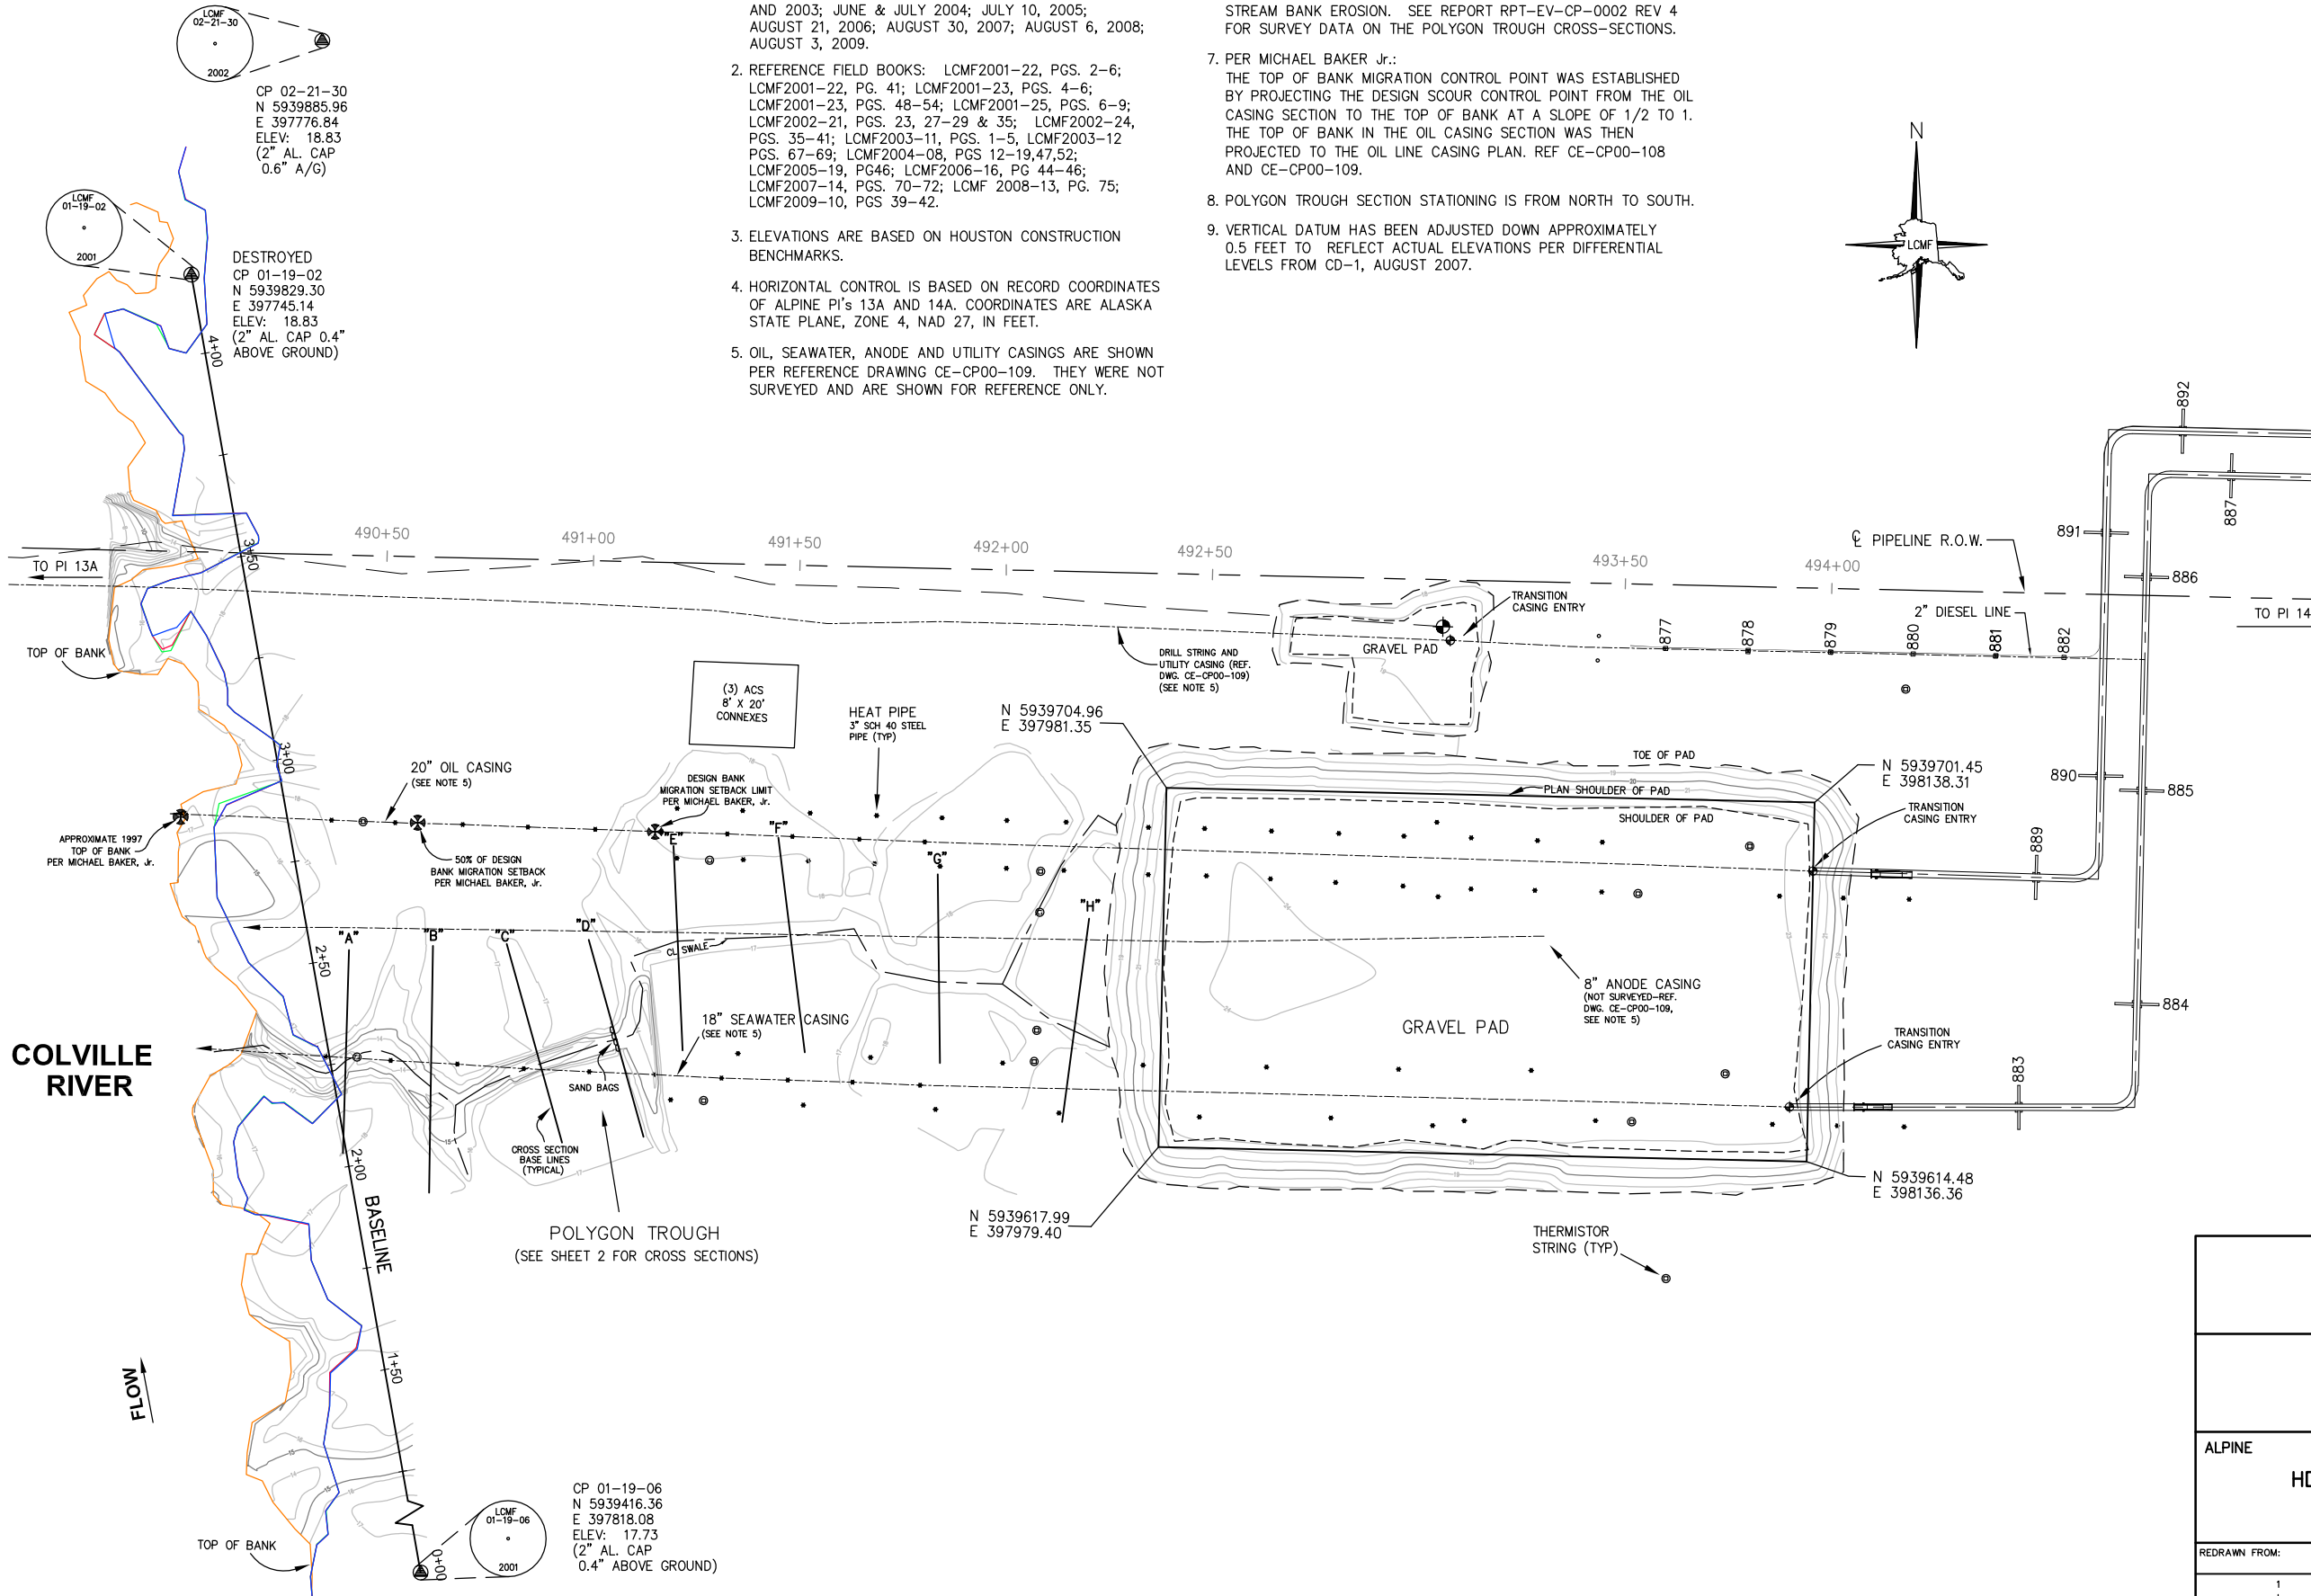
The greatest bank erosion observed between the 2008 and 2009 monitoring events was 2.9 feet occurring at Station 0+25, 255 feet south of the approximate NPS 14 oil pipeline centerline (STA 2+80).

Between August 2001 and August 2009, a maximum erosion of 33.2 feet at the top of bank was measured at Station 4+15. This location is approximately 135 feet north of the oil pipeline centerline (STA 2+80). This value yields a maximum average erosion rate of 4.2 feet/year over the 8-year monitoring period at this location. The average rate of erosion for the 2008-2009 period, as measured along the entire 450-foot top of bank, is approximately 0.02 feet/year. This value averages both erosion and deposition. This is less than both the observed long-term historical average erosion rate of 1.4 feet/year, and the estimated maximum design erosion rate of 2.5 feet/year (Baker 1997). A summary of the LCMF surveying results for the HDD East Bank crossing is presented in Appendix C.

Approximately 9.2 feet of bank erosion near the oil pipeline centerline (STA 2+88) has occurred since 1997 (an average of 0.8 feet/year) based on a comparison of 2009 survey data and the 1997 scour control point shown on the figure HDD Bank Erosion Topo/Monitoring HDD Site-East, as provided in Appendix C. As of 2009, the observed bank erosion of 9.2 feet equals 8% of the 115-foot design setback. The east bank erosion has not yet reached the 50% design setback. If at some point in the future the bank “migrates 50% of the design setback, erosion rates or possible mitigation measures will be evaluated” (Baker 1999).
