Dog Salmon Creek Watershed Assessment

Dog Salmon Creek, Port St. Nicolas Road, Prince of Wales Island

Prepared by The Nature Conservancy January 2013

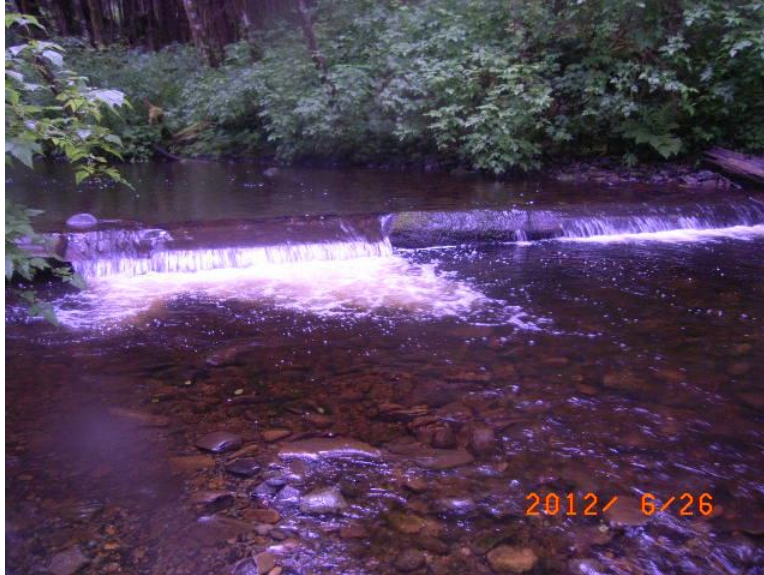
There were several restoration activities implemented by the Alaska Department of Fish and Game (ADF&G) in the early 1990s to address these habitat concerns. In 1992, two in-stream log structures were installed in the channel to function as sill logs, and a slide was stabilized with jute net and revegetation (Parry et al. 1993). These structures are still present in the stream channel (Figure 4).

Figure 4. A structure put in place by ADF&G in 1992 to function as a sill log. Although this structure has created a pool directly below the structure, the channel has remained mostly uniform both upstream and downstream from the structure.

The structures placed by ADF&G in the early 1990s have resulted in several additional pools, but these changes are very localized and do not appear to have resulted in adding complexity to the stream channel patterns.

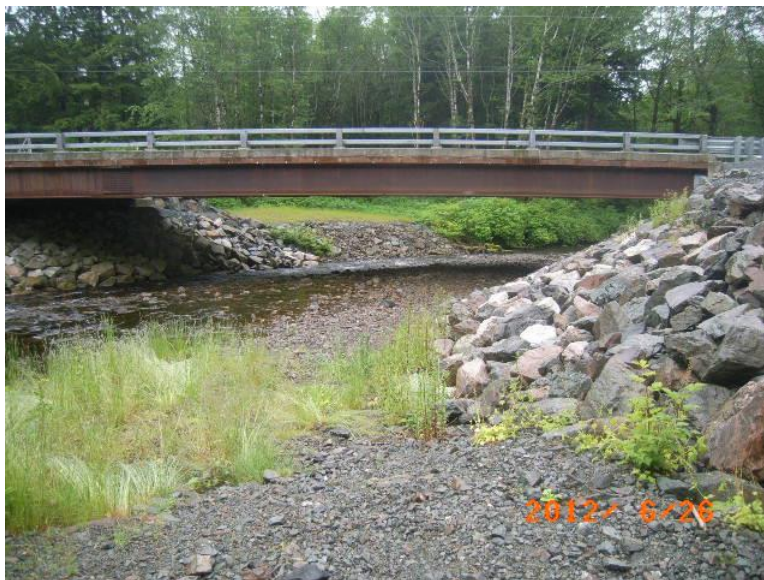
In 2010, a new 100 ft bridge was built over a lower section of Dog Salmon Creek as part of improvements on Port Saint Nicholas Road. This left unvegetated banks on either side of the new bridge (Figure 5). There is also a dirt road that runs through portions of the watershed; culvert condition and potential impacts on downstream habitat conditions are currently undocumented.

Figure 5. Looking downstream at the new bridge and unvegetated banks.

The area around the new bridge was left unvegetated and filled with gravel after construction. Revegetation in this area is a suggested enhancement activity as vegetation provides better freshwater habitat in the form of shade to maintain water temperature, overhanging cover for juvenile and adult salmon, and decreased sedimentation into the stream which can improve water quality and spawning habitat.

- Re-vegetation of the stream banks surrounding the new bridge would be a relatively easy task to stabilize banks and provide better habitat in the short stretch of river near the road.

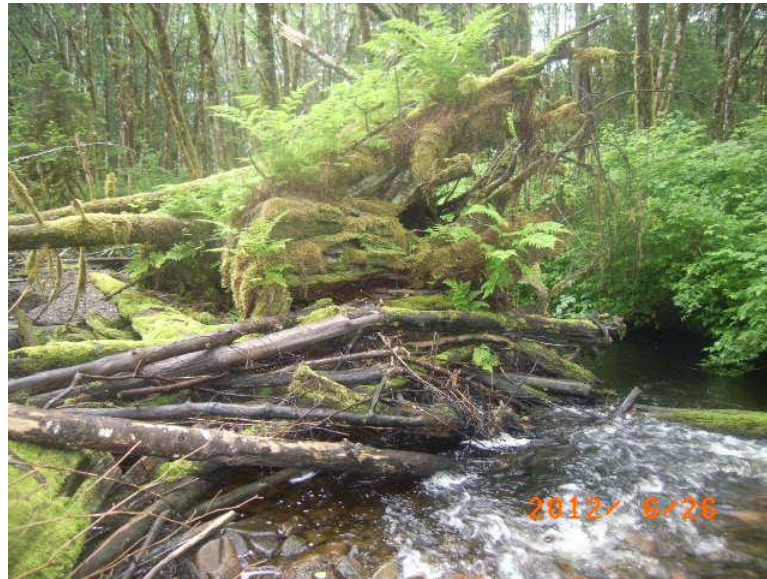
There is a good deal of “legacy wood” still present in some portions of the stream (Figure 7). “Legacy wood” refers to old wood that fell into the floodplain; most likely before most logging of old growth in the area took place. However, because of the history of logging, there are fewer large trees in the vicinity to fall into these stream areas. Large wood and large woody debris (LWD) provide good fish habitat by providing cover, pool formation where juvenile fish feed and hide and adult fish spawn (in pool tail crests), and shade, and as legacy wood disappears and is not replaced, these habitats will most likely decrease in the future.

Figure 7. Large legacy wood still exists in some portions of the lower watershed, but stream condition may worsen if these structures are removed, as there are no large conifers in the riparian area to replace them.

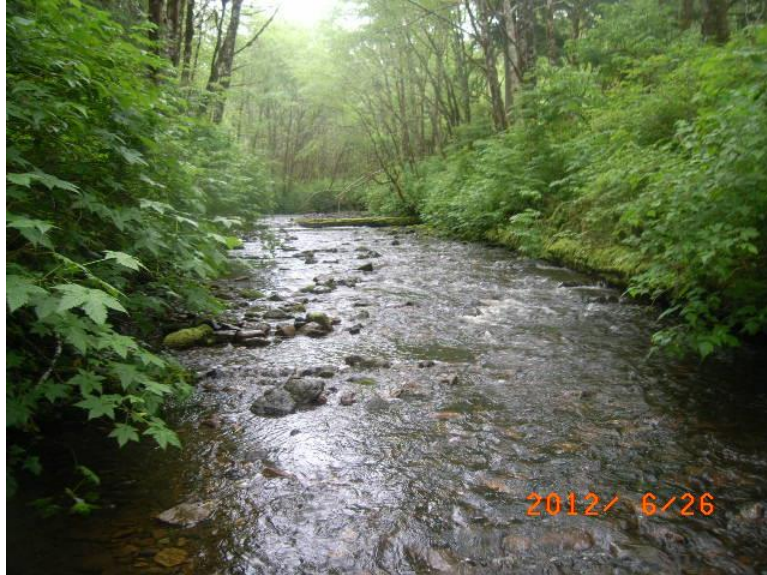
A few hundred meters above the bridge, the river becomes more channelized with less complex habitats, low amounts of LWD, and infrequent pools (Figure 8), which indicates decreasing habitat for rearing fish. This is most likely a product of loss of wood due to logging, but there is also evidence of stream clearing. The aquatic habitat survey for this section of the stream (Reach 2) showed that overall, the stream was usually within the 75 percentile for pool-related metrics as compared to other, unmanaged streams of this type in the Tongass National Forest (see Appendix A), which means that it is still valuable as fish habitat. However, for other metrics, including those related to LWD and width-to-depth ratios, which also indicate the quality of fish habitat, this stream reach is considered in poor condition as compared to other Tongass streams.

Figure 8. Looking upstream on Reach 2. This picture exemplifies the condition of this stretch of the river, with very few pools, minimal amounts of LWD, and riparian vegetation that is primarily small deciduous shrubs and trees.

- The channelized section above the bridge would most likely benefit from the input of wood structures or perhaps riparian thinning. These actions may increase pool and cover habitat for an

increase in spawning and rearing habitat. However, it is judged that access to these areas may make these actions difficult, and it is worth considering the cost-benefit associated with these actions. Again, an expert in stream restoration and design should be consulted for direction on this action.

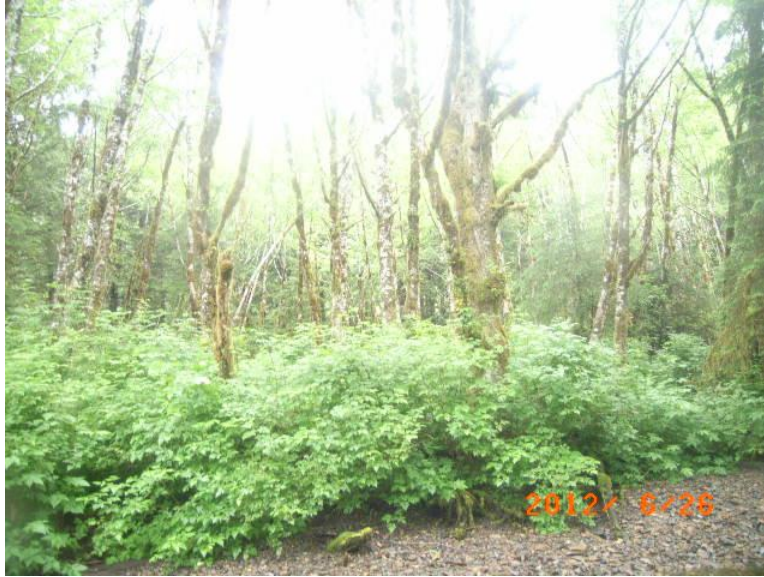
Riparian vegetation in this section consists mainly of deciduous trees, as shown in Figure 9. This is notable because these smaller trees and shrubs will not create the cover and pool habitat that is formed by old-growth size trees within the stream channel. There may be some merit of riparian thinning for the purpose of “releasing” the conifers, and allowing growth of large conifers that will eventually create better fish habitat.

Figure 10. Monocultures of deciduous riparian vegetation makes it difficult for establishment of large conifers that produce important LWD.

Although this area may benefit from habitat-creating structures, such as in-stream wood structures, access to these portions of the stream may be too difficult to justify at this time given that there is still some valuable fish habitat in this section. However, it is likely that habitat through this stretch will only decrease as legacy wood is released and not replaced and if immediate action is not taken, it will be worth monitoring in the future.

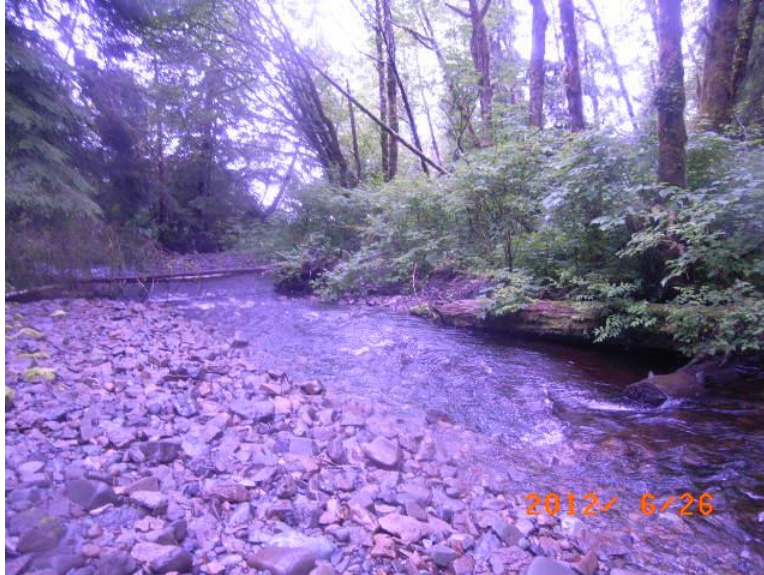
The area surveyed below the bridge contains some of the same characteristics as the stream area above the bridge that indicates lower quality fish habitat, including riparian vegetation dominated by deciduous vegetation and lack of pools (Figure 11). It has been observed that at low flows, some areas are too shallow for pink and chum salmon to get up the stream to spawn. The aquatic habitat survey done in this section confirmed that this section of stream is considered poor-to-fair as compared to similar streams in the Tongass National Forest, ranking consistently below the 50th percentile for categories indicative of the quality of habitat as related to pools, substrate, channel morphology, and LWD.

Figure 11. Downstream of bridge, an area with little habitat for staging spawners.

It is likely that the addition of jam-structures would be useful for creating pool habitat and altering channel morphology to make this area more conducive to both rearing fishes and to those trying to access the stream for spawning. Access to this section would be easy and make jam-structure design and implementation cost-affective.

- The design and implementation of wood structures below the bridge could be used to refine current channel morphology and increase pool habitat for staging spawning salmon. Access to this area would be easy. An expert in stream restoration and design should be consulted for direction on this action.

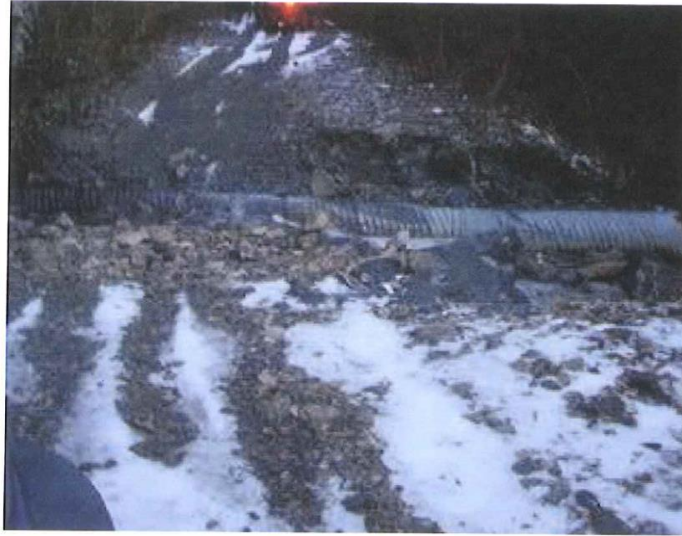
Initially, a road condition survey of the dirt road that runs through the watershed was intended to be completed as part of this watershed assessment. This has not yet been completed. However, from past inspection it has been noted that there may be hydrologic connectivity issues and stream diversions resulting from plugged culverts and an overall limited number of drainage structures along this road (Figure 12). This may be having negative impacts on water quality and fish habitat. Culvert replacement and/or sediment control in these high gradient streams near the road may be suggested as a result of a more formal road condition survey.

Figure 12. Failed culverts on Dog Salmon Creek may block passage.

- Initially, a road condition survey of the dirt road that runs through the watershed was intended to be completed as part of this watershed assessment. It is still strongly encouraged that this be completed and included in this watershed assessment. This would include an assessment of culvert condition and sedimentation issues. This assessment could easily be completed by a trained professional with an off-road vehicle, assuming that obstacles along the road are removed. Sheila Jacobson with USFS has volunteered to direct this effort if asked.
