Holgate Creek Assessment and Monitoring Project

Final Report

December 2006

Takshanuk Watershed Council

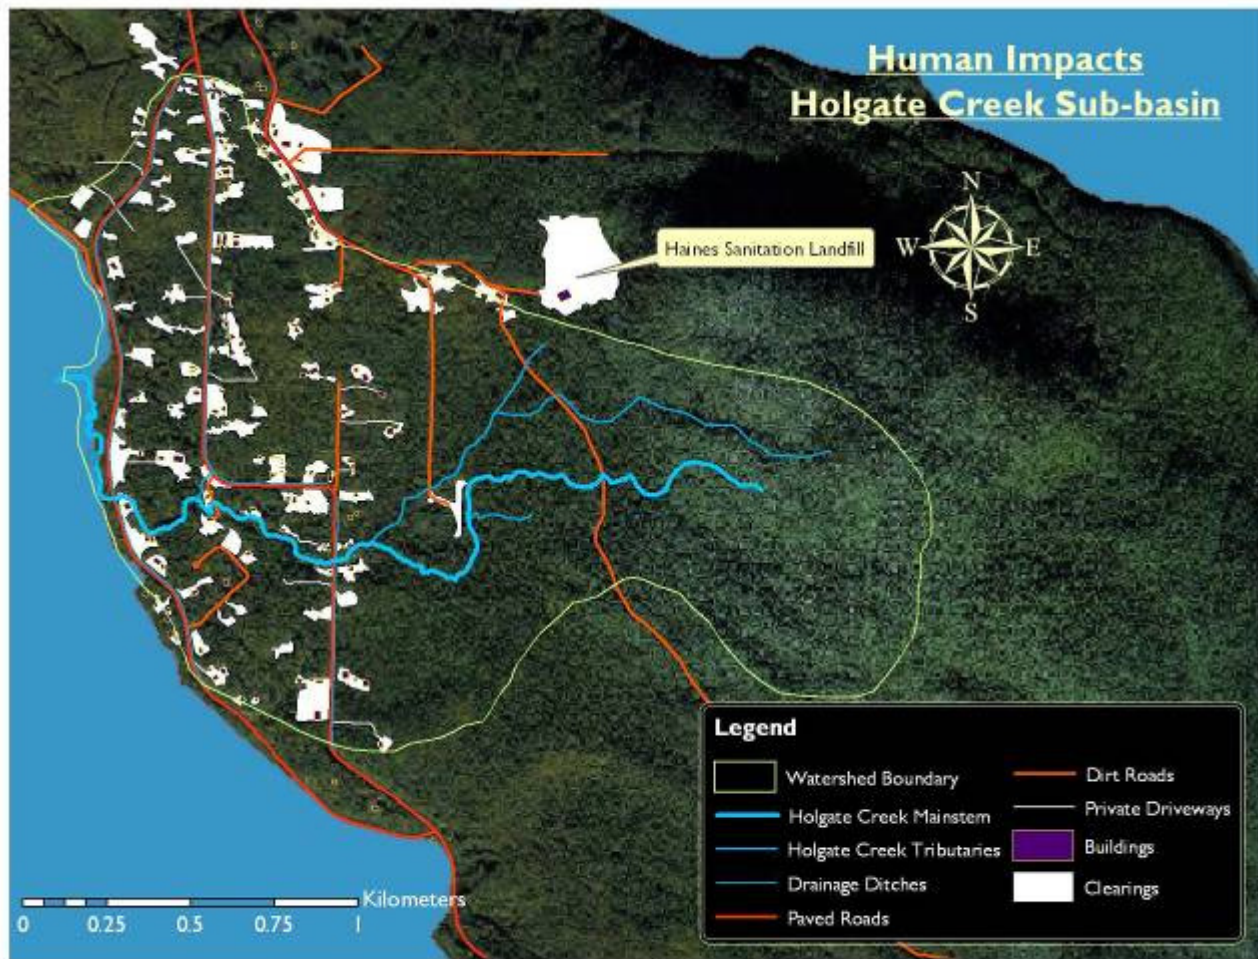
Figure 2: Human Impacts, Holgate Creek Sub-basin

Human impacts are primarily associated with housing development in the lower watershed. Figure 2 presents the cumulative human impacts in a single map: paved and dirt roads, driveways, cleared land and structures. Approximately 123 of a total of 185 lots in the sub-basin have been partially or entirely cleared and about eighty of these parcels have buildings. Note that this development is concentrated in the lower reaches of the basin and that ditches along the paved roads empty into the creek. These ditches are, in essence, tributaries of the creek.

A horse corral is located immediately above the west bank of the creek 150 m downstream of Small Tracts Road. Formerly, this was the site of a dog breeder's kennel housing dozens of very large malamutes. This is doubtless a source of fecal material entering the creek as it lacks any dedicated composting facilities or structures to control runoff from the yard.

Road Runoff: Small Tracts Road, Mud Bay Road and the network of driveways and private roads are sources of run-off of automotive fluids, sediment and trash. Within the Holgate Creek sub-basin there are 4.27 km of paved road. Small Tracts and Mud Bay Roads are the two main arteries and only paved roads. Average traffic counts per day in 2004 were 605 for Small Tracts and 578 for Mud Bay Road. There are 2.79 km of dirt roads. Lily Lake Road crosses the upper portion of the basin. This road is used principally by the Haines Borough water plant managers as access to Lily Lake, the primary source of domestic water for Haines townsite. It is very lightly traveled as is the unpaved portion of FAA road- an access road to a pair of navigation towers maintained by the FAA. Other unpaved roads intersect the two paved roads and provide access to low density residential areas.

Landfill contaminants: Haines Sanitation Inc. has a landfill located in the northeast corner of the watershed, apparently just beyond the watershed boundary. DEC has documented the leaching of toxins into groundwater in the area. However, DEC personnel state that the drainage from the dump is toward Portage Cove, on the Chilkoot side of the peninsula, not into the Holgate watershed that drains into the Chilkat River. Figure 2 shows the distribution of these discrete points of water quality concern including cleared lots, buildings and Haines Sanitation Landfill.

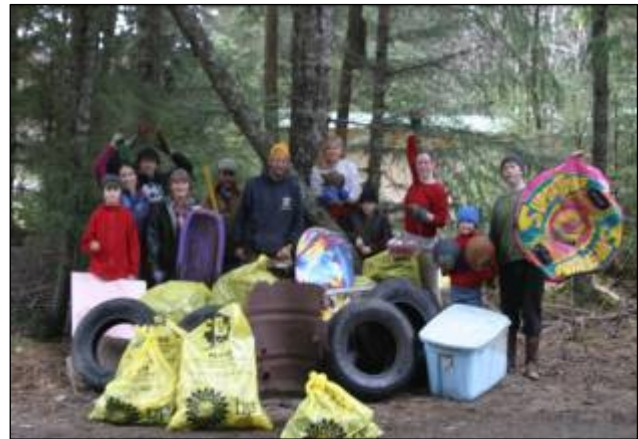
Refuse in creek: As part of a separate contract TWC organized a creek cleanup and carried it out with about 25 volunteers in April 2006. The results are indicative of the interaction between humans and the creek. In four hours of work the equivalent of 50 large trash bags of garbage of various kinds were removed from the creek. Items included a large piece of carpeting, numerous snow sleds, basketballs, various toys, etc. as well as large numbers of plastic bags, quart containers of automotive oil, plastic milk jugs and other packaging (see Photo above).

Plastics are known to have deleterious effects on aquatic organisms via toxicity and physical impairment.

1. The fact that TWC's stream clean-up in April 2006 netted the equivalent of 50 large bags of trash from the portions downstream of Small Tracts Road shows the prevalence of improper refuse disposal and its consequences. The trash recovered included many plastic bags, empty automotive oil containers, and car tires as well as the typical plastic drink bottles, aluminum cans and food wrappers. Recommendation: Make annual event of cleanup. Inform landowners

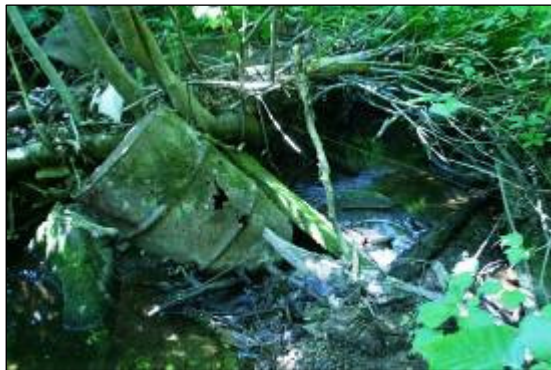
Several items were too large to remove. 30 meters downstream of Small Tracts Road we found several large diameter creosoted pilings at the base of a steep section of bank. In the same location were eight discarded tires, undoubtedly from the Small Tracts Tire shop nearby. Another 50 meters downstream were several very old rusted drums (see Photo at left). It is unknown what these barrels contained.

2. Run-off from Mud Bay and Small Tracts Roads and the network of driveways and small gravel access roads undoubtedly contributes to water pollution in the form of leaked automotive fluids. Several old, rusted 55 gallon drums now rest in the creek sediment, pointing to the possibility of significant past pollution events. In association with this, the most obvious human impact on the creek is the sedimentation of the lower reaches. Long-time resident Betty Holgate, a keen observer of the creek, asserts that sedimentation increased greatly in the early 1990's following road work on Small Tracts Road and contemporaneous with the development of many lots in the sub-basin. Recommendation: install permeable ditch blocks to capture sediment before it enters creek and monitor sediment levels in the creek, especially during large storm events. A set of sample locations should be selected which will allow the tracking of sediment contributions of different branches of the creek.

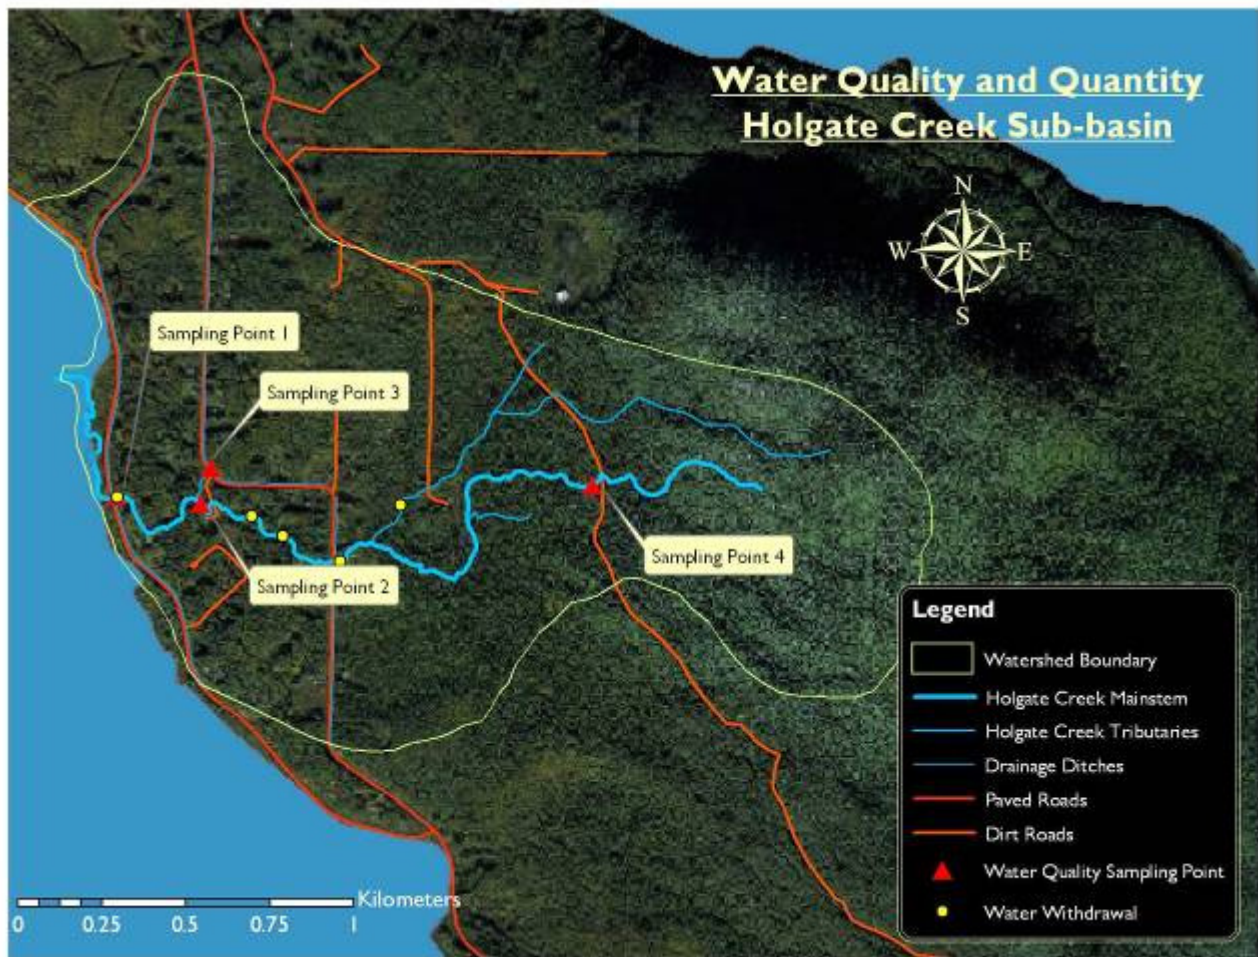
Figure 3: Water quality sampling points and Water Withdrawal Sites

Four sites were chosen for water quality sampling. They represent the geographic range and habitat quality spectrum of the creek. Sampling Point 1 is downstream of Mud Bay Road and shows the cumulative water quality impacts on the entire stream system. Sampling Point 2 is downstream of Small Tracts Road and just above the entrance of the tributary draining the ditch alongside Small Tracts. This sample shows the influence of the upstream portion of the developed land. Sampling Point 3 is located at the same point in the roadside ditch that was sampled by the Borough in 2001. Sampling Point 4 is located at the intersection of the main stem with Lily Lake Road upstream of the area of human settlement. Point 4 serves as a control.

Water Withdrawals: There are several water pumping systems in place on the creek between Mud Bay and Small Tracts Rd. These are apparently used as garden water sources. The volume of withdrawal is unknown as is its effect on the creek, especially in dry years. In an interview with one landowner we were told that he had turned his pump on only two times in the summer of 2006 which was a very wet season. We will continue to talk to landowners adjacent

to the creek to assess water use. Figure 3 shows the location of the water withdrawal systems on the creek. Some of these appeared to be inactive this year.

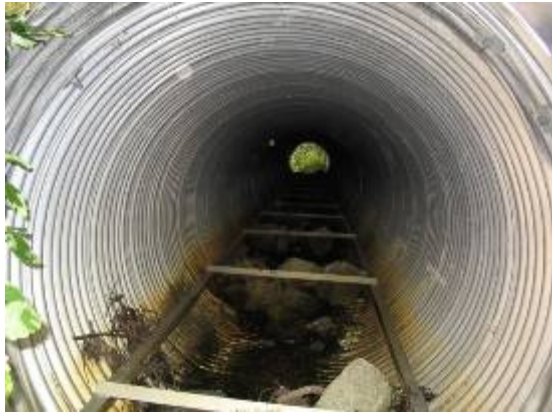
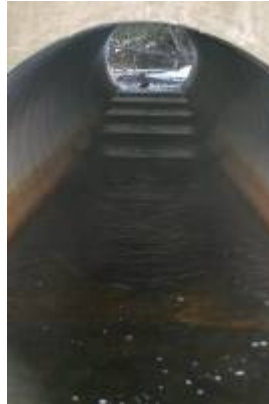
Photos of the Mud Bay Road fish ladder

The fish ladder was installed to compensate for the sub-optimal design of the culvert. Historically, it has been stocked with cobbles and small boulders. These create a series of pools within the culvert thus facilitating passage. Unfortunately these are regularly flushed out by high flows during wintertime rendering the fish ladder less effective (see photos).

6. **Fish passage may be a concern, particularly in times of low flow in the creek. The culvert under Mud Bay Road is considered to be undersized by Fish and Game personnel (Ben Kirkpatrick pers comm.). The current fish ladder was installed as partial compensation for this but the tendency of the cobbles within it to wash out calls into question its effectiveness. Recommendation: Survey these sites and use passage models to determine if they are indeed problems. Approach ADOT and landowners with solutions.**

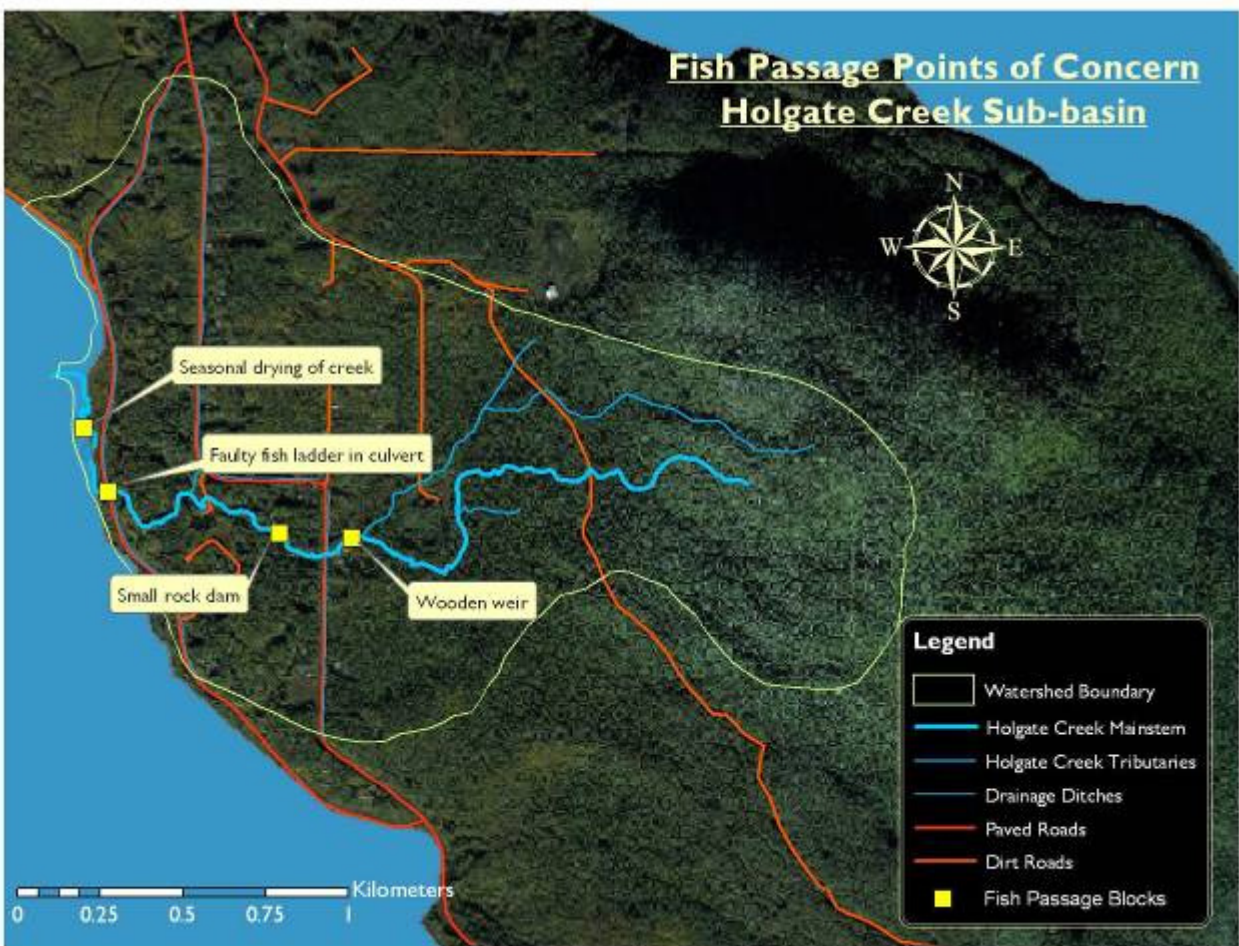
Figure 5: Fish Passage Points of Concern, Holgate Creek Sub-basin

There may be problems associated with a dual culvert set-up beneath a driveway that crosses the creek midway between Small Tracts and Mud Bay Roads. This is the only other roadway crossing the creek in the residential portion of the watershed. These culverts are small (24") and at low water only the lower of the two is available for fish passage.

Crude rock dams have been built in the creek near Small Tracts Rd. These were probably put in by kids and create a 25 cm fall. Such obstacles could be problematic in low flow periods. Debris jams in stretch along just downstream of Small Tracts Road could be a partial passage barrier if allowed to grow. The large storm of November 2005 cleared much of small material but left the larger wood in place and these pieces of key wood will collect smaller branches and other debris over time. Overall woody debris concentrations like this are advantageous but in association with human refuse (clogging by plastic sheeting or bags for instance) such jams could impede passage by larger fish.

A wooden weir has been built across the creek 150 m upstream of Small tracts Road. It appears to have been in place for several years and has created a 10 m pool upstream. This structure may impede fish passage but in early October of 2006 an adult coho salmon was seen well upstream of the site.
