# GREATER MOOSE'S TOOTH 1 (GMT1) ALPINE SATELLITE PROJECT

## 2009 SPRING BREAKUP HYDROLOGIC ASSESSMENT

September 2009  
117216-MBJ-RPT-001

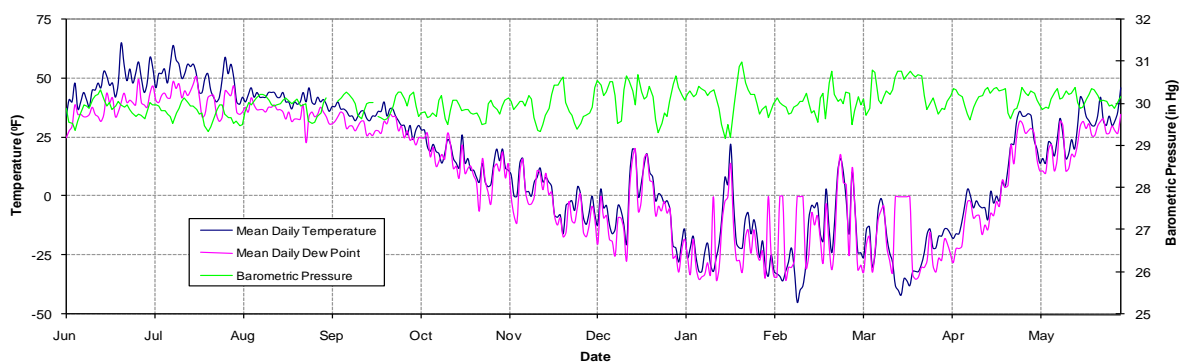
**GRAPH 1.1: NUIQSUT MEAN DAILY TEMPERATURE, DEW POINT, AND BAROMETRIC PRESSURE  
(JUNE 1, 2008 – JUNE 1, 2009)**

Consistent historical climatic data is generally limited to a record of daily average temperatures, barometric pressure, humidity, and wind speeds. Daily mean air temperatures, from 2003 to 2009, were compiled from weather stations at Nuiqsut, Alpine, Kuparuk, and Deadhorse.

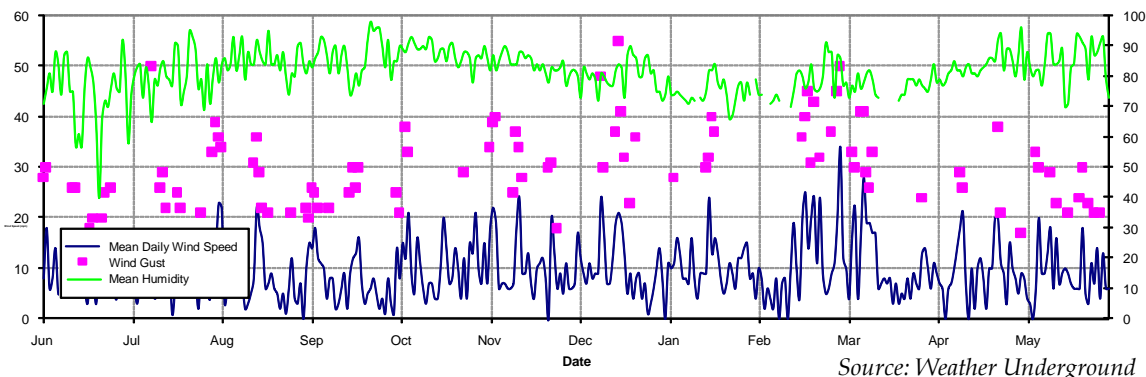
**GRAPH 1.2: NUIQSUT MEAN WIND SPEED, MAXIMUM DAILY WIND GUST, AND MEAN HUMIDITY (JUNE 1, 2008 – JUNE 1, 2009)**

accelerating sublimation (similar to evaporation), which reduces both snow water equivalence and available snowmelt runoff. Wind speed data for Nuiqsut between June 1, 2008 and June 1, 2009 may be seen in Graph 1.2, in addition to maximum daily wind gust and mean humidity.

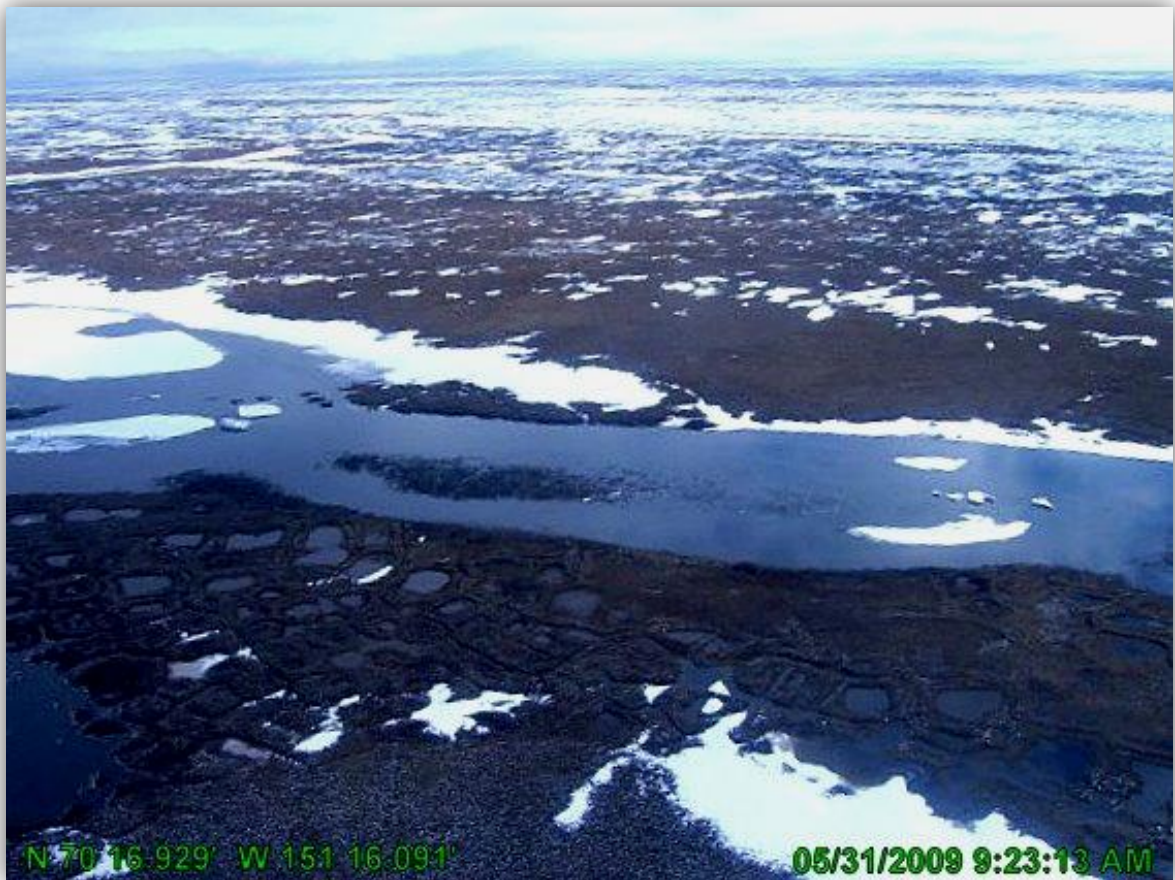
PHOTO 2.1: UBLUTUOCH RIVER PROPOSED GMT1 ACCESS ROAD CROSSING SITE, UB 6.8, MAY 31, 2009

The proposed Ublutuoch bridge location at UB 6.8 remains the same as it was in 2005 and 2006. An aerial view of the proposed bridge location is provided in Photo 2.1. At the proposed bridge site, the Ublutuoch River has a drainage area equal to approximately 228 square miles.

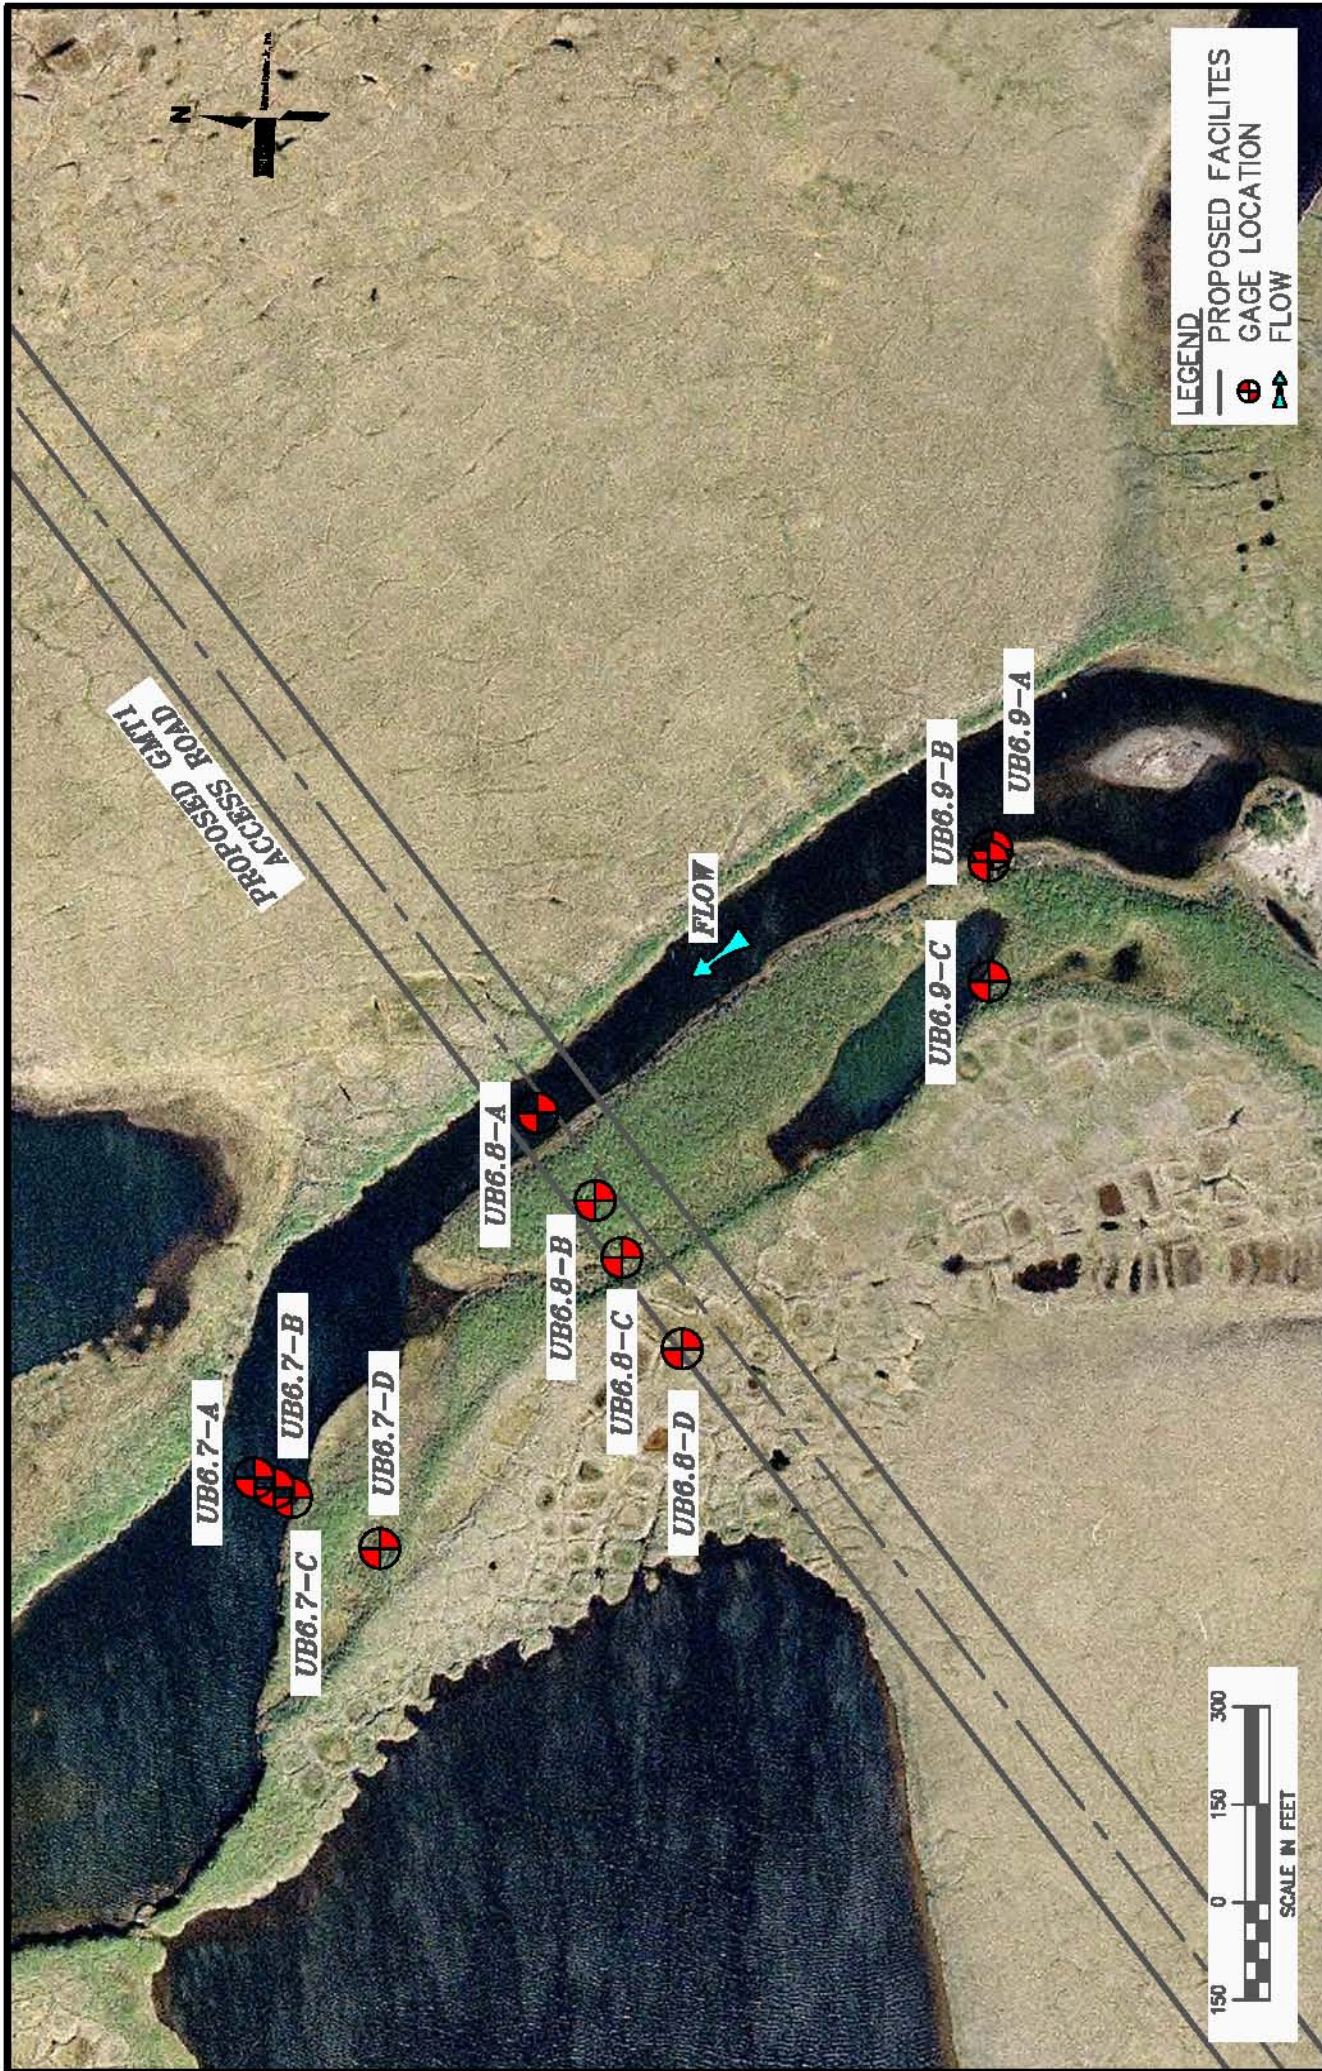
2009 SPRING BREAKUP  
 UBLUTUOCH RIVER  
 GAGE LOCATIONS  
 FIGURE 2.1  
 (SHEET 1 OF 1)

The Ublutuoch River monitoring sites included sets of three to four gages installed at RM 6.7, 6.8, and 6.9, as shown in Figure 2.1. The RM location designations, UB 6.7, UB 6.8, and UB 6.9, refer to the distance in river miles from the confluence of the Ublutuoch River and Fish Creek. The gages are located on the west bank of the Ublutuoch River. The gage locations were selected to monitor and document local breakup conditions at the proposed bridge location as well as upstream and downstream from the crossing.

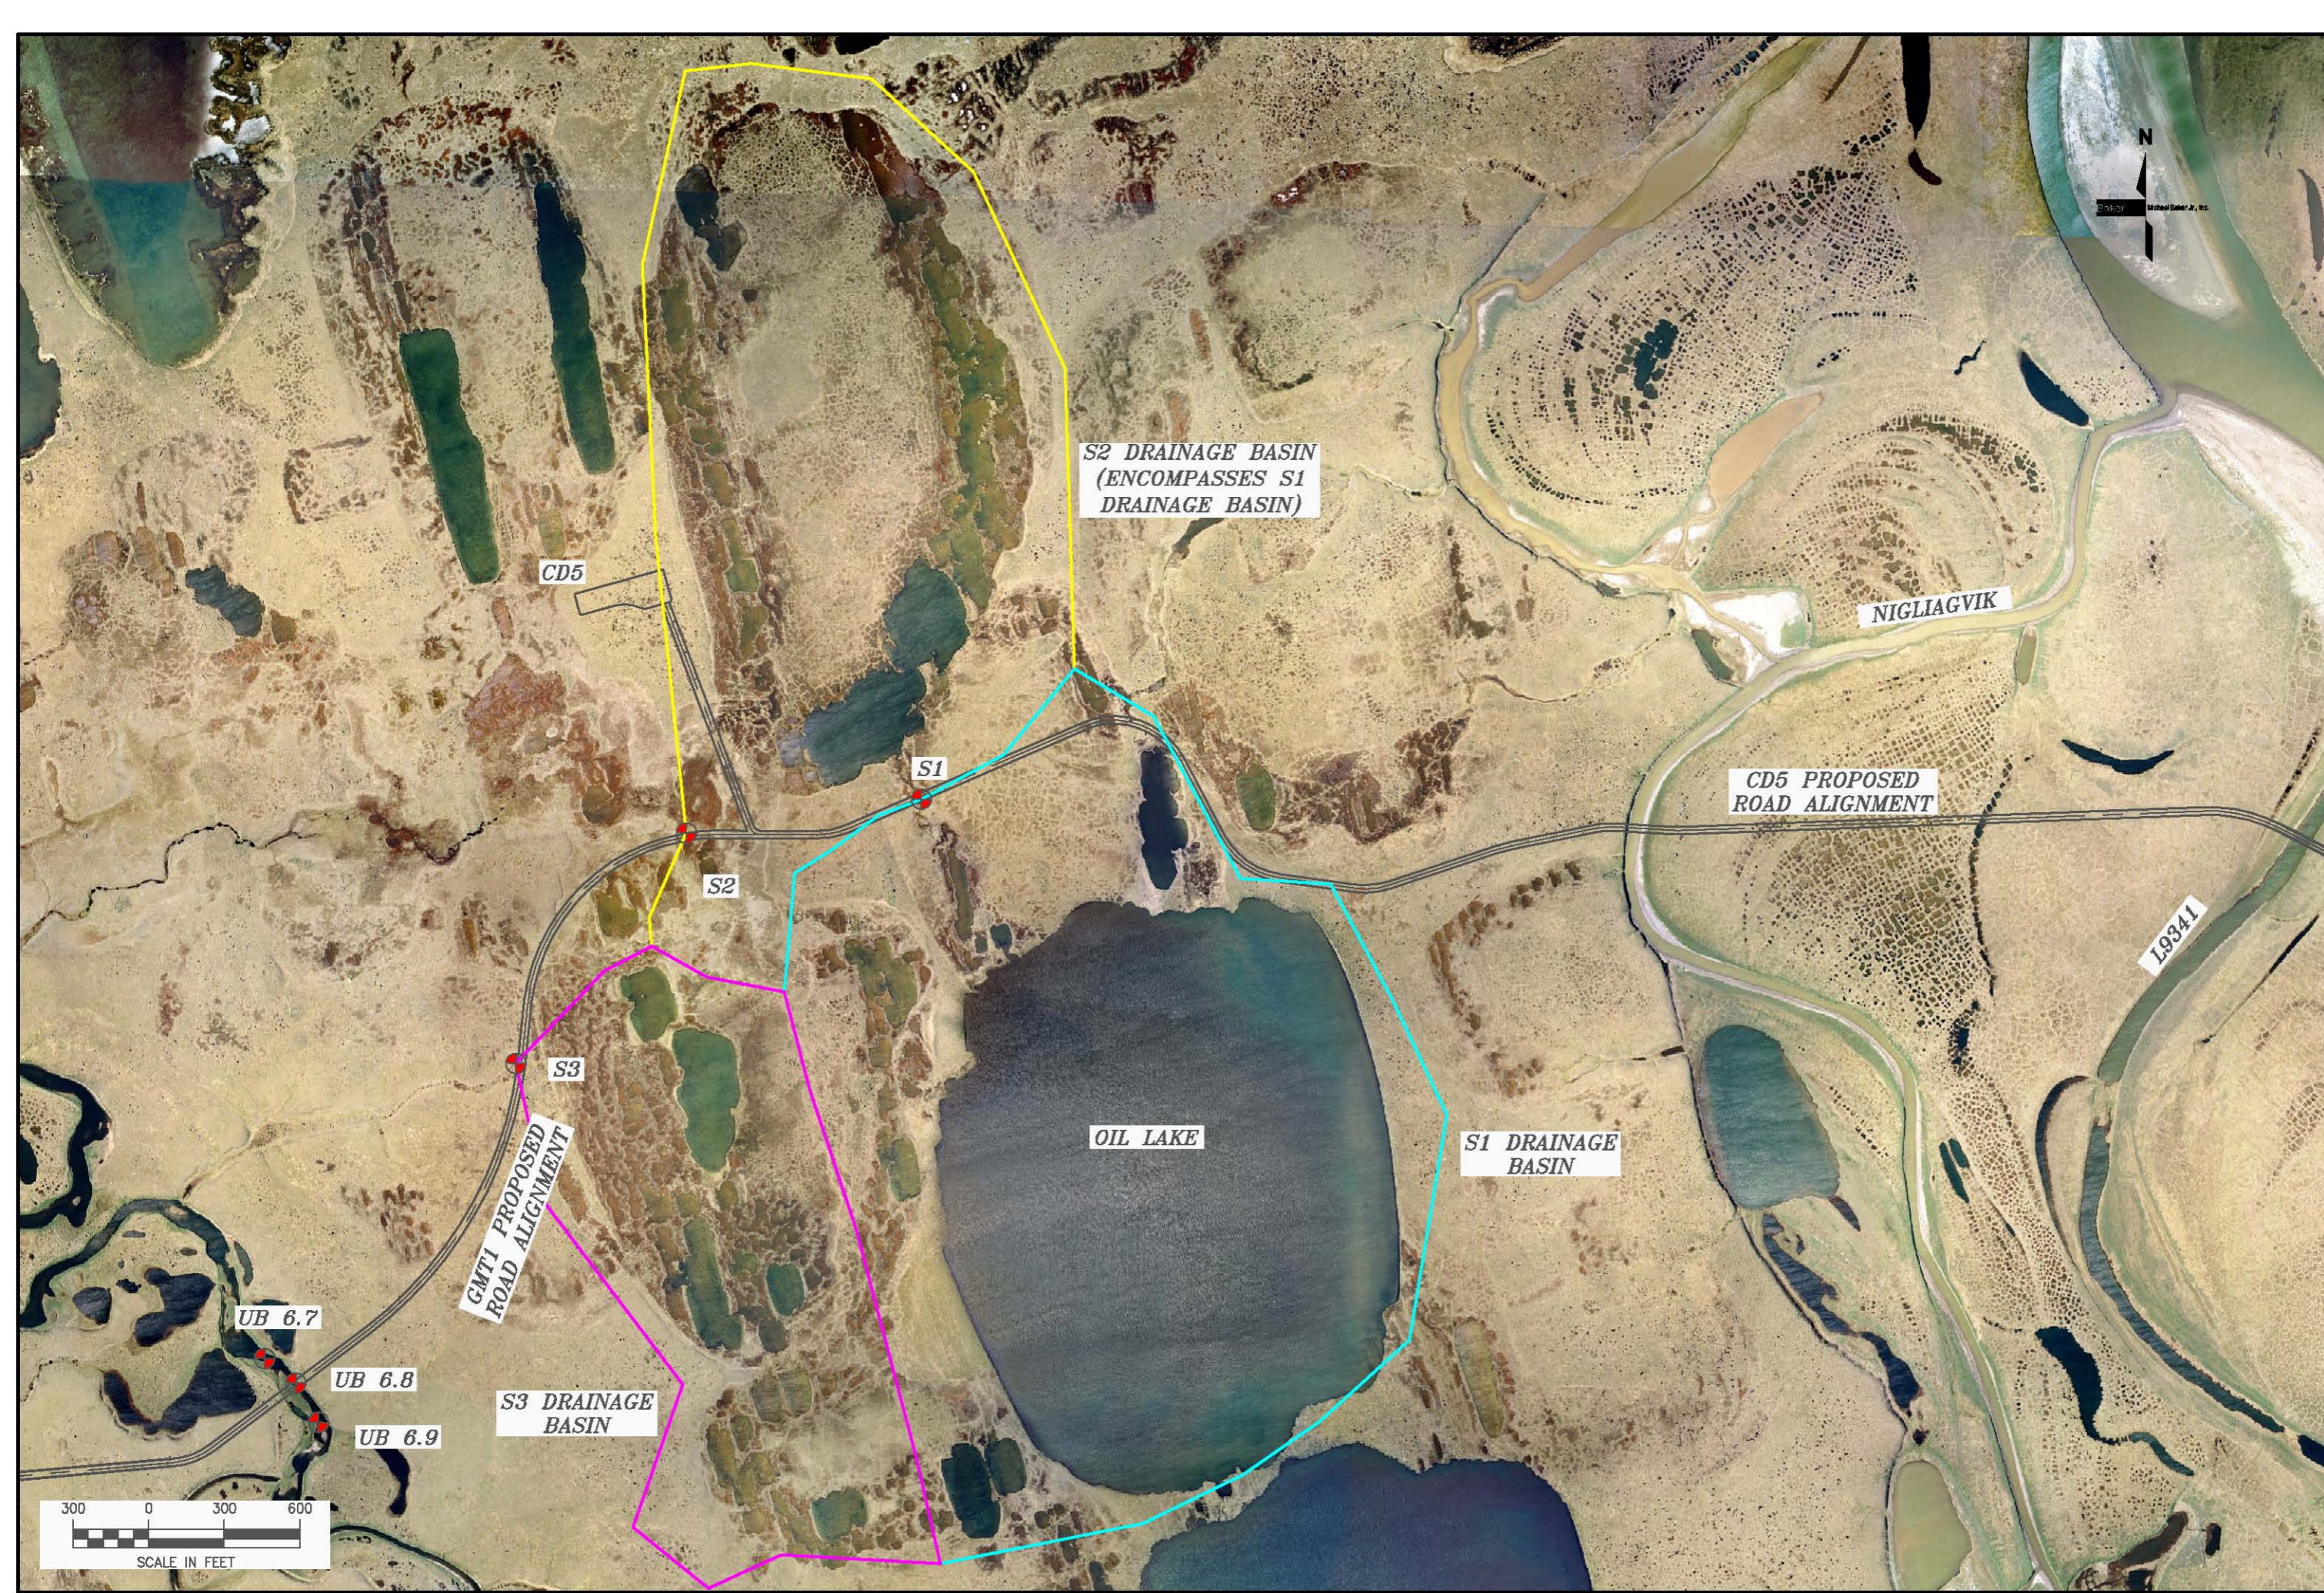
S2 DRAINAGE BASIN  
(ENCOMPASSES S1 DRAINAGE BASIN)

Site S2 is located within a relatively flat, shallow basin approximately 4.1 square miles in size and includes Lake MB0301 and some small ponded areas. A channel drains the basin toward the Ublutuoch River, located approximately 0.4 miles to the west. Ground cover is mostly comprised of native grass, with some tussocks and dwarf willows. Figure 2.4 shows the S2 gage location and Figure 2.3 shows the S2 drainage basin delineation.

A small channel drains the approximately 0.9 square mile drainage basin associated with Site S3 directly into the Ublutuoch River, over a distance of approximately 0.27 miles. Site S3 is near the head of the small channel, which serves some small nearby ponds. Tussocks are abundant in the area. See Figure 2.5 for the S3 gage location and Figure 2.3 for the S3 drainage basin delineation.

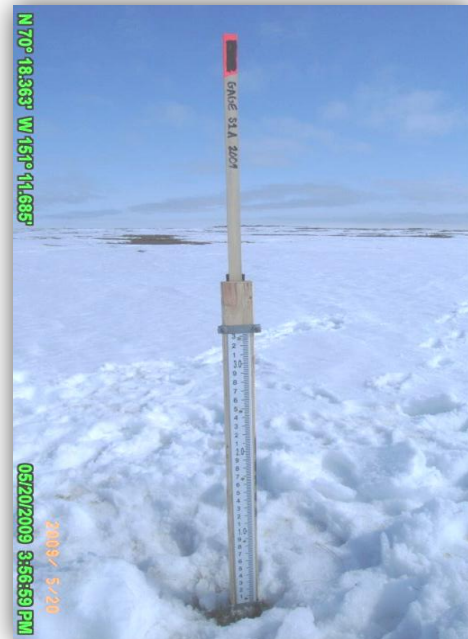
**PHOTO 3.1: STAFF GAGE INSTALLED AT SITE S1, MAY 20, 2009**

The elevation of each gage was surveyed from a local benchmark tied to British Petroleum Mean Sea Level (BPMSL) using standard level loop

techniques. The basis of elevation for each gage and the horizontal position of respective benchmarks and gages are presented in Appendix A. The most recent (as of spring 2009) basis of elevation of vertical control was used. Gage surveys along the GMT1 route commenced on May 25 and were completed on May 31, 2009.

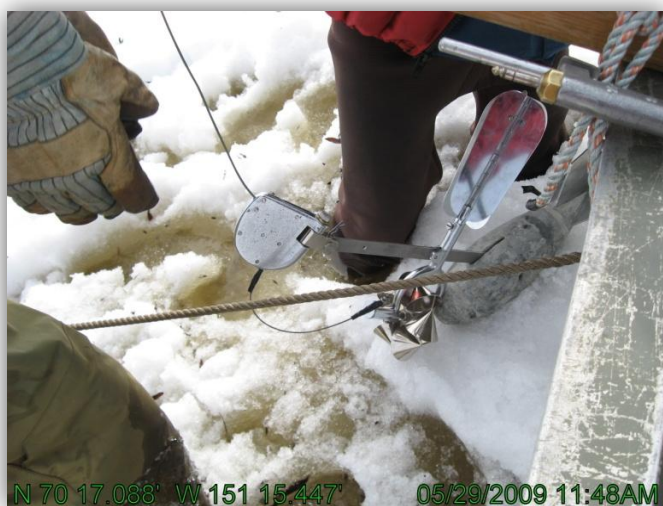
**PHOTO 3.2: UBLUTUOCH RIVER BOAT DISCHARGE MEASUREMENT INSTRUMENTATION, MAY 29, 2009**

Standard USGS midsection techniques (Rantz 1982) were used to determine discharge at the Ublutuoch River (UB 6.8) as well as at Site S4 and Site S5.

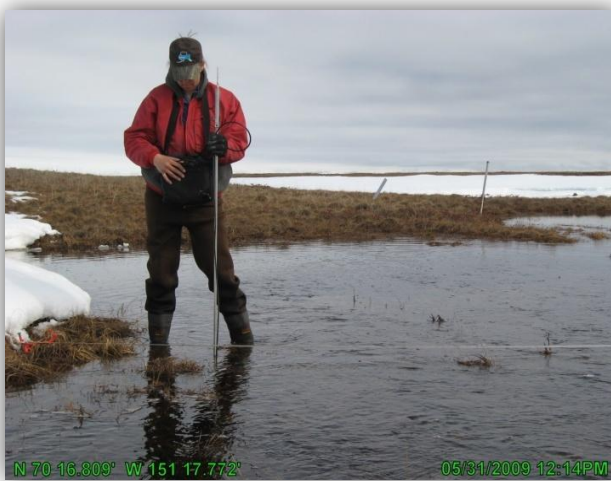
**PHOTO 3.4: SMALL STREAM WADING DISCHARGE MEASUREMENT AT S4, MAY 30, 2009**

A Marsh-McBirney Flo-Mate 2000 portable velocity meter and USGS wading rod were used to determine discharge at Site S4 and Site S5. A tag line was used to define the cross section and delineate measurement subsections within the channel. Photo 3.4 shows the small stream discharge measurement at Site S4.

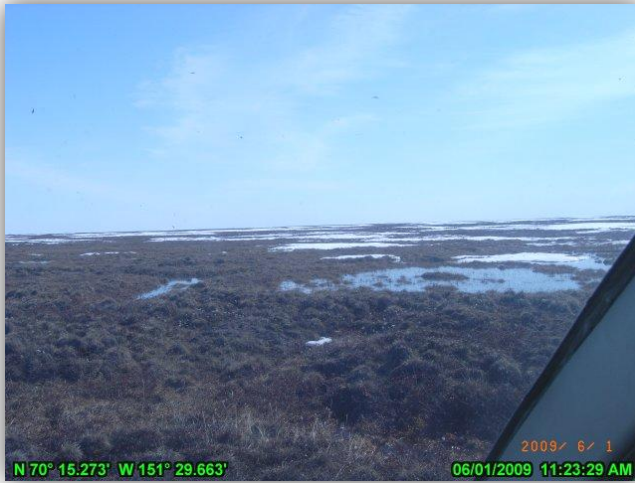
**PHOTO 4.1: GMT1 PAD LOCATION, JUNE 1, 2009**

Water was first noted in the proposed pad area on May 27 and determined to be the result of local melt, having no velocity and occurring only in isolated troughs and depressions in the terrain. Measurements made at S8 on subsequent days showed an increase in WSE. All increases were determined to be a result of local melt with no velocity or hydraulic connection to any flow. The peak water surface elevation at S8 occurred midday on June 3. Subsidence of water was noted on the afternoon of June 3 and WSE measurements were discontinued. Photo 4.1 shows the proposed GMT1 pad location and flooding extent on June 1, prior to peak WSE.

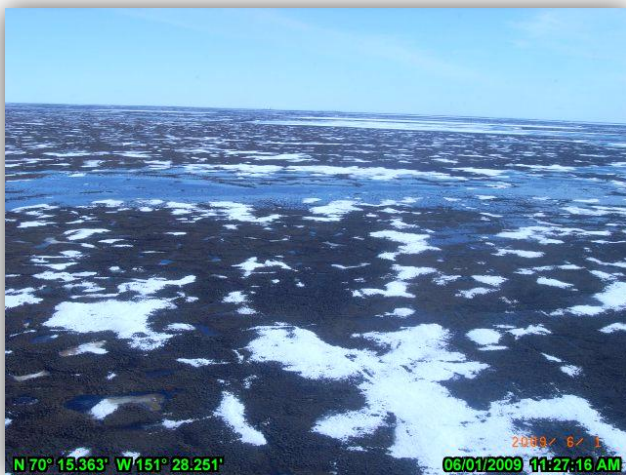
**PHOTO 4.2: UNIDENTIFIED FLOW PATH MIDWAY BETWEEN PROPOSED GMT1 PAD AND S7, JUNE 1, 2009**

On June 1, an unidentified active flow path was observed crossing the alignment approximately halfway between the proposed GMT1 pad and gage S7, as shown in Photo 4.2. The flow was aligned north-south and appeared to be less than one half-foot deep with sustained low velocity flow. This flow path should be considered for quantitative investigation during the 2010 breakup program.

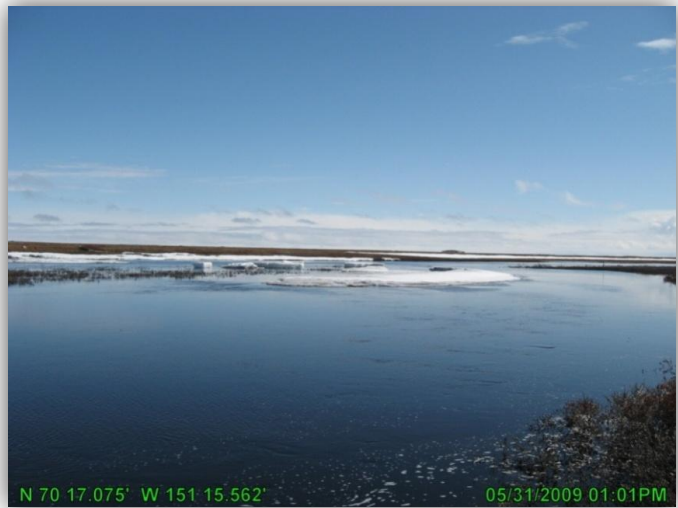
**PHOTO 4.3: UBLUTUOCH RIVER PROPOSED GMT1 CROSSING, MAY 31, 2009**

The Ublutuoch River is the only perennial stream along the proposed GMT1 right-of-way. On May 22, localized melt and standing water along the Ublutuoch were noted during a reconnaissance flight to the area. Gage installation and survey was completed on May 25. Gage installation consisted of straightening and repairing gages used in previous years, as well as installing new gages at those locations where gages had been destroyed or were no longer usable. Areas of limited local melt within the channel were present during installation. A May 25 flight upstream from the monitoring site revealed no leading edge of saturated snow or other flooding indications.

Daily monitoring began with observations of flow on the Ublutuoch River on May 27. On this day, water was observed at UB 6.9. Floodwater continued to rise until peak stage was reached late in the evening on May 29. Peak discharge was estimated to have occurred shortly after peak stage. Flow steadily abated for the remainder of the observation period. No ice jams were observed in the proximity of the monitoring area.

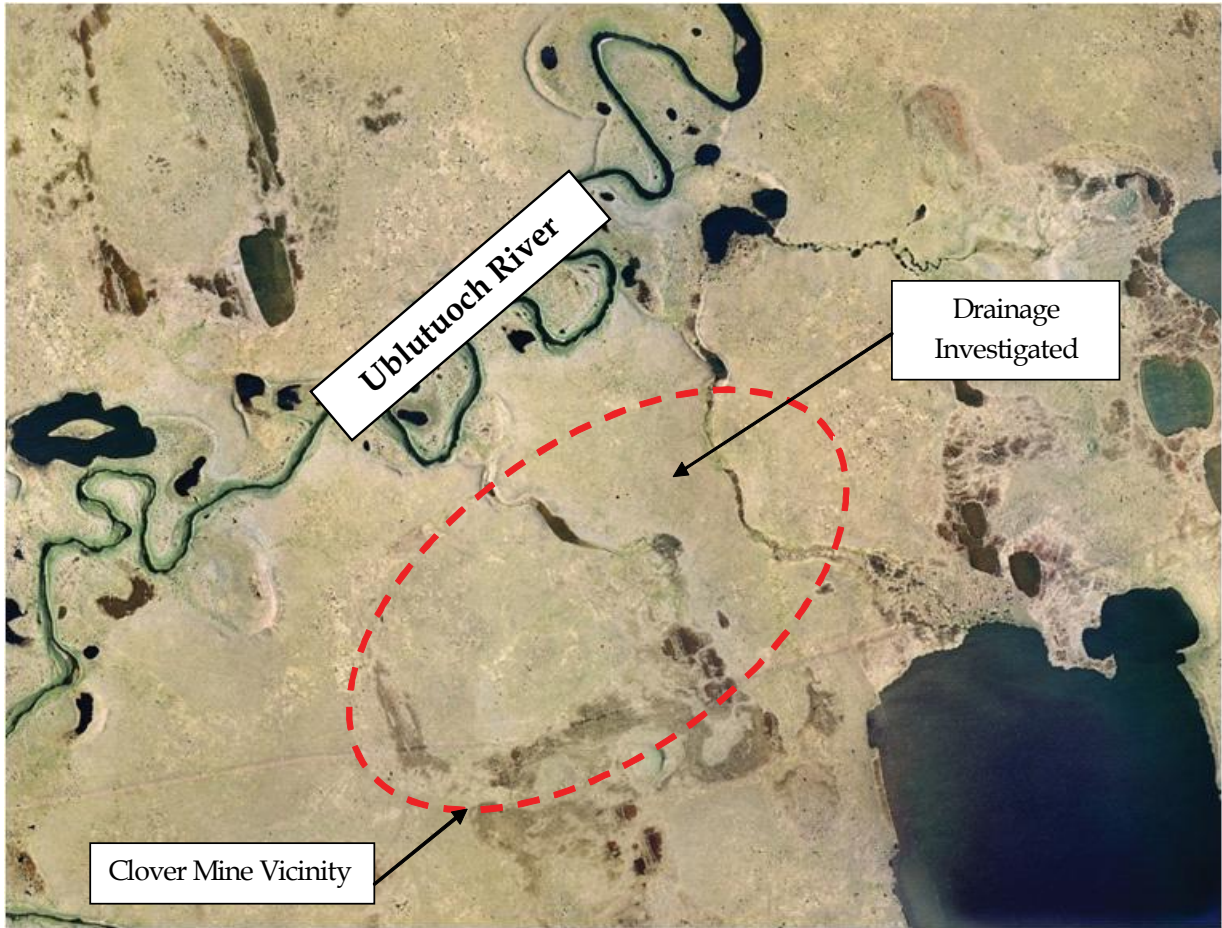
FIGURE 4.2: CLOVER MINE SITE

2009 breakup conditions in the Clover Mine area were similar to those observed throughout the FCB, characterized by local melt resulting in little to no overland flow. Meltwater in the only significant drainage investigated remained within the defined channel during the observation period. Figure 4.2 and Photo 4.4 show the Clover Mine Site.

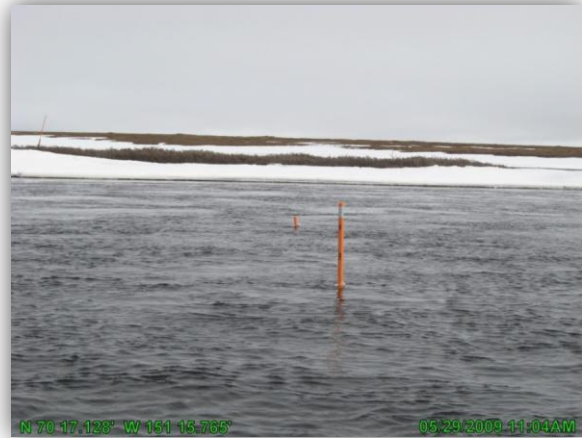
PHOTO 4.5: UBLUTUOCH RIVER UB 6.7, MAY 29, 2009

Photo 4.5 shows the conditions of the Ublutuoch River at UB 6.7 on May 29. Photo 4.6 shows the conditions of the Ublutuoch River at UB 6.8 on May 31. Photo 4.7 shows the conditions of the Ublutuoch River at UB 6.9 on June 1.

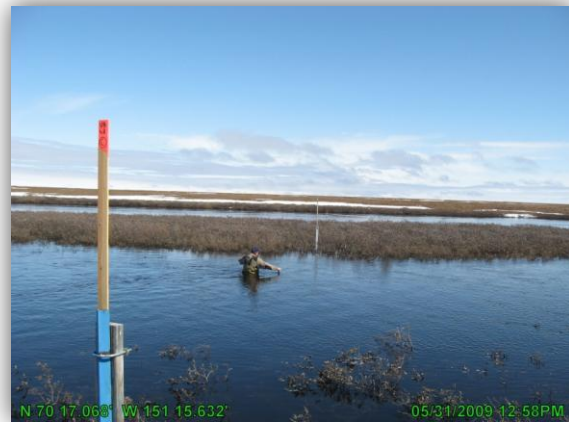
PHOTO 4.6: UBLUTUOCH RIVER UB 6.8, MAY 31, 2009

During the measurement procedure the right bank was snow-covered and intact snow and ice in the channel encroached on the flow. The left bank was ice- and snow-free. The bottom was generally ice-covered with the exception of the far left portion of the channel.

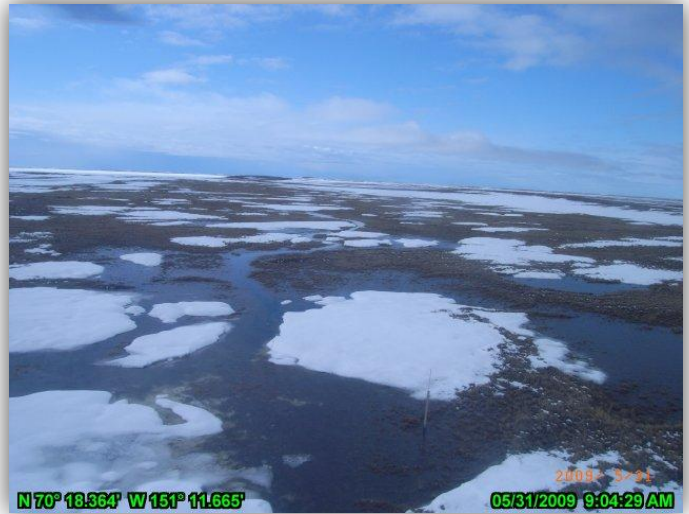
PHOTO 4.8: SITE S1, MAY 31, 2009

The S1 site was typically characterized by accumulated local melt. A possible channel was identified, however the channel dimensions were too small and flow so minor that a discharge measurement was not practical. On June 4 the extents of accumulated water were marked with GPS. The width of the water perpendicular to the proposed alignment was approximately 1,056 feet with a maximum depth of 0.9 feet.

The May 31 conditions of Site S1 are shown in Photo 4.8.

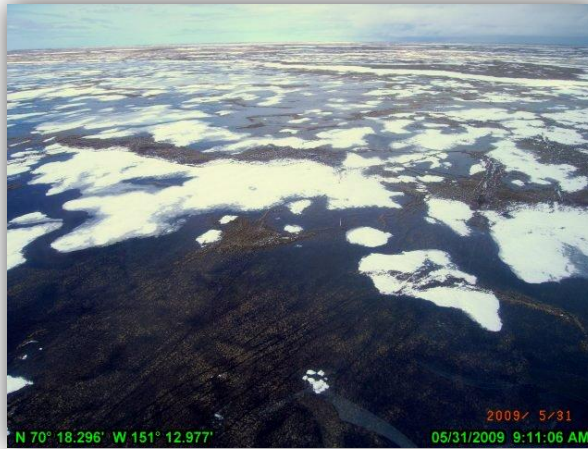
**PHOTO 4.9: SITE S2, MAY 31, 2009**

The S2 site was generally characterized by accumulated local melt; no direct discharge measurement was made. Areas of very low velocity sheet flow with minimal depth were observed in the vicinity of the proposed crossing. On June 4, the extents of accumulated water were marked with

Table 4.4 presents the observations and water surface elevations recorded for Site S2. The May 31 conditions observed at Site S2 are shown in Photo 4.9.

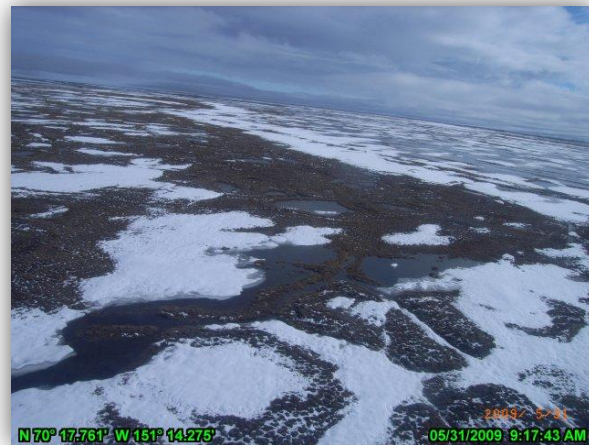
**PHOTO 4.10: SITE S3, MAY 31, 2009**

The S3 site was characterized by accumulated local melt; no direct discharge measurement was made. No measureable flow was observed. On June 4, the extents of accumulated water were marked with GPS. The width of the water perpendicular to the proposed alignment was approximately 80 feet with a maximum depth of 0.8 feet.

Table 4.5 presents the observations and water surface elevations recorded for Site S3. Photo 4.10 shows the conditions of Site S3 on May 31.

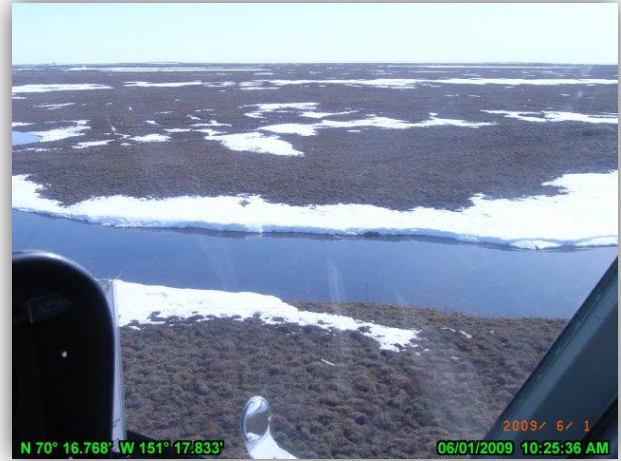
PHOTO 4.11: SITE S4, JUNE 1, 2009

At Site S4, floodwaters were mainly confined to a single, well-defined channel with good flow. A direct discharge measurement was completed at S4-B on May 31 and was measured as 5.6 cfs. Indirect discharge calculations yield an estimated peak discharge of 7 cfs at S4-B.

Table 4.6 presents the discharge measurements recorded for Site S4. Table 4.7 presents the observations and water surface elevations. Photo 4.11 shows the conditions at Site S4 on June 1.

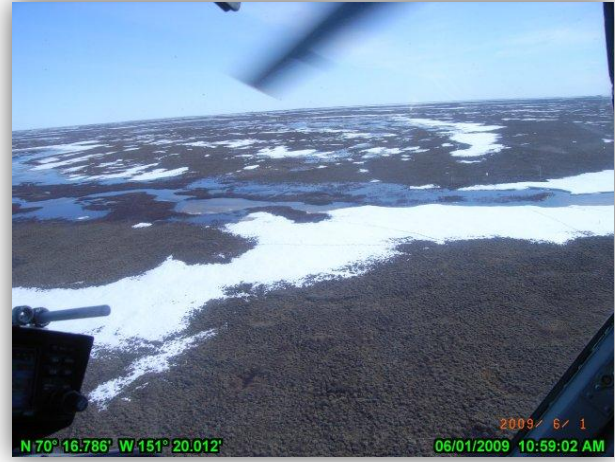
PHOTO 4.12: SITE S5, JUNE 1, 2009

While the stream was characterized by braids and is willow-choked both upstream and downstream of the monitoring location, there was a short reach at Site S5 where floodwaters were confined to a single, well-defined channel.

A direct discharge measurement was completed at Site S5 on May 30, and was measured as 6.8 cfs. Indirect calculations yield an estimated peak discharge of 9 cfs. During the discharge measurement the reach was narrowed by snow and ice on both banks, with some flow occurring under the snow. The channel bottom was primarily slush except for the thalweg where bottomfast ice defining the low water channel was still intact. There was thin ice in place across much of the cross section prior to the discharge measurement. This ice was broken up and floated away before beginning. The width at the measured cross section was 40 feet, with a maximum depth of 1.7 feet.

Table 4.8 presents a summary of the discharge measurement recorded for S5-B. Table 4.9 presents the observations and water surface elevations. Photo 4.12 shows the conditions on June 1. On the left side of the image (downstream of the discharge site), heavy willow growth may be seen.

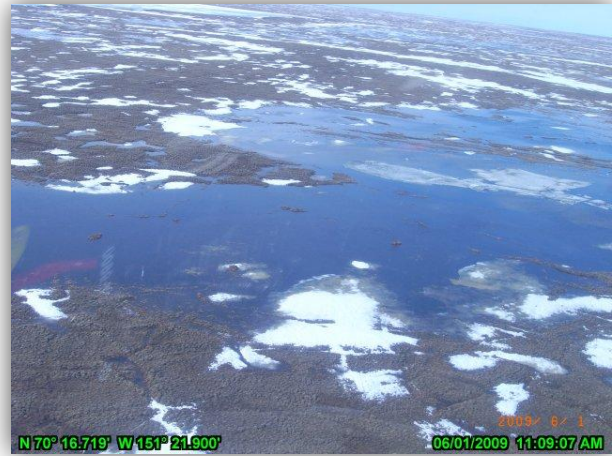
PHOTO 4.13: SITE S6, JUNE 1, 2009

The S6 site was characterized by accumulated local melt; no direct discharge measurement was made. No measureable flow was observed. On June 4, the extents of accumulated water were marked with GPS. The width of the water perpendicular to the proposed alignment was approximately 248 feet with a maximum depth of 1.0 feet.

Table 4.10 presents the observations and water surface elevations recorded for Site S6. Photo 4.13 shows the conditions of Site S6 on June 1.

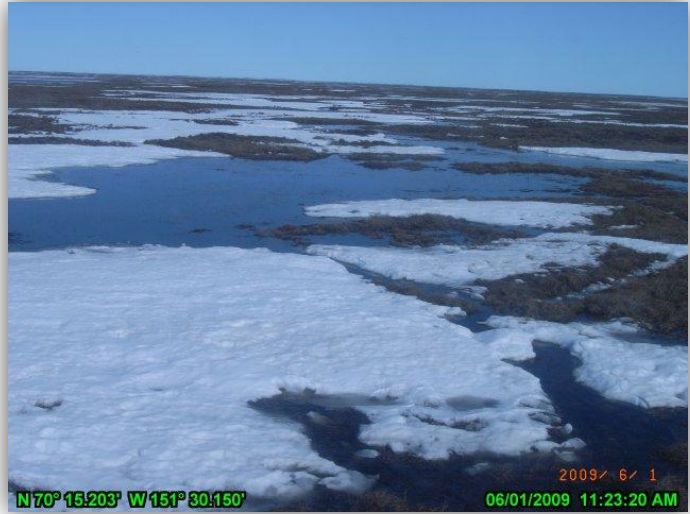
PHOTO 4.15: SITE S8 (GMT1 PAD), JUNE 1, 2009

On June 4, an attempt was made to mark the extent of accumulated water. The width of the water in the vicinity of the proposed pad could not be determined because there was no defined area of continuous accumulated melt. The meltwater was instead contained in many discontinuous and separate potholes and within polygon troughs.

Table 4.12 presents the observations and water surface elevations recorded for Site S8. Photo 4.15 shows the conditions of Site S8 on June 1.

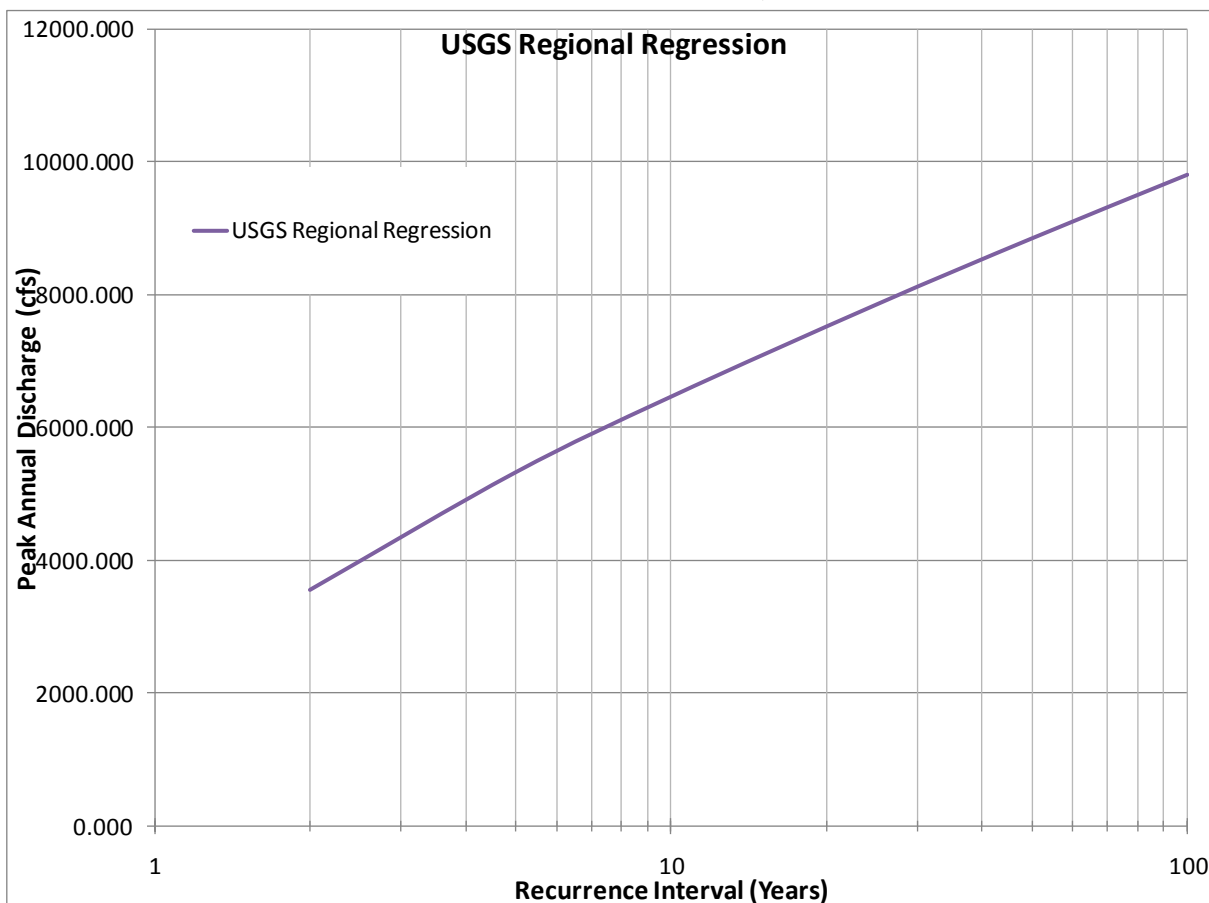
**GRAPH 5.1: UBLUTUOCH RIVER FLOOD FREQUENCY ESTIMATES**

The Ublutuoch peak discharge occurred shortly after peak stage, early on May 30, and was estimated to be 1,990 cfs with a WSE of 8.45 feet BPMSL. The 2009 peak discharge has a recurrence interval of 4 years, based on the Ublutuoch River flood frequency analysis.

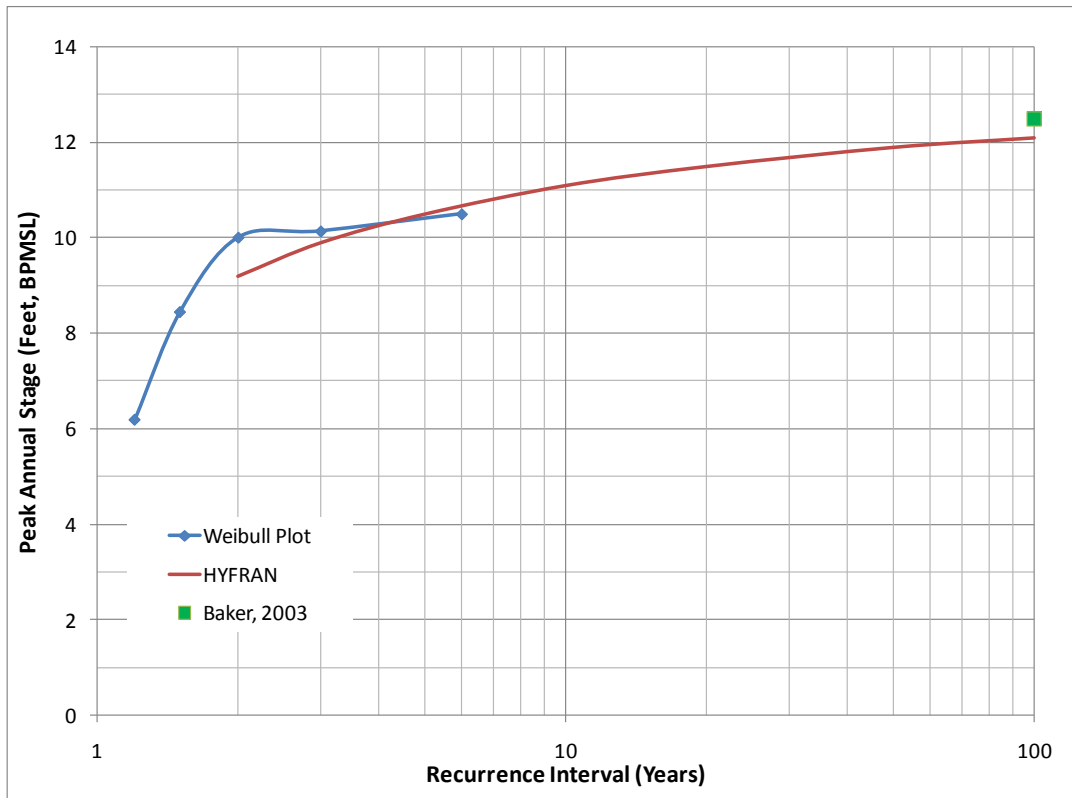
**GRAPH 5.2: UBLUTUOCH STAGE FREQUENCY ESTIMATES**

The peak water surface elevation at the Ublutuoch River crossing occurred on May 29 and was measured at 8.45 feet British Petroleum Mean Sea Level (BPMSL) at river mile (RM) 6.8. The 2009 peak water surface elevation was approximately two feet lower than the maximum peak observed over the historic record. The peak water surface elevation recurrence interval is 1.5 years, based on stage frequency analysis calculations.
