Alaska Geobotany Center Publication

AGC 14-01

LANDSCAPE AND PERMAFROST CHANGES IN THE PRUDHOE BAY OILFIELD, ALASKA

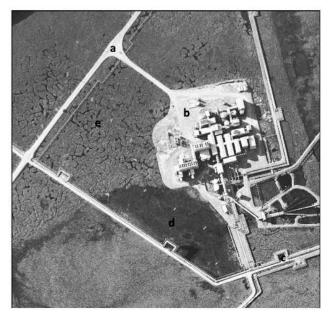
Figure 4.3. Examples of direct infrastructure-related effects: (a) road, (b) pad, (c) pipelines; and indirect effects: (d) flooding due to impeded drainage, (e) permafrost degradation due to altered drainage patterns—in a 1-km² area of the Prudhoe Bay Oilfield, Alaska, as seen on 2010 aerial photography. Other indirect effects are visible at full resolution, including: powerlines (one crosses from upper left to lower right, passing near (d), trails in lower left corner, and gravel and dust adjacent to the road in upper left. This site is located in Map B (Fig. 4.2), near letter (**n**) in Figure 4.8.

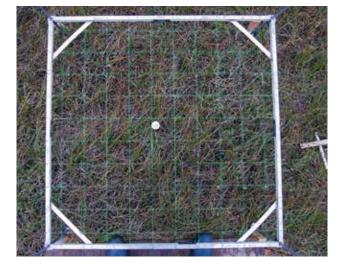
Figure 5.8. Plot T2 025 C with point quadrat in place. The grid defines the 100 points of the point sampling. The point quadrat is mounted on legs that are inserted in metal washers that are nailed into the tundra to allow the frame to be re-positioned at the same point for resampling. Plant species are recorded at each of the intersections of two layers of monofilament lines, minimizing parallax error. The central metal disk is the photo-point marker.

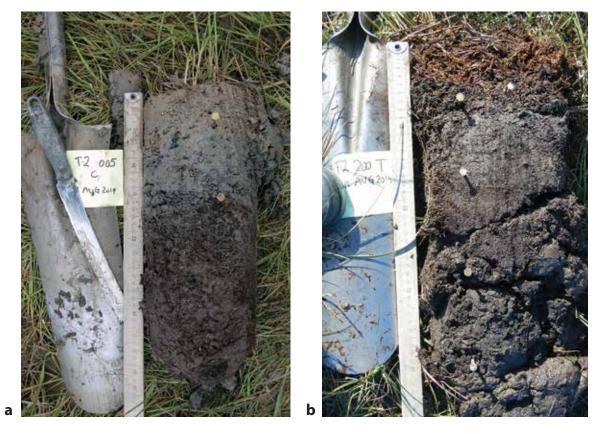
Figure 5.9. (a) Soil plug from center of an ice-wedge polygon at 5 m from the road along transect T2. Note the 13-cm thick mineral surface horizon, which is the dust layer above the original organic surface horizon. **(b)** Soil plug from trough of an ice-wedge polygon at 200 m from the road along transect T2. Note the gray color at the top of the organic soil horizon underlying the surface layer of moss, indicating leaching of dust into the organic layer. The blade of the Sharpshooter shovel used to extract the soil plugs is shown in both photos.

Soils within approximately 50 m of the road, on both sides, have mineral soil surface horizons composed largely of road dust and gravel that overlie the original organic soil horizons (Fig. 5.9). Near the
