PULLEN CREEK ACTION PLAN

PUBLISHED BY THE

TAIYA INLET WATERSHED COUNCIL

FEBRUARY 2006

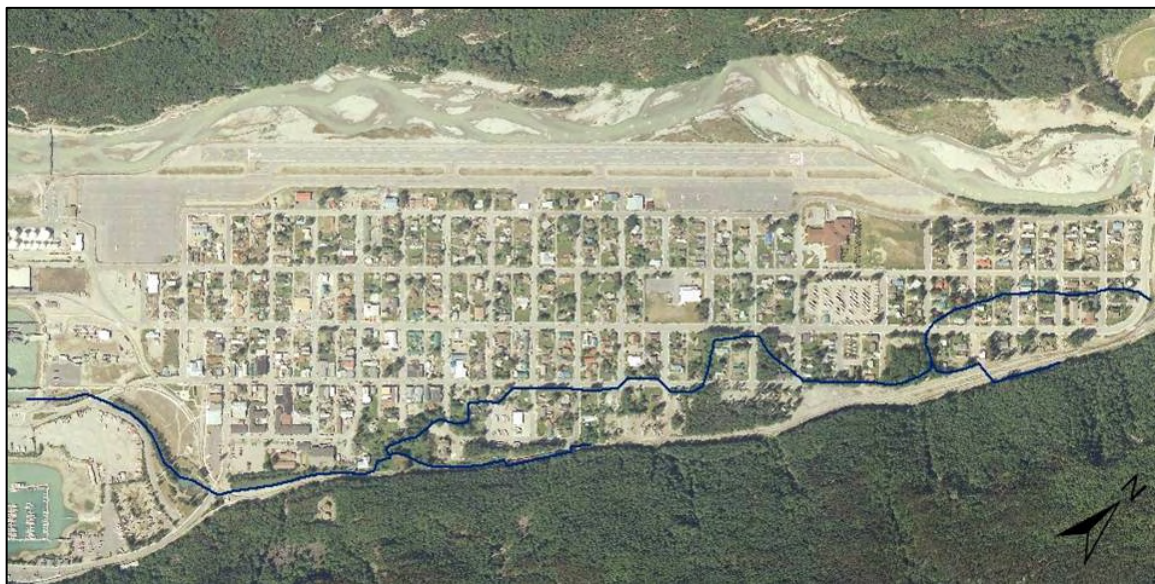
Figure 3: Pullen Creek (shown in blue) runs through Skagway and into the Skagway Harbor.

The creek has received supplemental flows from hydroelectric generation (up to 40 cfs) for more than 100 years. The tailrace, where flow from the AP&T hydroelectric plant enters the creek, divides Pullen Creek into two distinct sections. Above the tailrace the creek is generally less than 10 feet in width, below it the channel is less complex and varies from 19 to 58 feet in width (Rusanowski 2004). Much of this section parallels the railroad tracks and portions of streambank are heavily degraded and trampled. The Jerry Myers Fish Hatchery is a small hatchery which was built in 1981. It is run by the Skagway School District for education purposes. As a result, introduced or enhanced species in the creek include Chinook and pink salmon in addition to its native species.

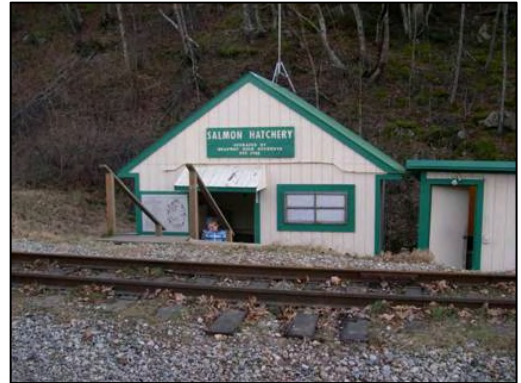
Figure 8: The Jerry Meyers Fish Hatchery is a small facility run by the Skagway City School.

In 1979 Pullen Creek was designated an Area Meriting Special Attention (AMSA) as part of the Skagway Coastal Management Plan. As part of the long-range plan, the Skagway School system was given a Scientific Education Permit to operate a fish hatchery. The Jerry Meyers Fish Hatchery, built by the school district in 1981 with a \$30,000 appropriation by the Alaska State Legislature, is owned by the city and run by the School District. The hatchery was built on the upper portion of tributary 1, which is spring fed approximately 100 meters upstream of the structure. The hatchery, as an outdoor classroom, was recognized as the Alaska Vocational Education Program of the Year in 1989. Chinook and coho eggs are harvested from Pullen and Lillegraven Creeks for the hatchery.

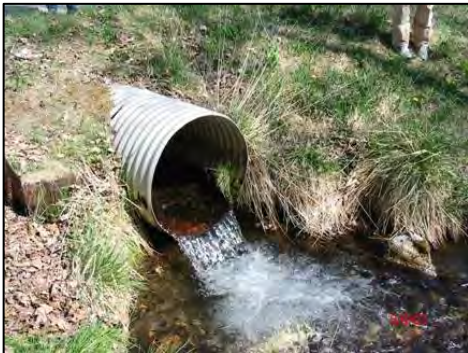
Figure 9: Perched culverts like this one create formidable and sometimes impassable barriers to juvenile salmonids

As a part of a mitigation project for the Skagway Airport, the Alaska Department of Transportation and Public Facilities (ADOTPF) placed a flume structure at the opening of the culvert to improve access. The structure was damaged during subsequent winter storms, and the outfall was once again in need of improvements to benefit fish passage. In another mitigation project, WP&YR is in the process of installing a new outfall for the creek which is hoped to reduce or eliminate fish passage issues at the outfall.

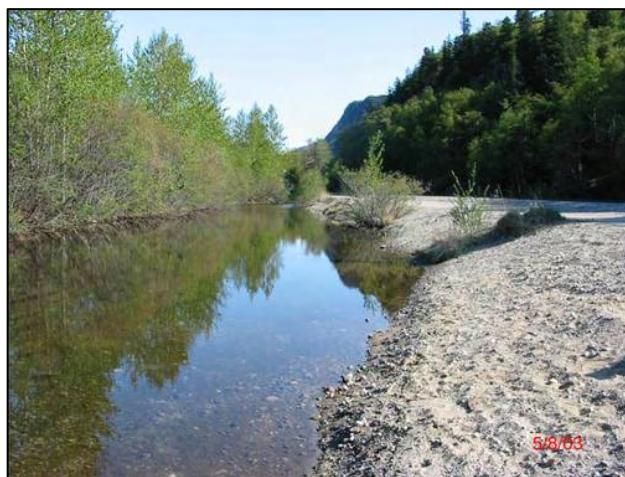
Figure 11: Areas like this one, with no riparian vegetation, contribute significant amounts of sediment to the creek

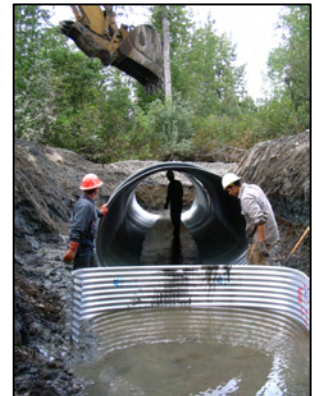
Figure 17: Replacing culverts which block fish passage is essential to restoring habitat and hydrologic function

The natural hydrology of Pullen Creek has been impacted by channel relocation, hydroelectric supplementation and road crossings. Several improperly sized or placed culverts limit fish passage and impede the natural hydrology of the system. Restoration of aquatic habitat and channel morphology will require improved culvert sizing and placement as well as stream channel restoration. Restoration and maintenance of the riparian zone will help ensure the long-term sustainability of restoration to the hydrologic processes in Pullen Creek.

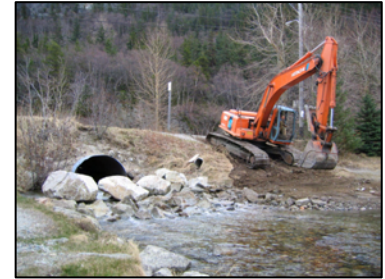
Figure 20: ADOT&PF installed this rock weir at the upstream end of Pullen Pond

The weir structure at the Congress Way culvert was rebuilt in spring 2004 with larger rocks. Rock dams in the daylighted reach were replaced with larger boulders. 2004 monitoring reports that *it is unlikely that juvenile salmonids can move upstream through the Second Avenue (Congress way) culvert under the flow conditions encountered*. The report indicates that juvenile fish are present above the culvert and that, at a minimum, successful coho and Dolly Varden spawning is occurring there (Sogge 2004).

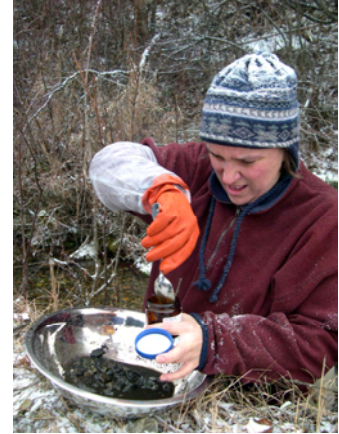
Figure 23: Soil & sediment samples were collected during the study to test for heavy metal and hydrocarbon contamination

Contaminants appear to be more closely associated with the Fish Hatchery site (Reach 4, see Appendix B), where arsenic, barium, cadmium, chromium, lead, mercury and zinc were all found in exceedence of standards in soils and sediments. It is recommended that a comprehensive site specific study be conducted in this area to determine the extent of contamination (Skagway Traditional Council 2005).

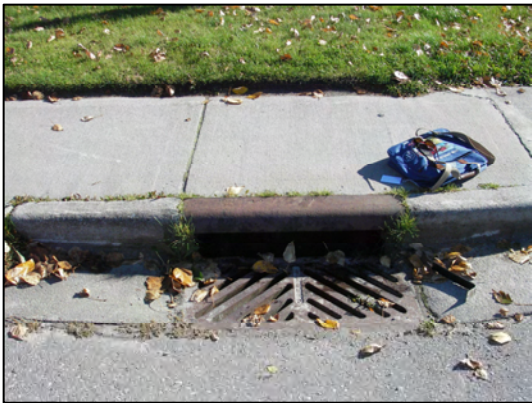
Figure 25: Stormwater catchbasins dot the town of Skagway

The Alaska Clean Water Action (ACWA) program recently funded TIWC to map the Skagway stormwater system. This project is part of a longer-term goal of ensuring the watershed has high water quality for many years to come. The first part of this process is to build an accurate picture of our stormwater system by mapping all of our catchbasins and discharge pipes.

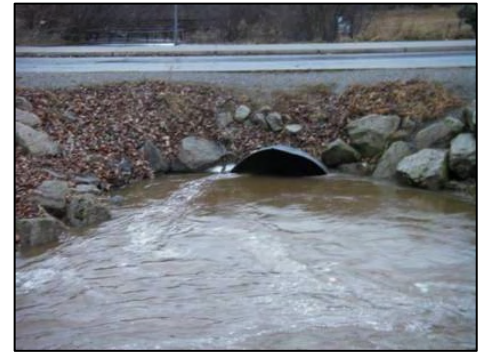
Figure 26: Culverts that are too small inhibit fish passage by increasing stream velocities, at negatively impact stream hydrology

Improper sizing and installation of culverts has created notable problems in Pullen Creek. The damming effect created at crossings has degraded the stream channel in some locations and the stream no longer flushes sediments or passes water efficiently. We recommend resolving this by

In recent years some culverts have been removed and those creek sections “daylighted”, examples include a site near the AP&T powerhouse and the site just above the outfall. This improves fish habitat. There are still some culverts that force Pullen Creek to run underground for unnecessarily long distances. In the future, we recommend that stakeholders work together to remove these culverts and daylight all possible portions of the creek.

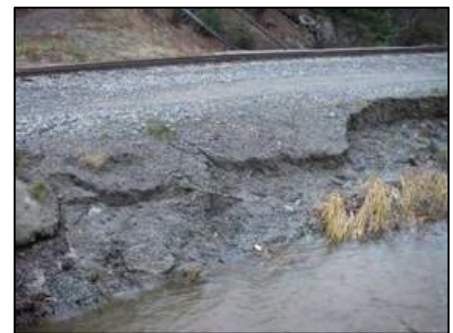
Figure 27: Sluffing of stream banks, as has occurred at this location along Pullen Creek, damages stream habitat and infrastructure necessary for community functions

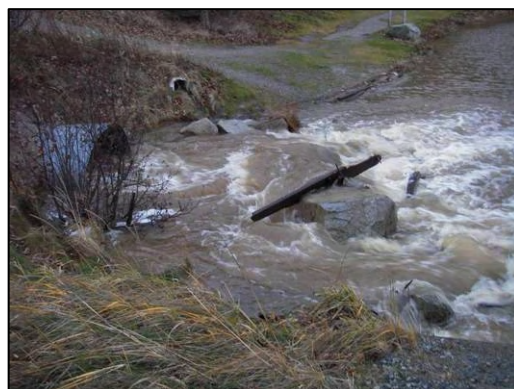
Figure 28

Stormwater can pose threats to the environment. In developed areas runoff from rain or snowmelt carries natural and manmade pollutants into wetlands, lakes, streams and groundwater. This stormwater can affect water quality, habitat and living resources, and may carry bacteria, nutrients, pesticides and hydrocarbons. Stormwater also conveys sediments that cause siltation of aquatic habitats, and contributes floatable debris, resulting in increased turbidity and declining water clarity. If land owners and managers can work together to manage stormwater, its impacts to Pullen Creek can be minimized.

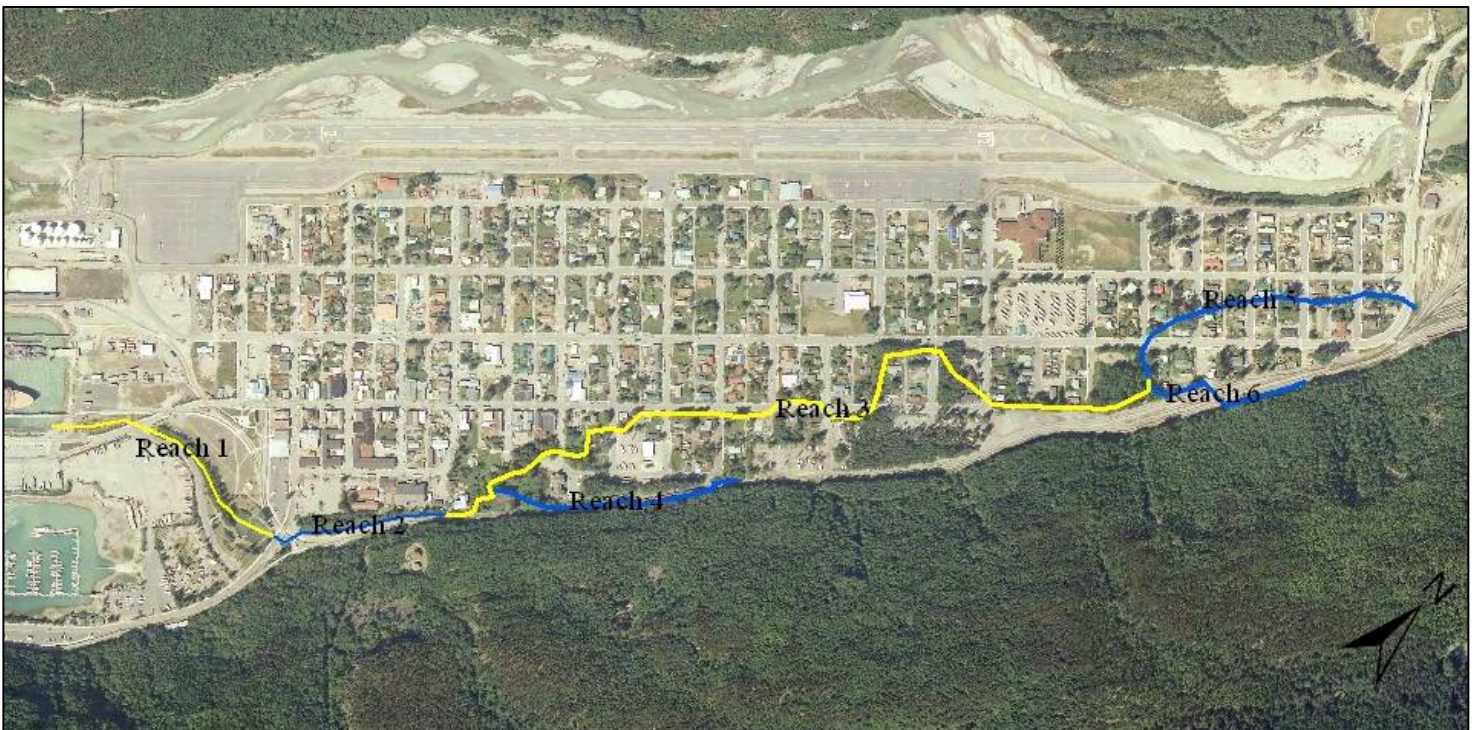
Figure 1: Pullen Creek has been divided into six reaches, indicated above in yellow or blue.

1. Outfall to Pullen Pond
2. Pullen Pond to AP&T tailrace (also called Congress Way reach)
3. AP&T tailrace to 18th Avenue fork
4. Fish hatchery
5. 18th Avenue headwater spring in WP&YR railyard (near 23rd Avenue)
6. 18th Avenue to headwater spring at base of hill on the east side of town (near 21st Avenue)

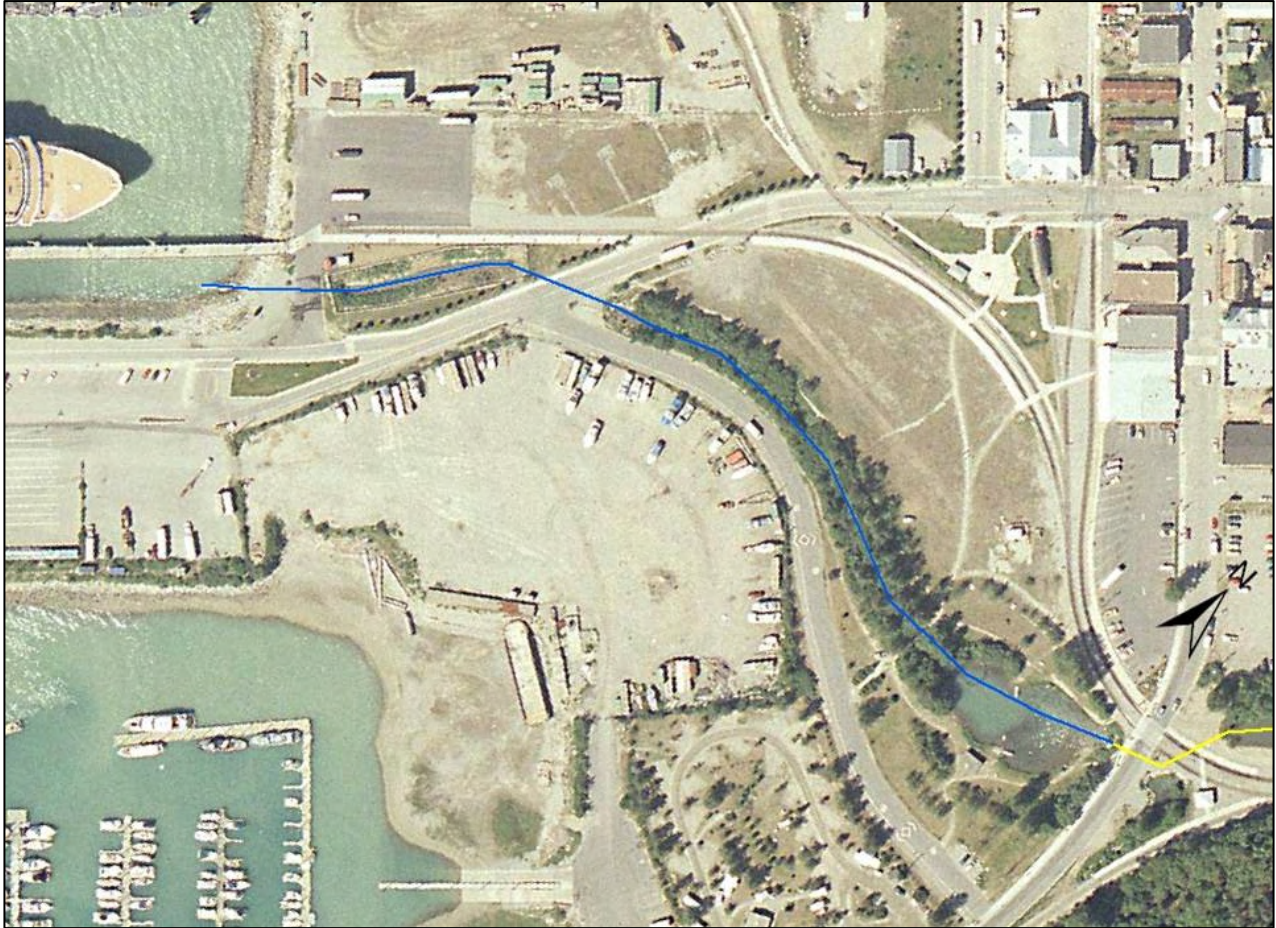
Figure 2: Reach 1 of Pullen Creek

This reach of Pullen Creek begins at the mouth of the creek, where Pullen Creek spills out of a culvert and into the Skagway harbor. The reach extends approximately 1/4 mile upstream to the upstream end of Pullen Pond. Much of the reach harbors a wide riparian buffer zone. Pullen Pond is surrounded by a network of “social” trails and contains little native vegetation. There are two culverts within the reach.

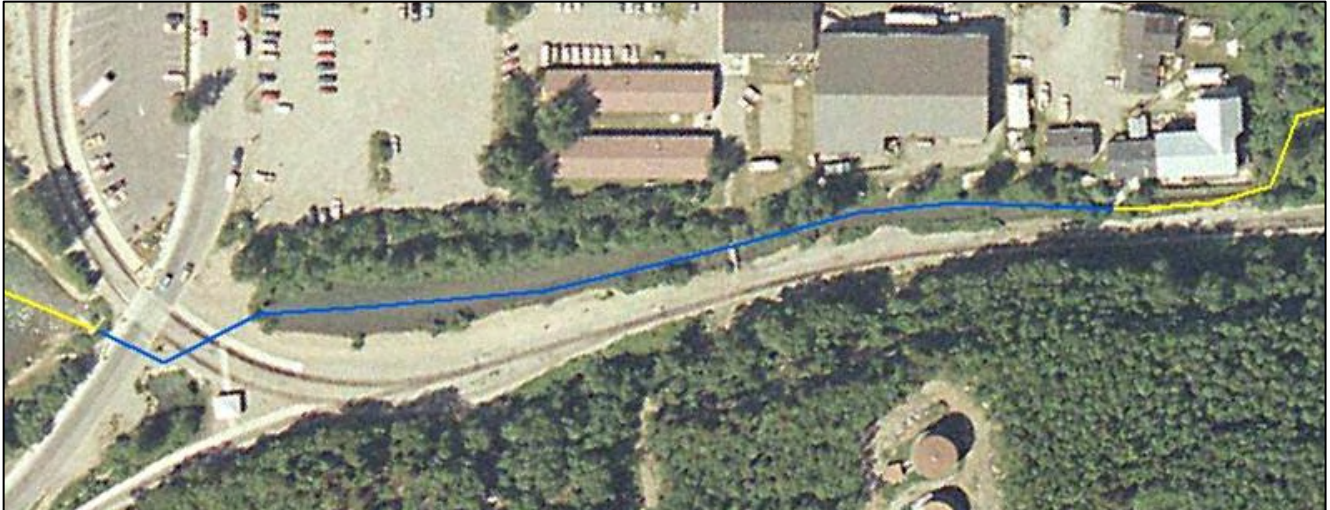
Figure 3: This figure illustrates reach 2 in blue. This reach extends from Pullen Pond upstream to the AP&T power plant and tailrace.

Reach 2 of Pullen Creek has been dubbed the Congress Way reach. It extends from the south side of the culvert passing under Congress way approximately .17 miles north, where the AP&T tailrace enters the creek. The WP&YR railroad parallels the creek on the east side, and a dike composes the west bank. The east bank is virtually devoid of vegetation and lacks riparian cover, essential for juvenile fish, while the left bank has reasonably good alder and shrub cover.

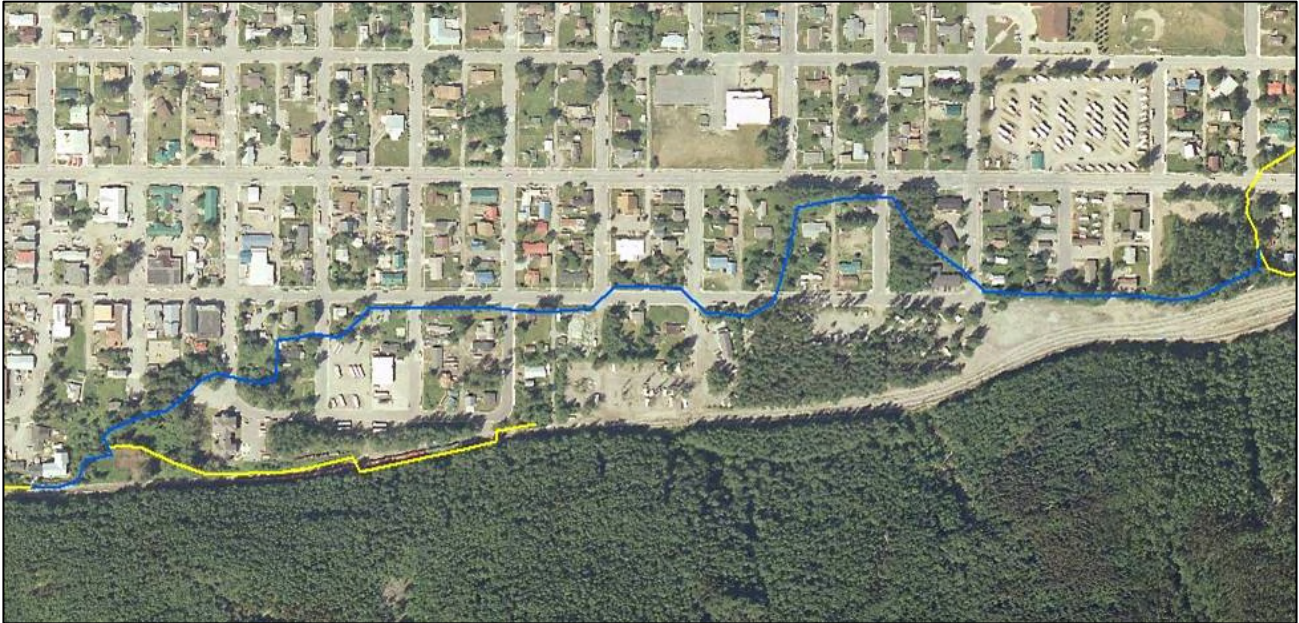
Figure 4: This figure illustrates reach 3 in blue. This reach extends AP&T power plant and tailrace upstream to a fork in the creek (junction with reaches 5 & 6). Reach 4, the Fish hatchery reach can be seen in yellow at the bottom.

This reach of the creek extends from above the AP&T tailrace to a creek junction near the intersection of 18th and State streets. Due to the heavily residential nature of most of the reach, it contains limited riparian vegetation and passes through 15 culverts as it courses its way through the community.

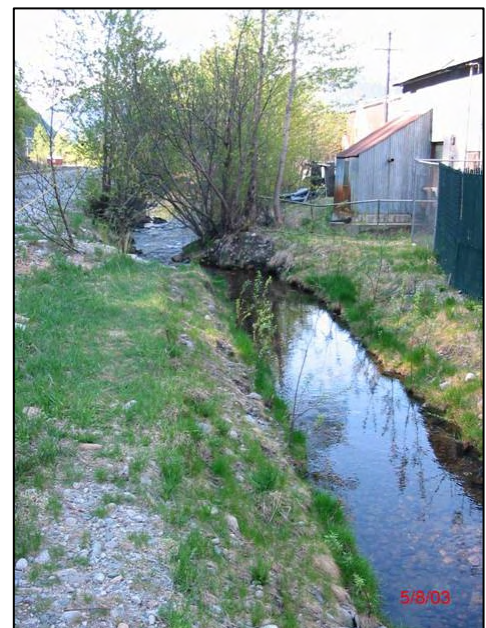
- There are a number of sites along the creek that require improvements to restore fish passage including culvert removal or replacement, dams removal, and other structures limiting fish passage or otherwise causing degradation of the stream and/or its habitat. Some of these include:

- The culvert at 15th street near Broadway is possibly not set right, or restoration of stream hydrology needs to occur above the culvert, for water is pooling there.

- The culvert in the alley between 16th and 17th, at the east end near the railroad tracks may need to be replaced. Sediment transport through this area could be enhanced if flows were restored by recreating a channel above the culvert.

- The culvert in the alley between 13th and 14th is perched and should be replaced as it inhibits fish passage.
 - Considerable restoration of native riparian vegetation due to trampling is possible in this reach. Much of this has been caused by uncontrolled access to the creek by visitors in public areas, but restoration opportunities are also apparent on private property.

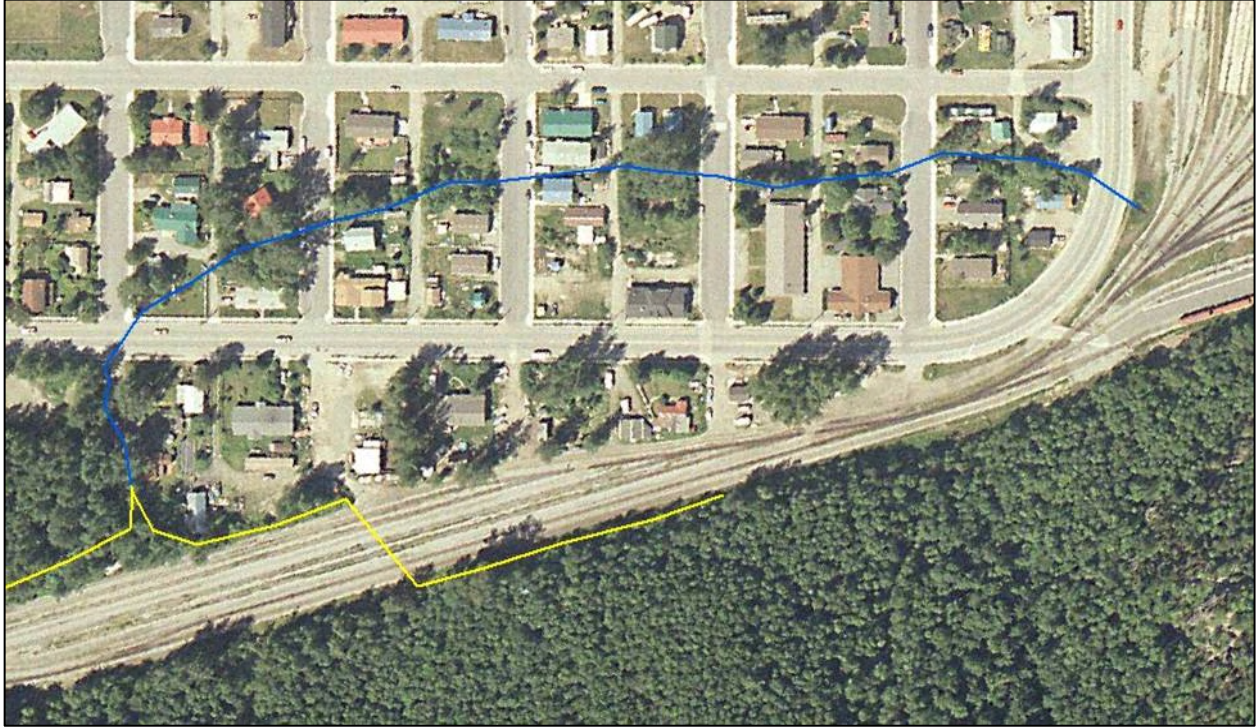
Figure 6: Reach 5 branches off the mainstem of the creek near the intersection of 18th and State streets. It originates from a small spring in the WP&YR railyard.

This spring fed tributary of Pullen Creek is another low flow channel. It extends upstream from the junction near 18th & State streets, through residential properties to the WP&YR rail yard, where a spring flows. This reach faces many of the same challenges as Reach 3, urbanization, impervious surfaces, and approximately 10 culverts.

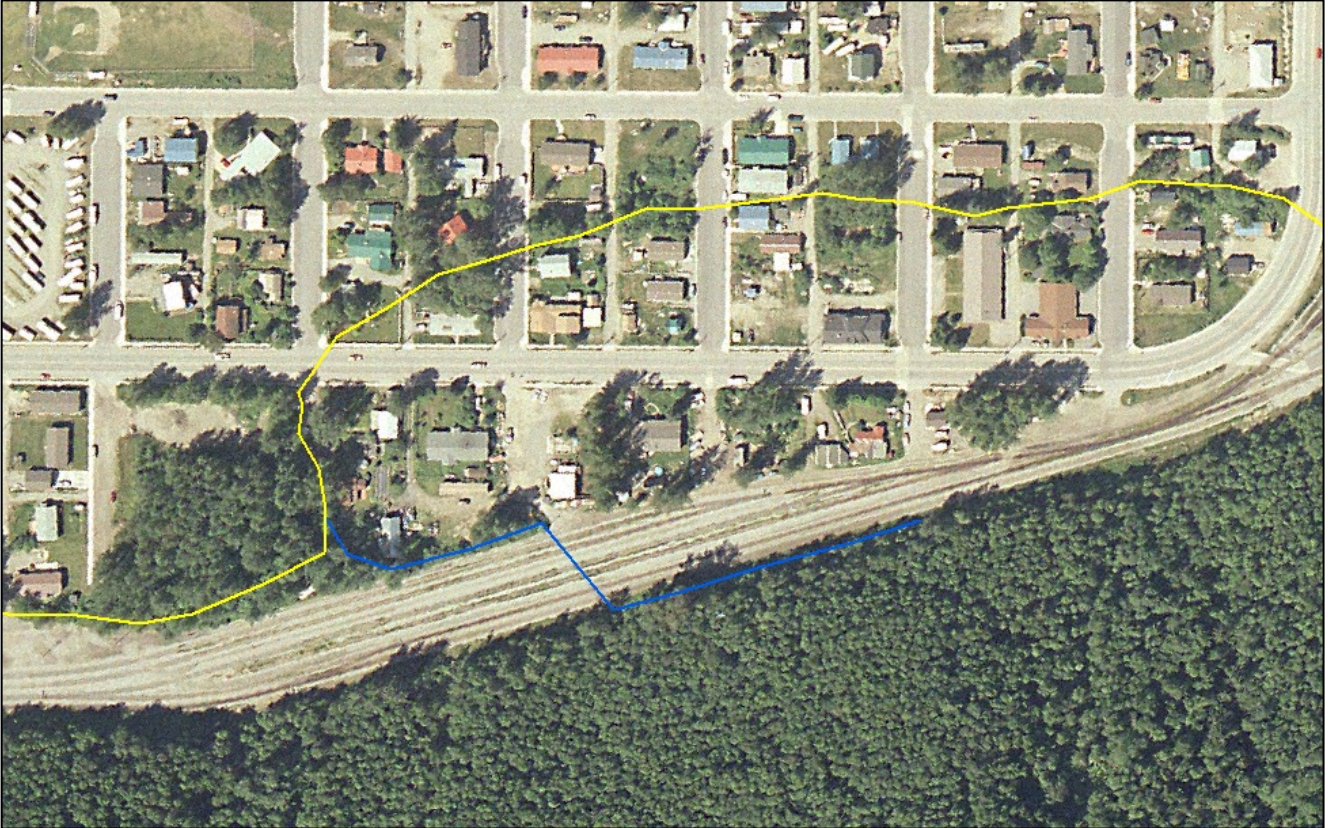
Figure 7: Reach 6 contains the main headwater of Pullen Creek, a spring at the base of the mountain, on the east side of Skagway. This reach extends from the fork in the creek to the spring.

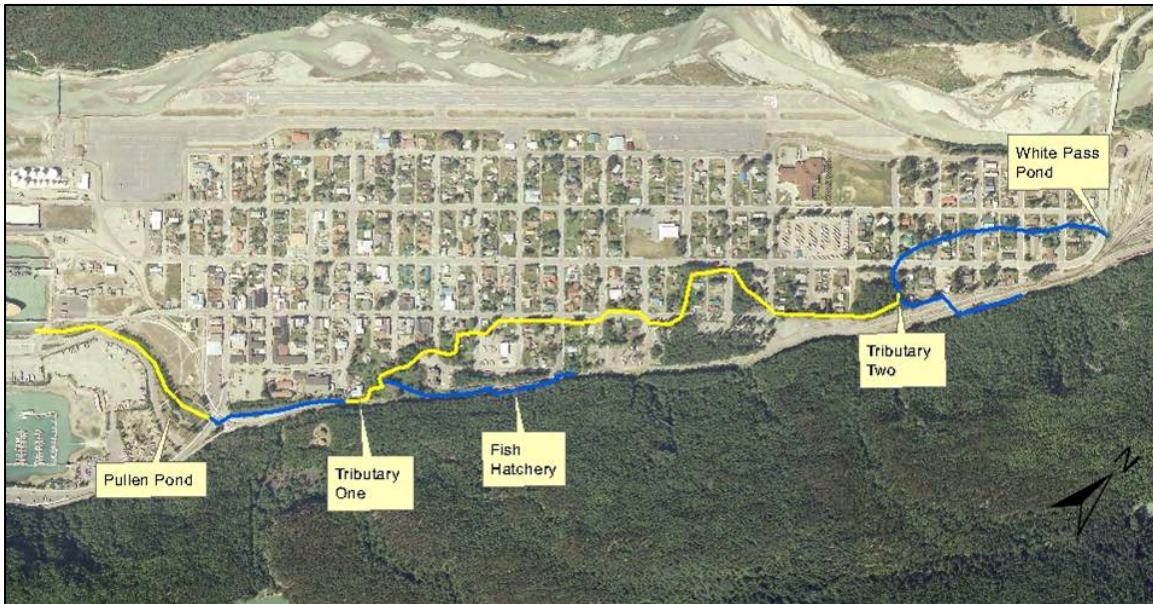
Figure 1: Sampling sites used in the STC assessment of Pullen Creek.
