ALPINE SATELLITE DEVELOPMENT PLAN

2011 WATER QUALITY MONITORING REPORT

Rev. 0 Final
December 2011
123685-MBJ-RPT-001

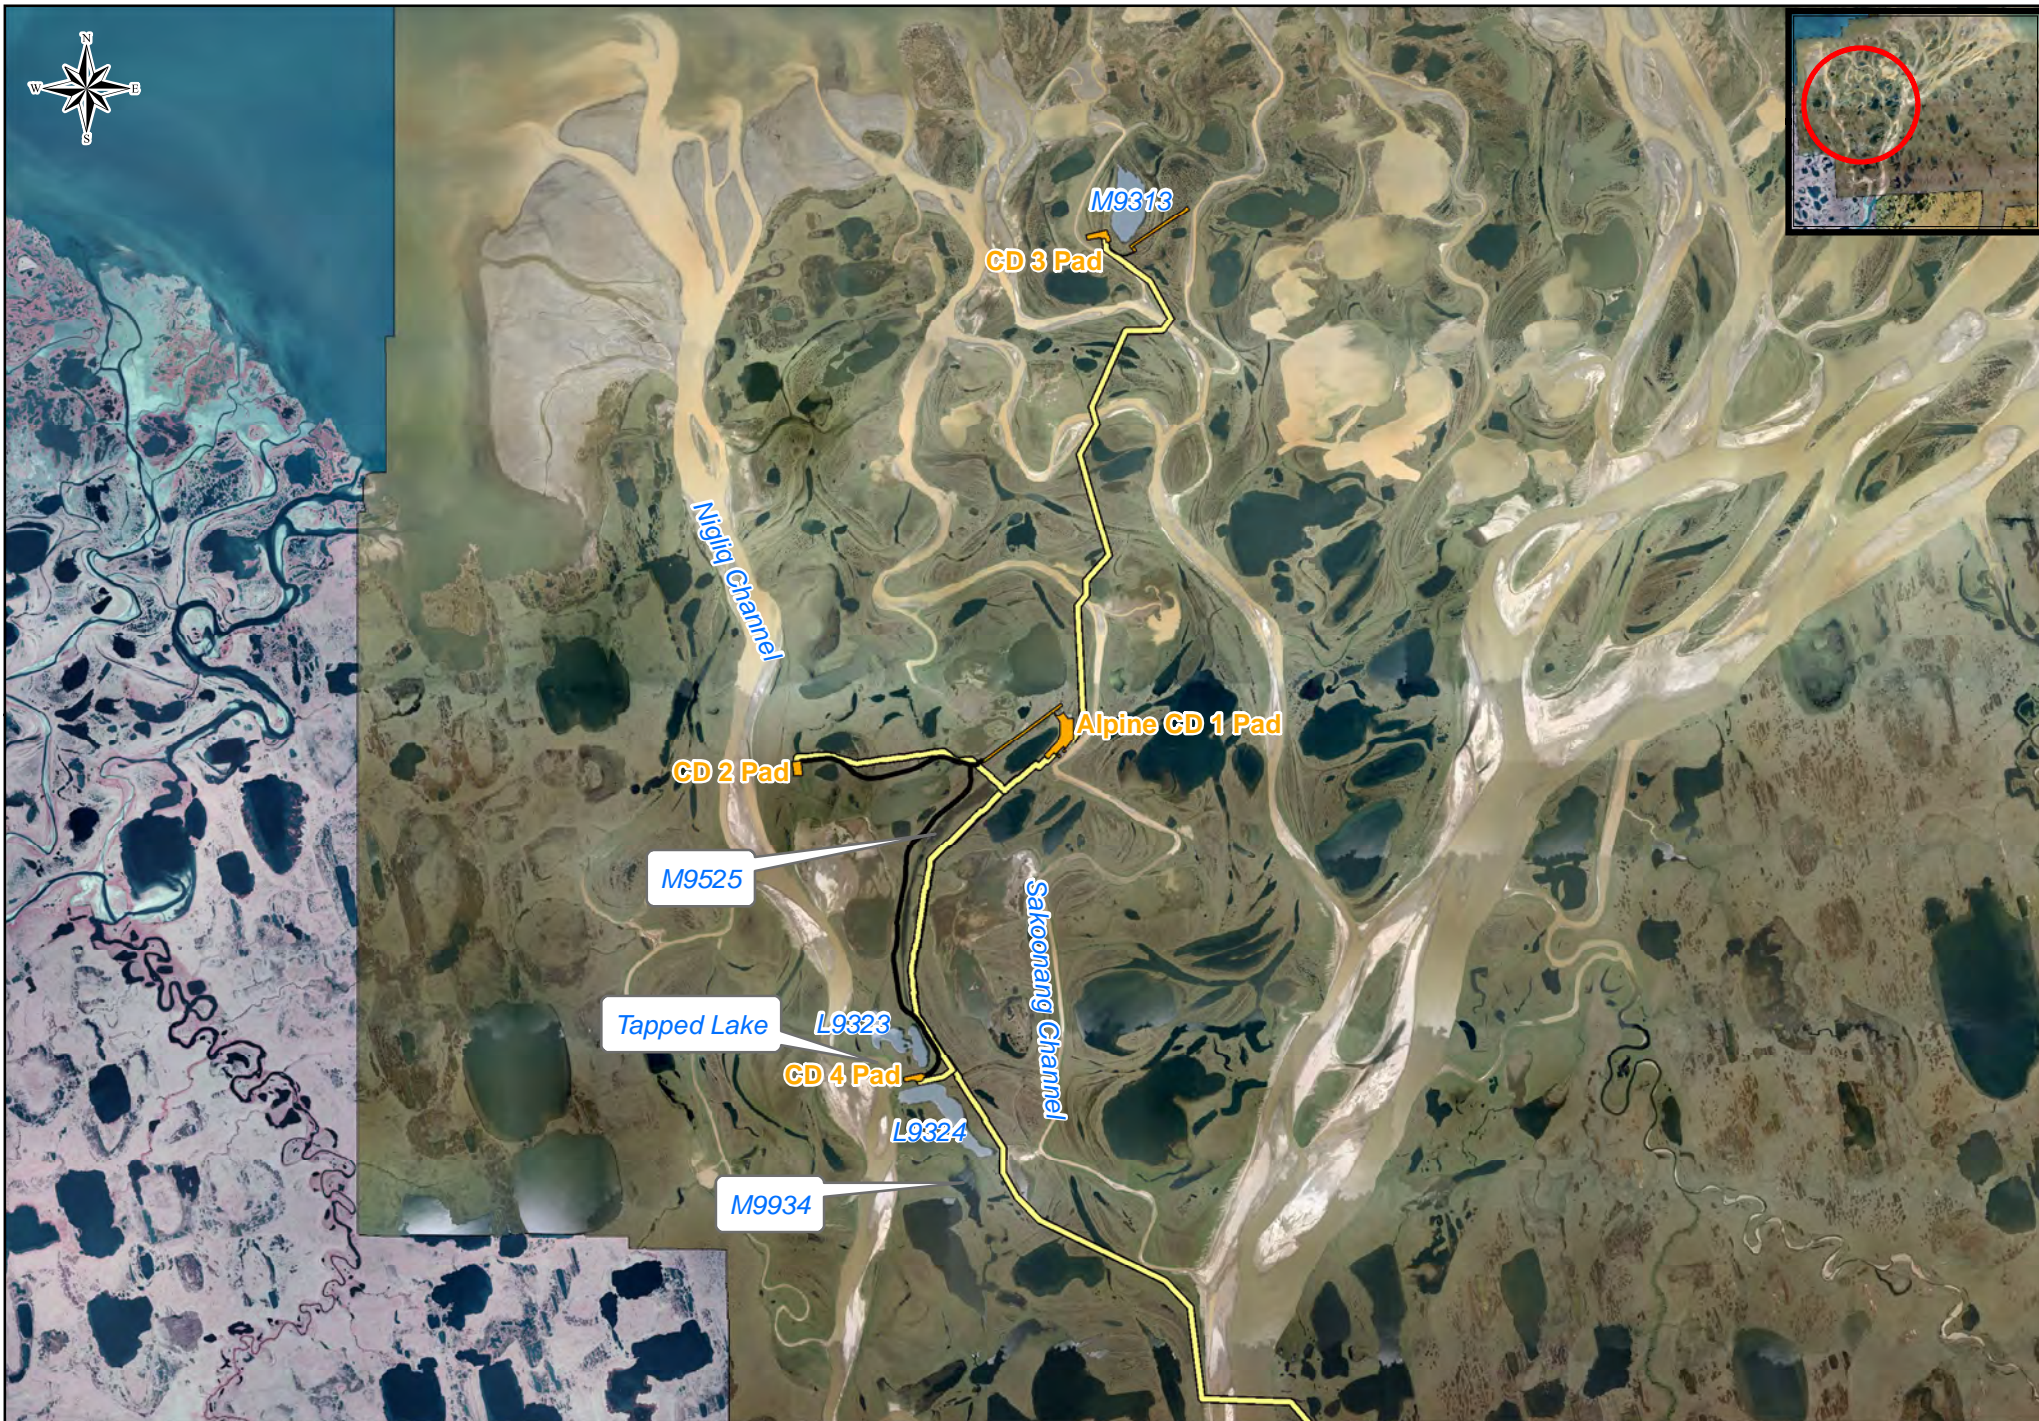
FIGURE: 1.1
(SHEET 1 of 1)

2011 OVERVIEW
ASDP WATER QUALITY
MONITORING AREA

The Alpine Satellite Development Plan (ASDP) 2011 Water Quality Monitoring Report presents the result of the field sampling conducted in August 2011 for ConocoPhillips Alaska, Inc. (CPAI). Annual monitoring of lakes M9313, L9323, and L9324 is required by North Slope Borough Ordinance Serial No. 75-6-46, Stipulation IV.2.4.3(h). At the request of CPAI, these three lakes have been monitored annually by Michael Baker Jr. Inc. (Baker) since 2007. An overview of the three study lakes relative to Alpine facilities is presented in Figure 1.1.

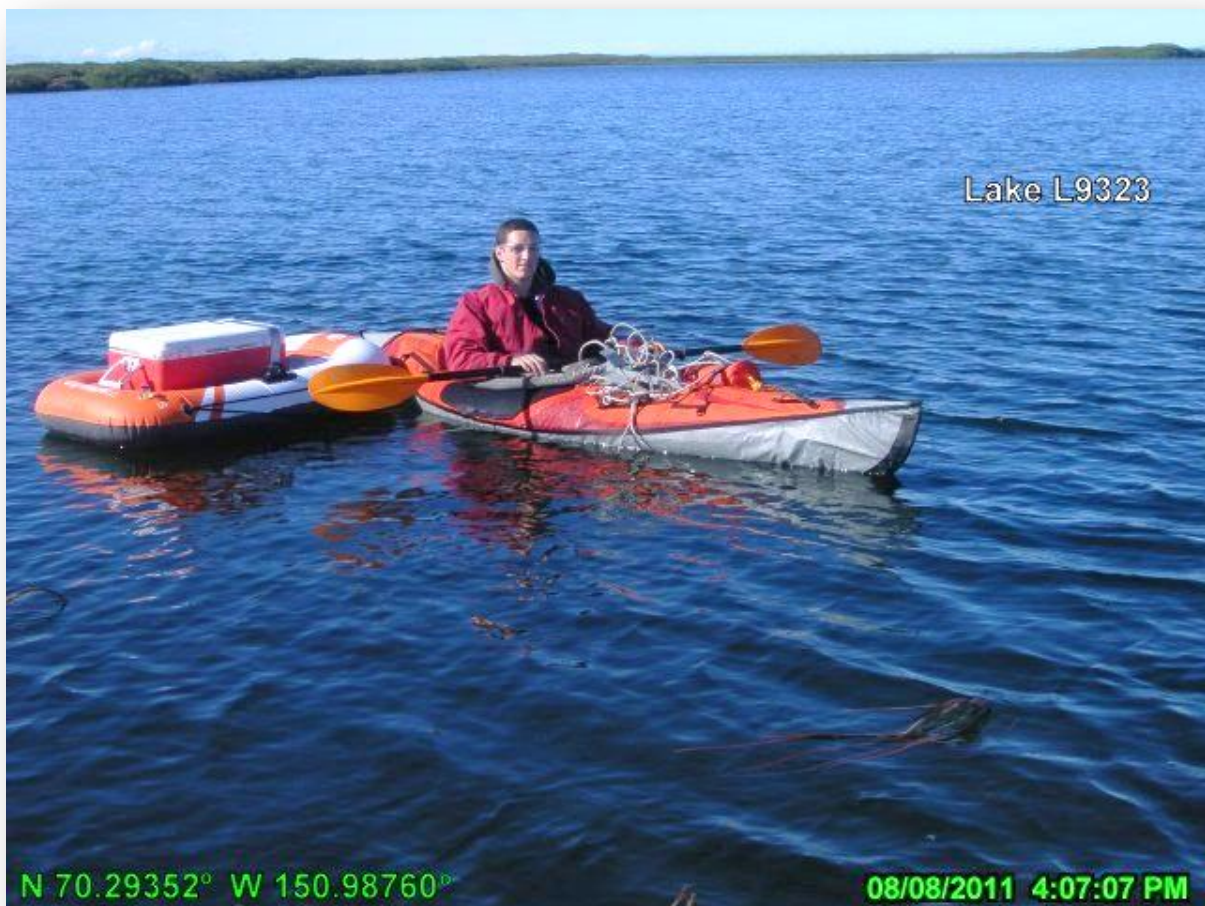
Photo 2.1: Inflatable kayak and support equipment, Lake L9323; August 8, 2011

In-situ water quality data measurements and laboratory sample collection were performed by a two-person Baker team; each in an inflatable kayak, with an attached support raft for transporting the sampling equipment (Photo 2.1). In-situ water quality instruments were provided by TTT Environmental. Laboratory analyses and sample collection bottles were provided by SGS North America, Inc. (SGS).

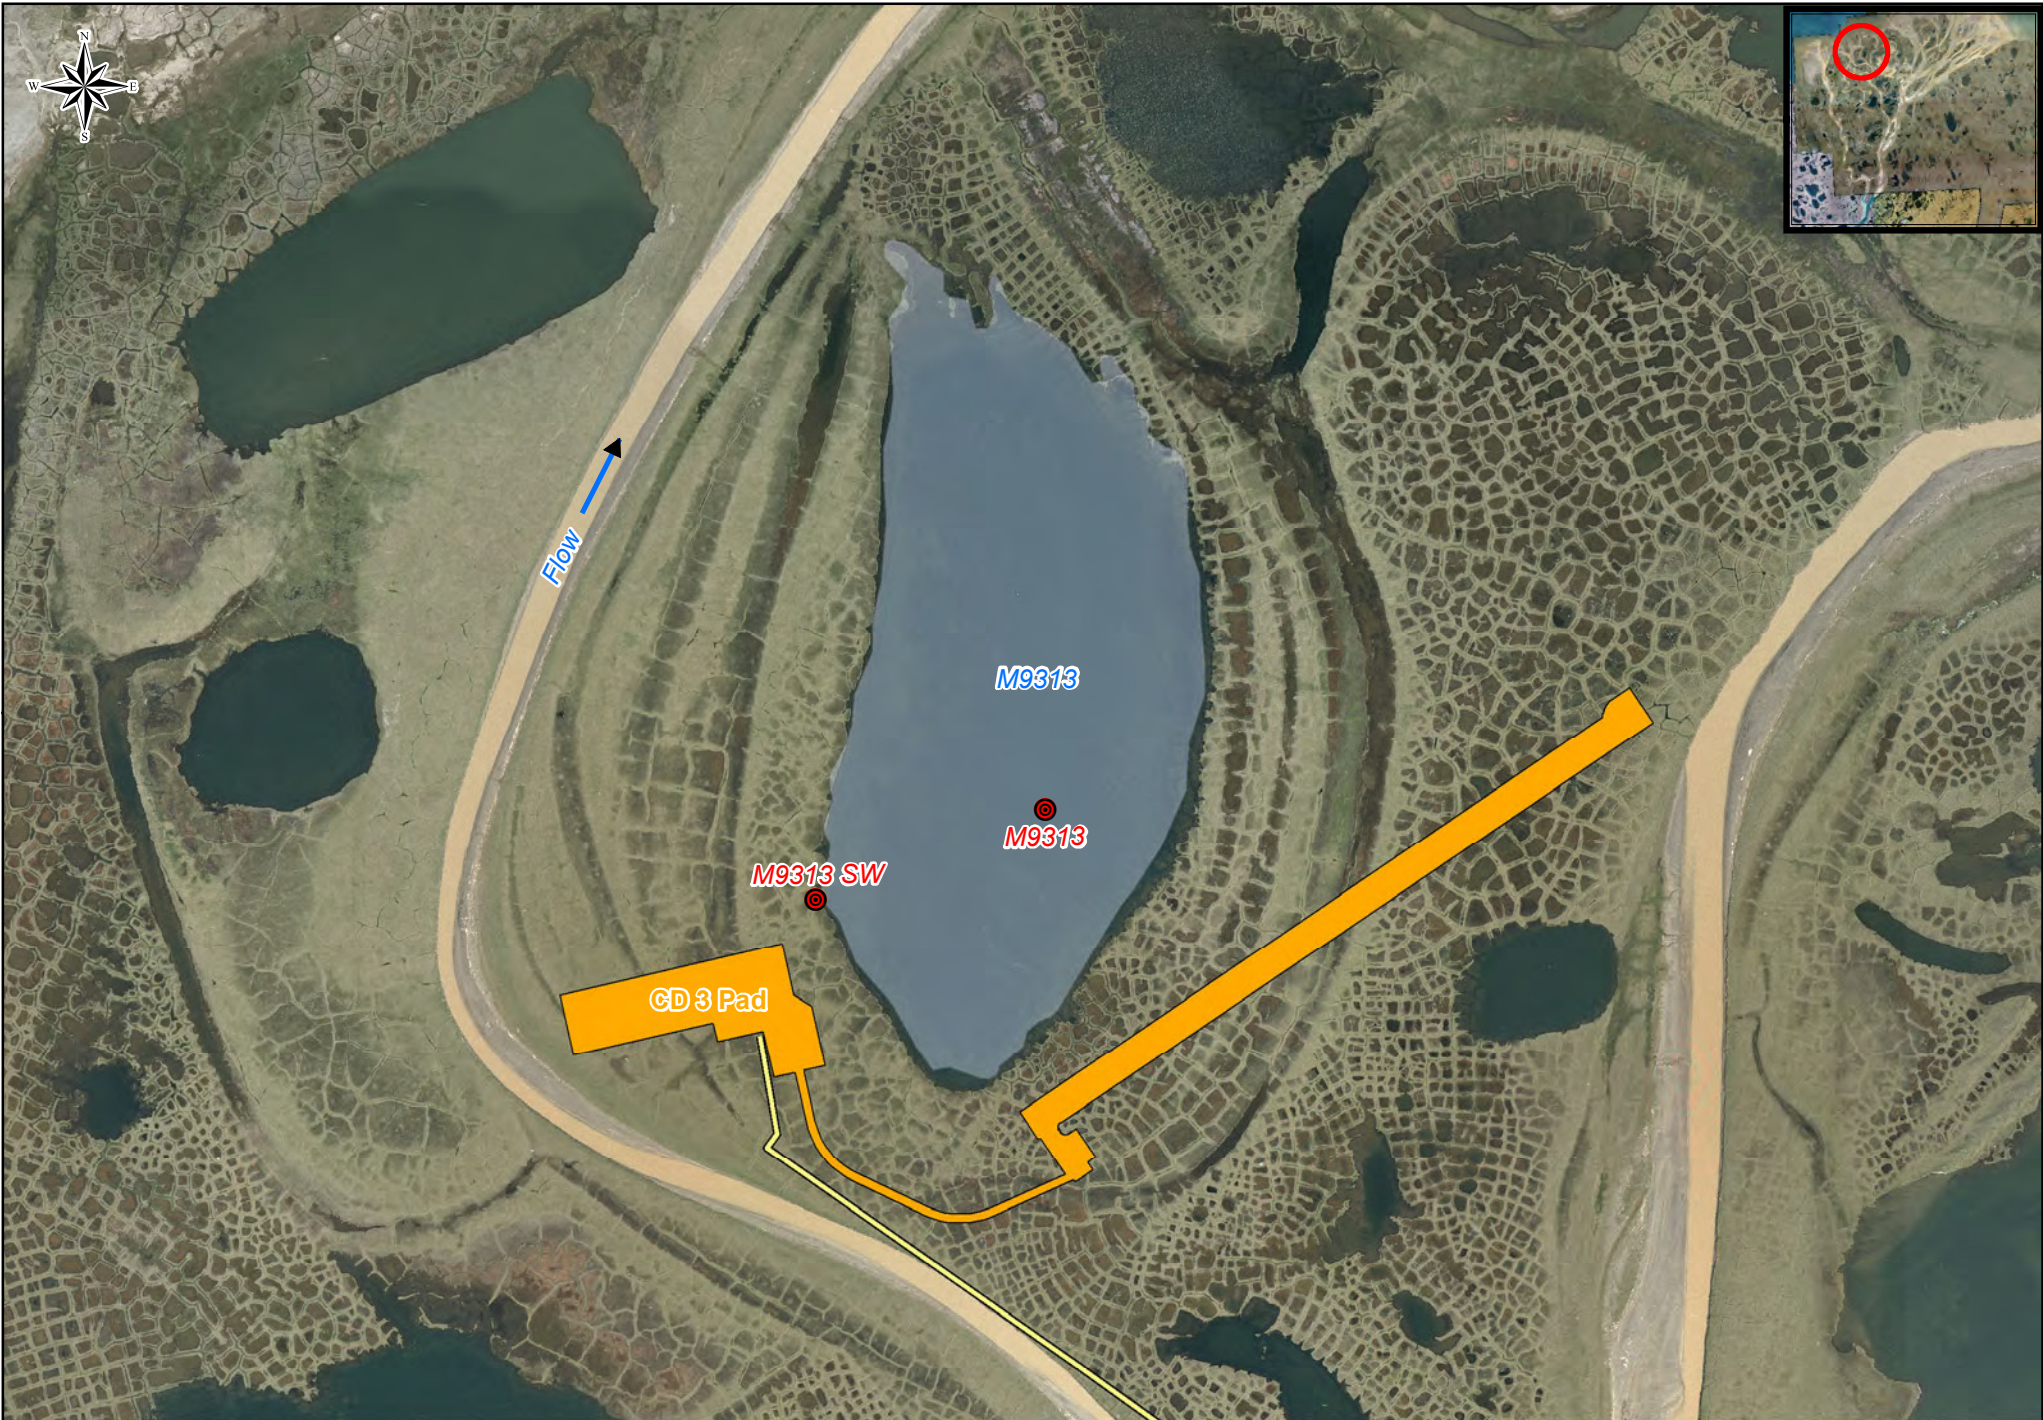
LAKE M9313 ASDP WATER QUALITY SAMPLING LOCATIONS
FIGURE: 2.1
(SHEET 1 of 1)

Sample locations were identified and confirmed using a handheld global positioning system (GPS) Garmin Rino 520HCx referenced to the North American [horizontal] Datum of 1983 (NAD83). Samples were collected at locations confirmed by the 2010 field investigation to be the deepest part of lakes M9313, L9323, and L9324 (Baker 2010). The sample location for Lake M9313 is shown in Figure 2.1. Figure 2.2 shows the sample locations for lakes L9323 and L9324.

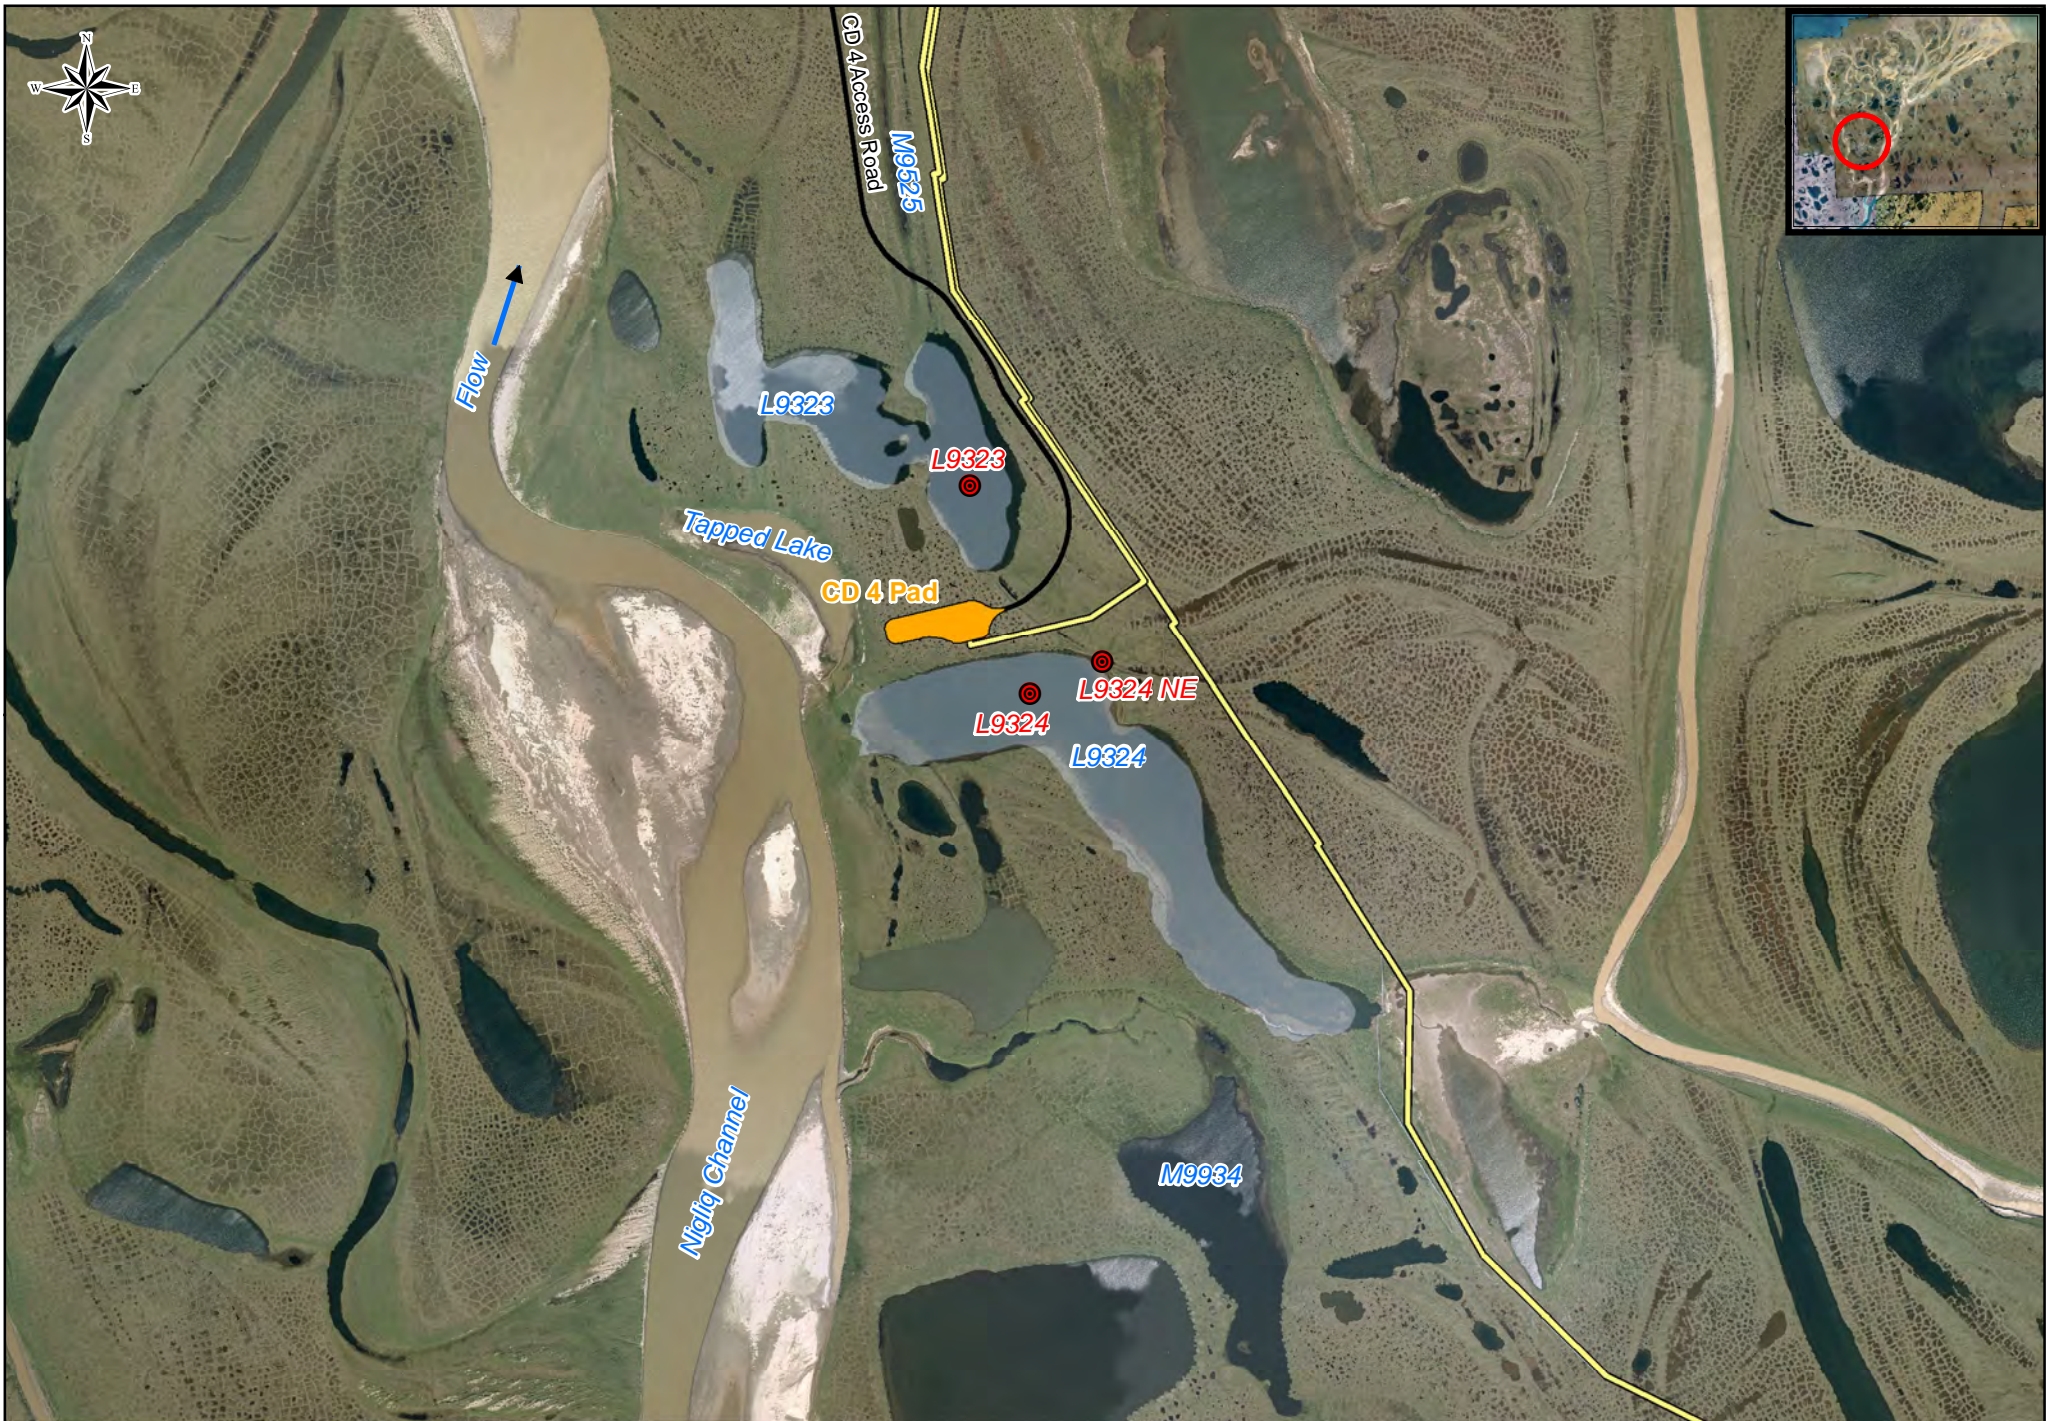
FIGURE 2.2
(SHEET 1 of 1)

**LAKE L9323 & L9324
ASDP WATER QUALITY
SAMPLING LOCATIONS**

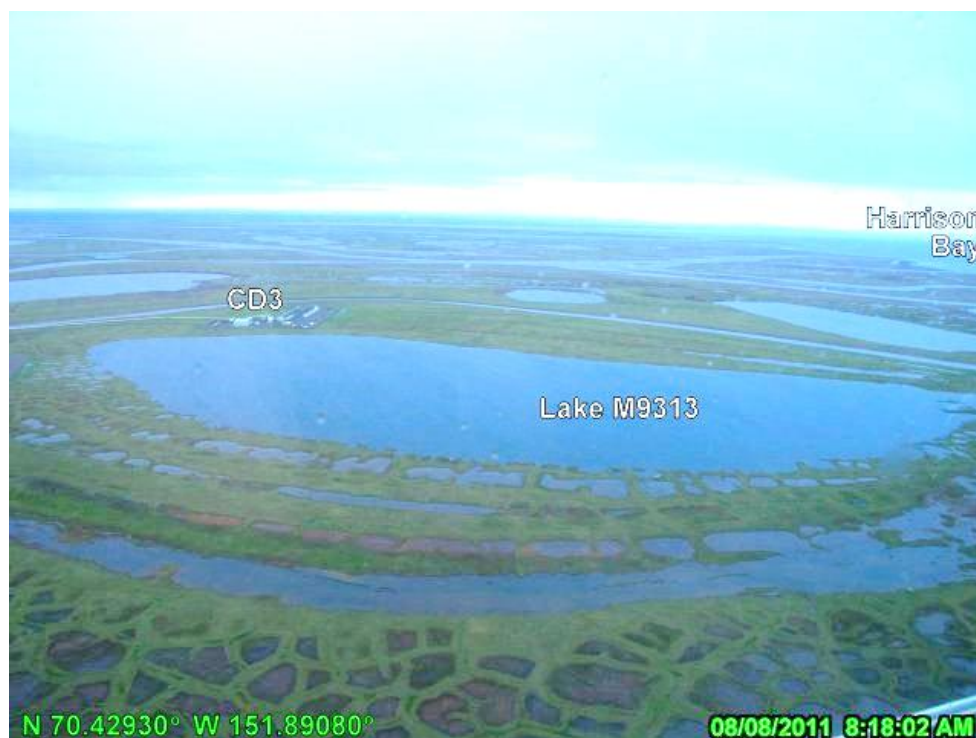
Lake M9313, located near CD3, is large with low grassy banks (Photo 3.1). No hydraulic connectivity between M9313 and any other body of water was observed during spring breakup 2011.

Photo 3.1: Lake M9313, looking west; August 8, 2011

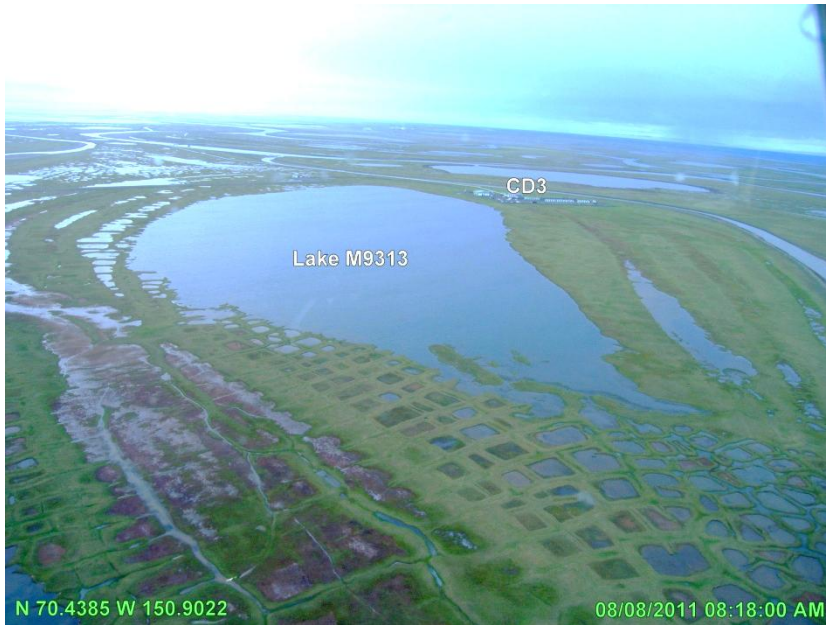
Photo 3.2: Lake M9313, looking southwest; August 8, 2011

At the time of sampling, Lake M9313 was connected to some areas of water ponded in adjacent polygons along the eastern side, but flow was localized within the bank areas (Photo 3.2). Neither odor nor film was observed on the lake. A film was present in the tundra adjacent to the southwest bank, M9313 SW (Photo 3.3), but no odor was detected and surrounding vegetation appeared healthy.

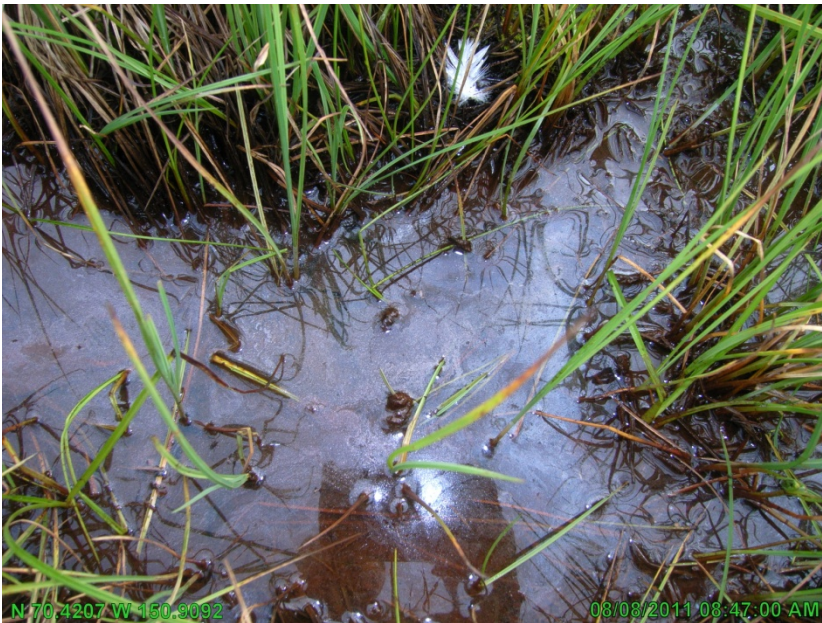
Photo 3.3: Marshy area adjacent to Lake M9313 (M9313 SW); August 8, 2011

procedure used to separate analytes from interfering compounds. SG cleanup was used in M9313 SW and L9324 NE samples. RRO was detected at a concentration of 3.33 mg/L in sample M9313 SW. The same sample after the SG cleanup method was applied showed RRO concentrations of 2.69 mg/L above the ADEC cleanup level of 1.1 mg/L.

The laboratory results are presented with a low level of confidence. There was a potential for cross contamination during onsite equipment decontamination and sample collection. However, vegetation in the area appeared healthy, no odor was noted, and no other indications of hydrocarbons were present. Additional sample collection during the open water season in summer 2012 is suggested to further investigate the area and verify the laboratory results.

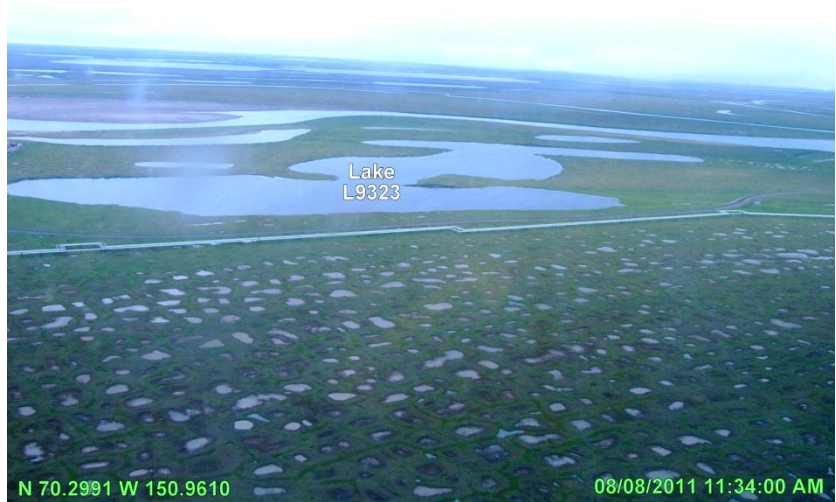
Located near CD4, Lake L9323 is moderately sized with grassy banks and some reeds on the periphery (Photo 3.4). During spring breakup flooding, this lake was hydraulically connected to Lake L9324 to the south via CD4 road culverts, to Lake M9252 to the north also via CD4 road culverts, and briefly to the Nigliq Channel to the west. No hydraulic connectivity between Lake L9323 and any other body of water was observed at the time of sampling (Photo 3.5). Neither odor nor film was observed on the lake. No film was observed on the tundra when accessing the lake.

Photo 3.4: Lake L9323, looking northwest; August 8, 2011

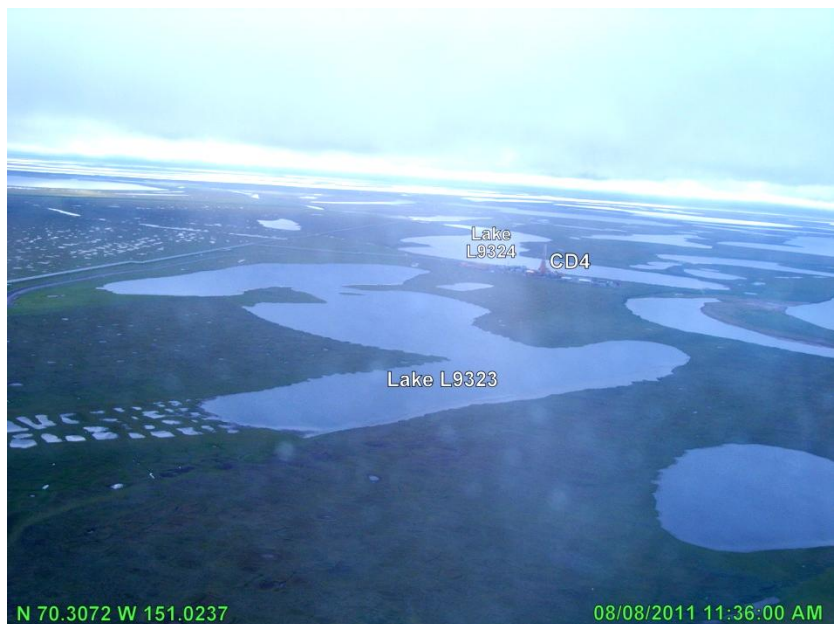
Photo 3.5: Lake L9323, looking southeast; August 8, 2011

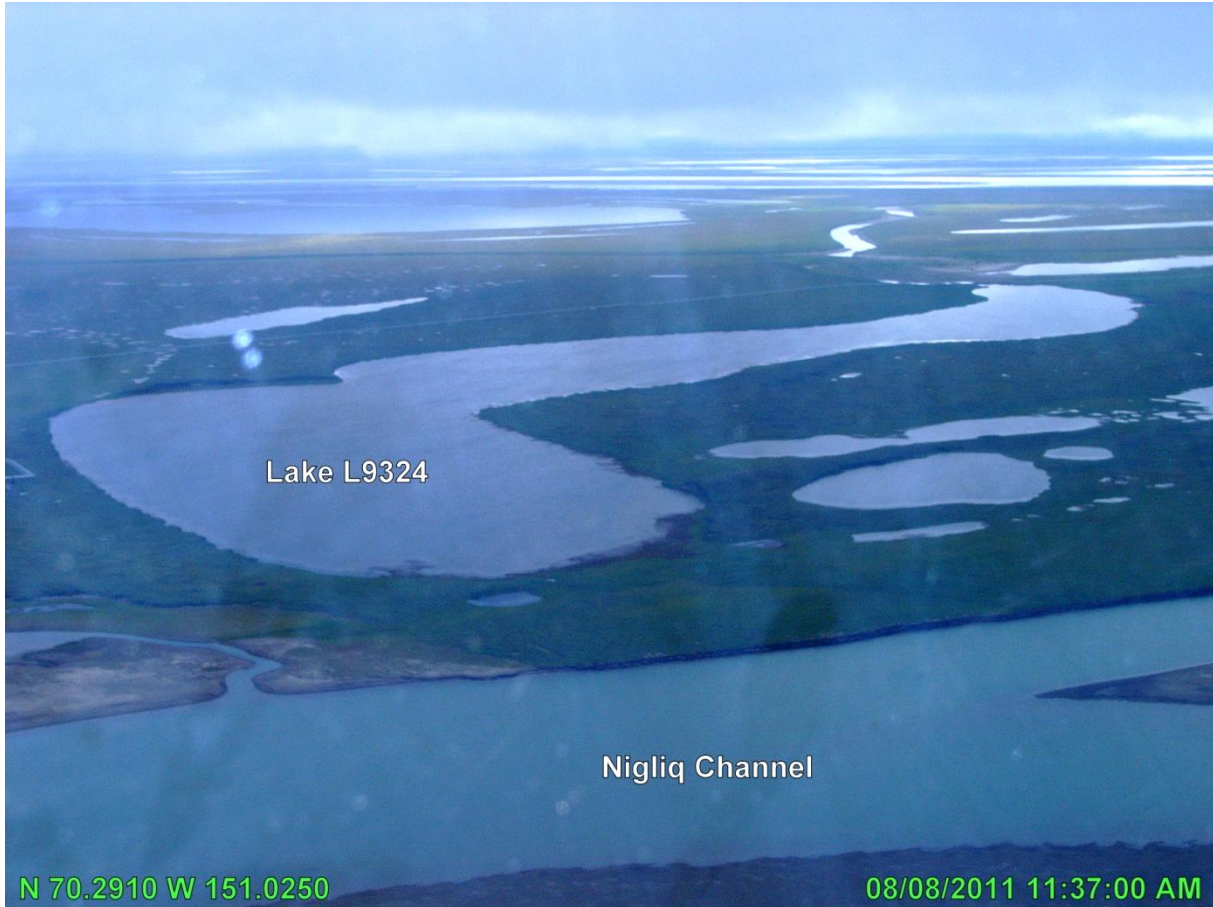
Located near CD4, Lake L9324 is moderately sized with grassy banks and willows (Photo 3.6). Some large bluffs surround the lake.

Photo 3.6: Lake L9324, looking east; August 8, 2011

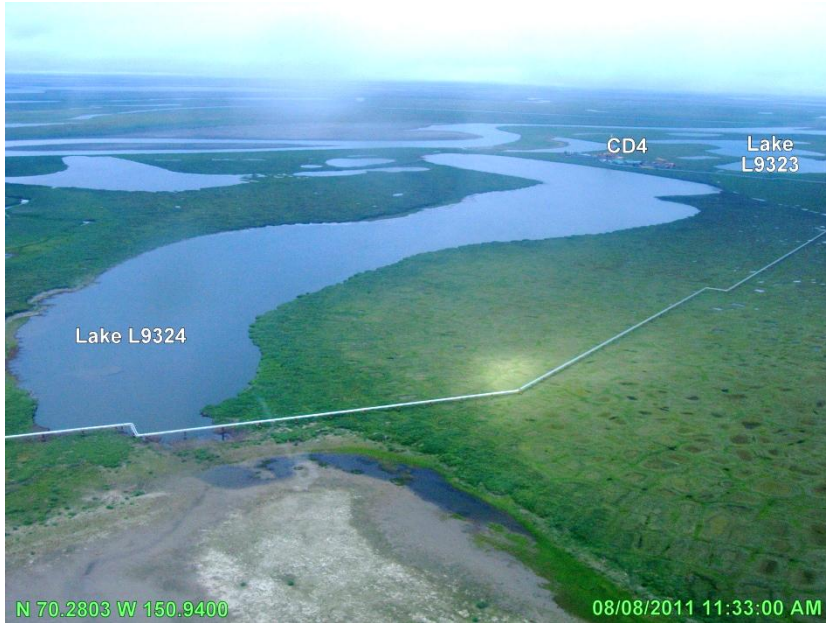
Photo 3.7: Lake L9324, looking northwest; August 8, 2011

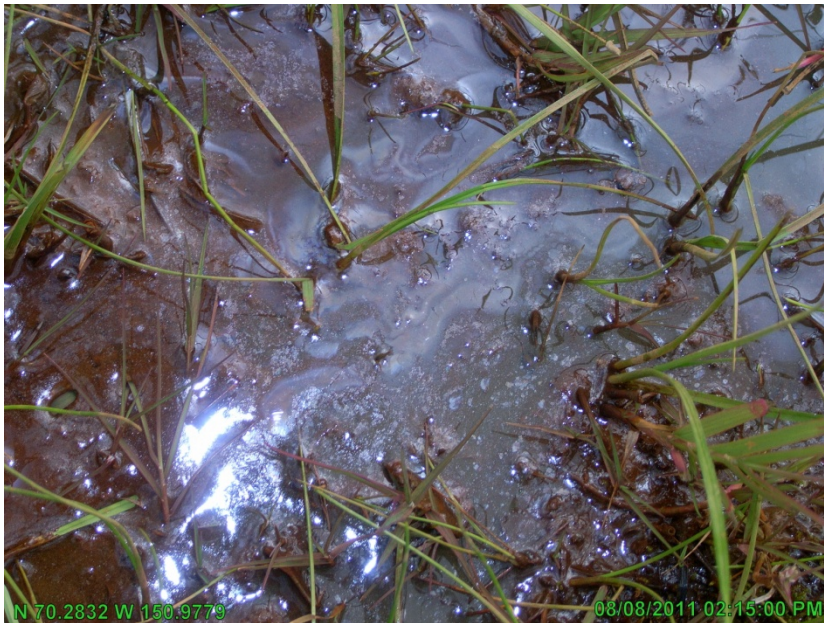
Photo 3.8: Marshy area adjacent to Lake L9324 (L9324 NE); August 8, 2011

During spring breakup flooding, this lake was hydraulically connected to the Sakoonang Channel and Lake M9934 to the south, to Lake L9323 via CD4 road culverts to the north, and to the Nigliq Channel via Tapped Lake to the west. No hydraulic connectivity between Lake L9323 and any other body of water was observed at the time of sampling (Photo 3.7). Neither odor nor film was observed on the lake. A film was observed on the tundra adjacent to the northeast bank, L9324 NE (Photo 3.8), but no odor was detected and surrounding vegetation appeared healthy.
