**Culvert Assessment
and Recommendations**

**Fish Passage Evaluation
Holgate Creek
Haines, Alaska**

April 2008

**Natural
Channel
Design, Inc.**

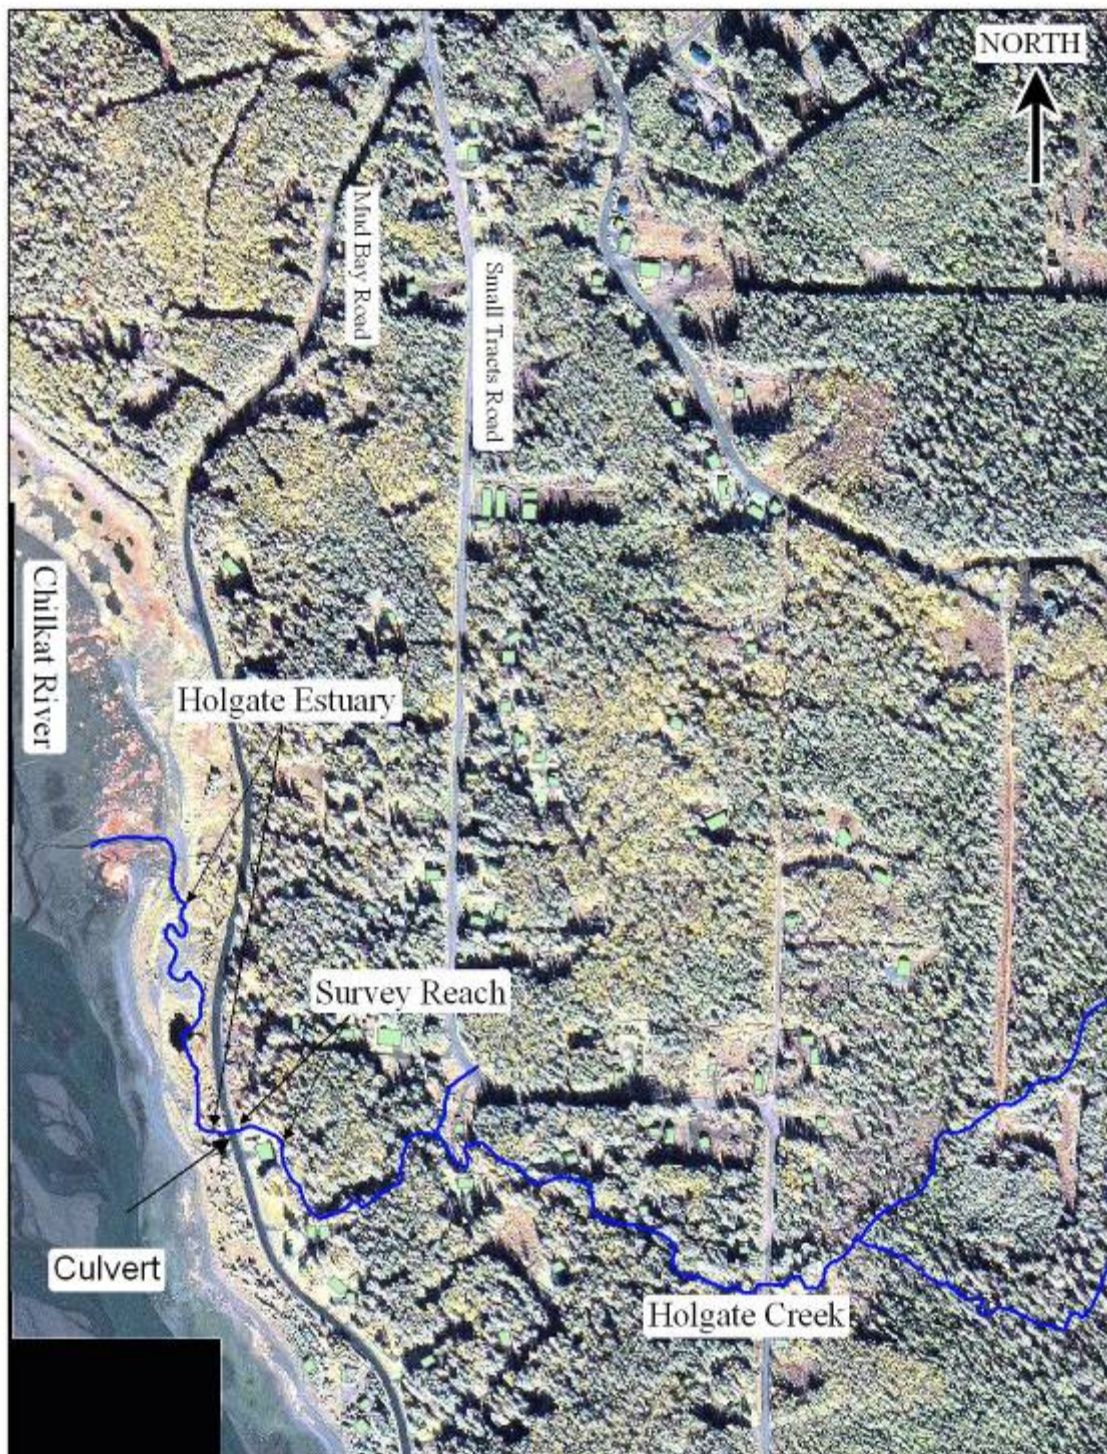
Figure 1. Project location

The culvert is located where Mud Bay Road crosses Holgate Creek near Haines, Alaska. The crossing is the most downstream culvert in the system as Holgate Creek joins the Chilkat River (left side of photo).

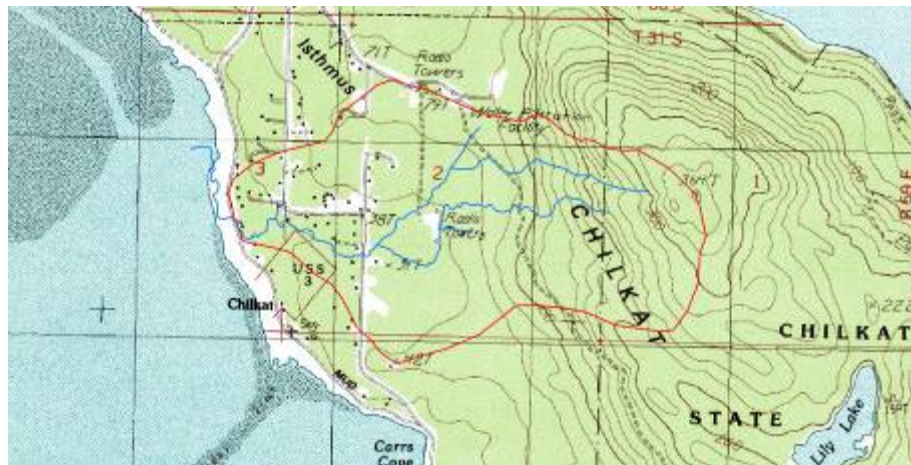
Figure 2. Watershed Map

Holgate Creek watershed includes the west slope of Mt Riley with a watershed area of 0.83 sq miles.
