Dog Salmon Creek Watershed Assessment

Dog Salmon Creek, Port St. Nicolas Road, Prince of Wales Island

Prepared by The Nature Conservancy January 2013

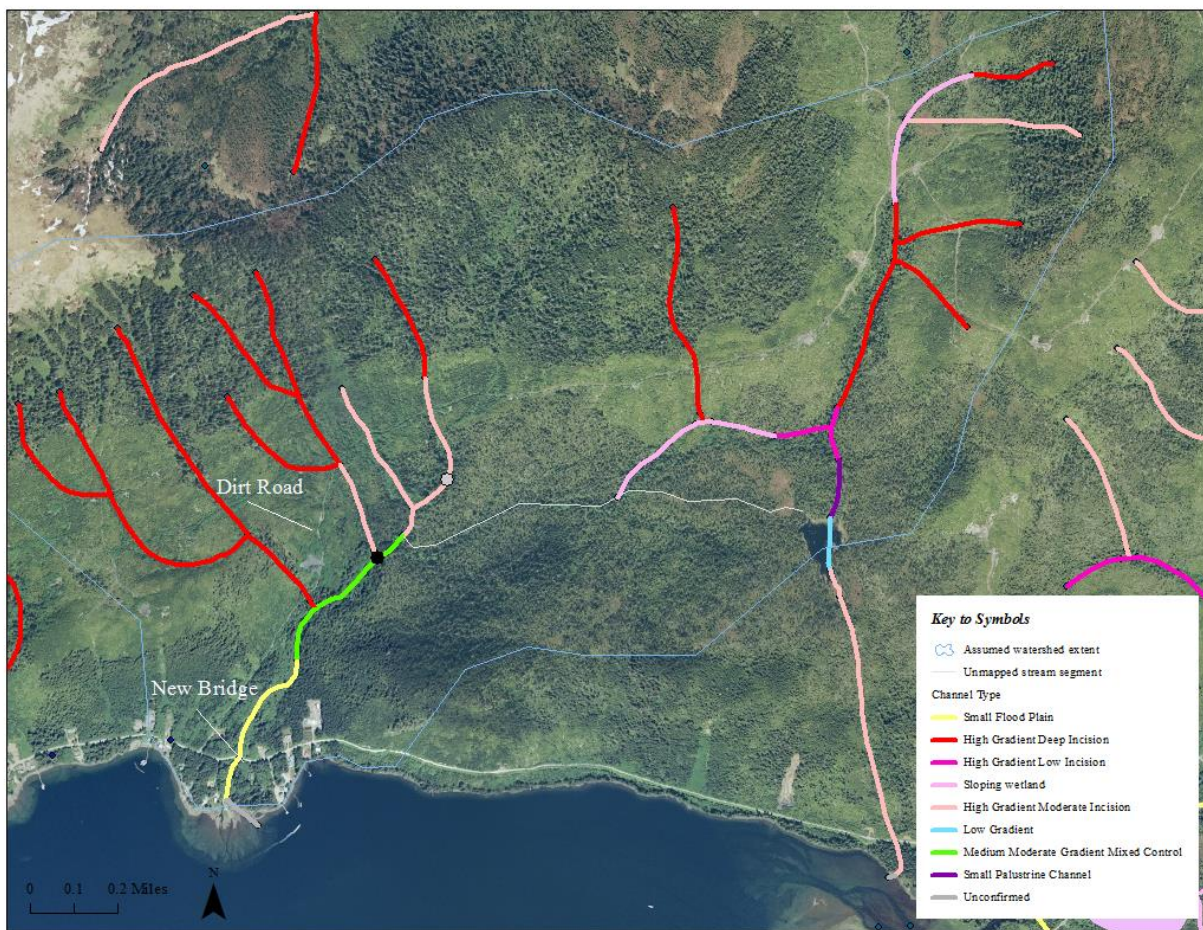
Figure 2. The assumed Dog Salmon Creek watershed. This includes channel types for all mapped waterbodies, and includes the presumed path of an unmapped stream segment that enlarges the originally mapped watershed extent.

Of the channel types found within the watershed (Figure 2), only small floodplains and medium moderate gradient mixed control channels are expected to be important for salmonid spawning and rearing. The ratings for spawning and rearing of anadromous species for these two channel types are found in Tables 1 and 2, respectively.

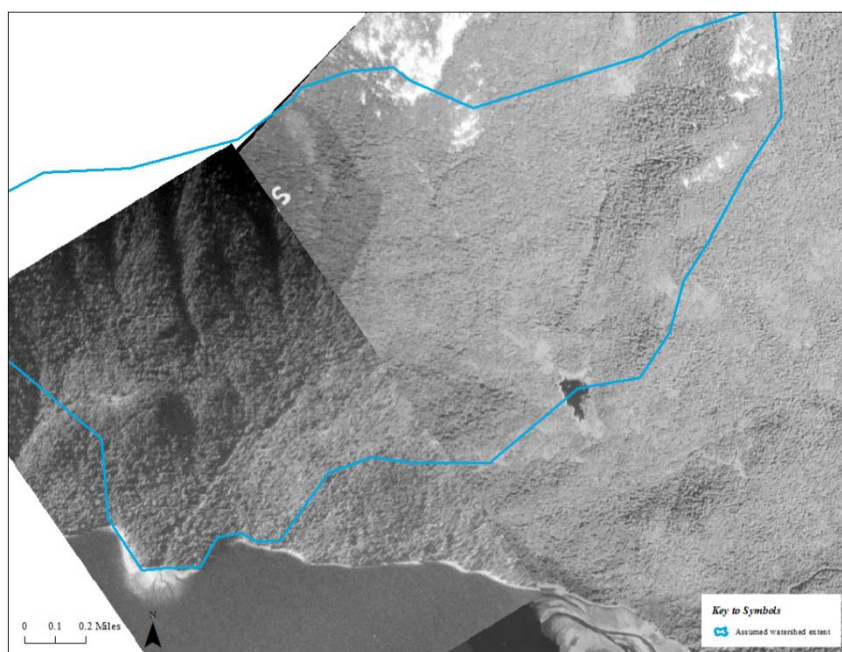
Figure 3. Aerial photographs from 1948 show forest conditions prior to commercial logging.

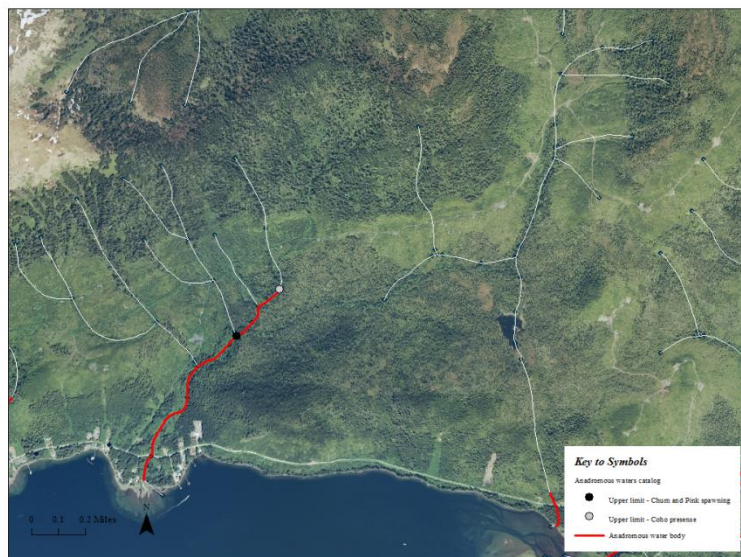
The extent of the anadromous waters catalog for Dog Salmon Creek is shown in Figure 6. This includes documentation of pink and chum salmon spawning, and the presence of coho salmon. [Adult steelhead have also been visually observed migrating through Dog Salmon Creek, although they are not officially documented in the anadromous waters catalog \(Sheila Jacobson, USFS, personal observation\).](#) Minnow trapping in the lower portion of the watershed also documented the presence of juvenile (rearing) coho salmon, juvenile rainbow trout, juvenile cutthroat trout, Dolly Varden char, and freshwater sculpins. Dolly Varden char were also found in several steep tributary streams. No information about current populations or run sizes of any fish species is known about this creek.

Figure 6. Current extent of the anadromous waters catalog

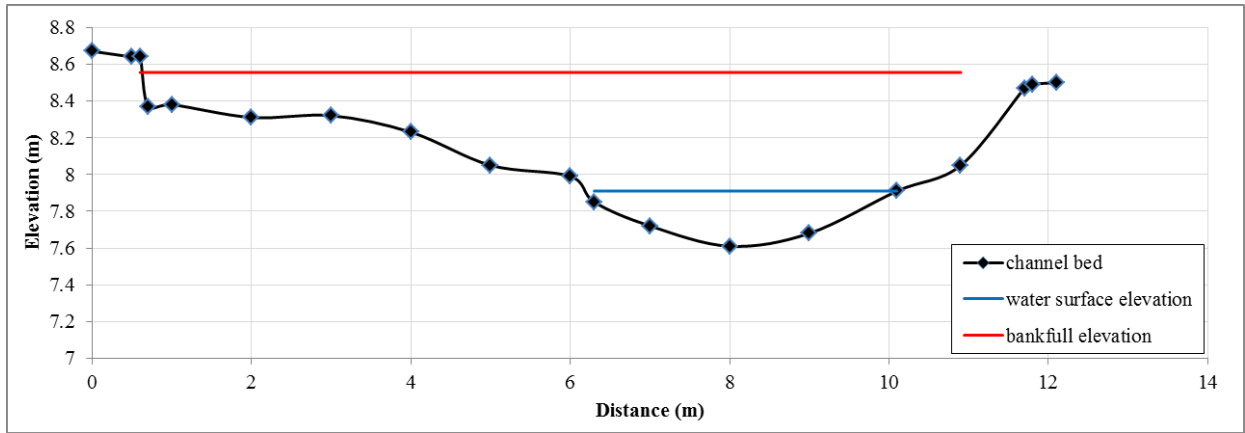
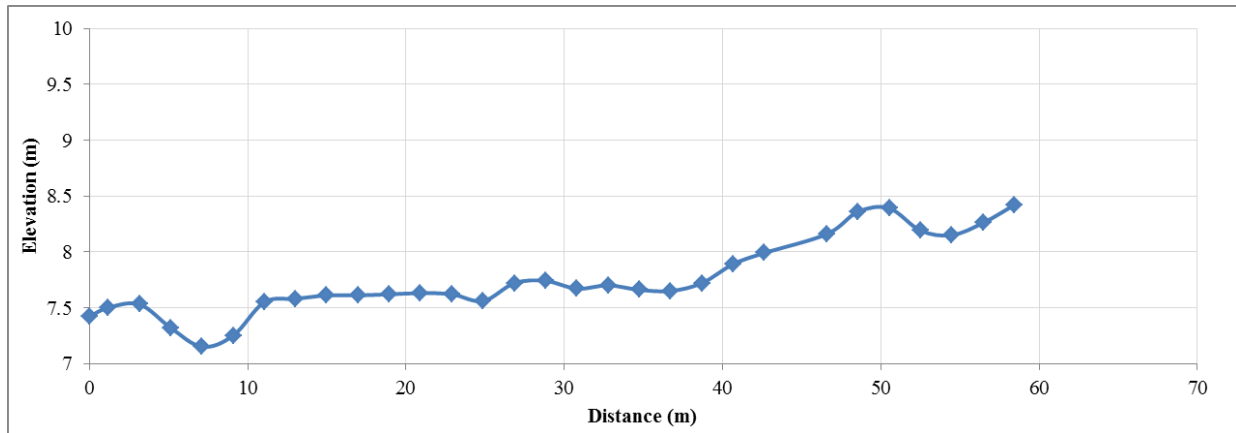
Reach 1 was ultimately ranked as having a poor-to-fair fish habitat condition, as compared to similar stream types in the TNF. Pools represent good fish habitat as they offer cover, refuge and feeding areas for rearing salmonids, resting and staging areas for spawning fish migrating upstream, and spawning habitat in tail crests. Reach 1 had fewer pools and smaller pools than unmanaged streams in “pristine condition”. Large woody debris is also an indicator of good fish habitat, as the structures create pool habitat and habitat complexity, as well as provide shade and cover for juvenile rearing salmonids. Reach 1 again had a low number of LWD and “key” wood (i.e., big pieces more likely to create habitat), meaning that quality was degraded. Large wood not only creates pools, but produces food inputs for juvenile fish. Furthermore, the width-to-depth ratio for this reach was very high, indicating increased sediment storage and/or channel widening, which can have negative impacts on pool formation and spawning substrate.

Figure A2. Vertical (a) and longitudinal (b) profiles at representative cross sections of Reach 1.

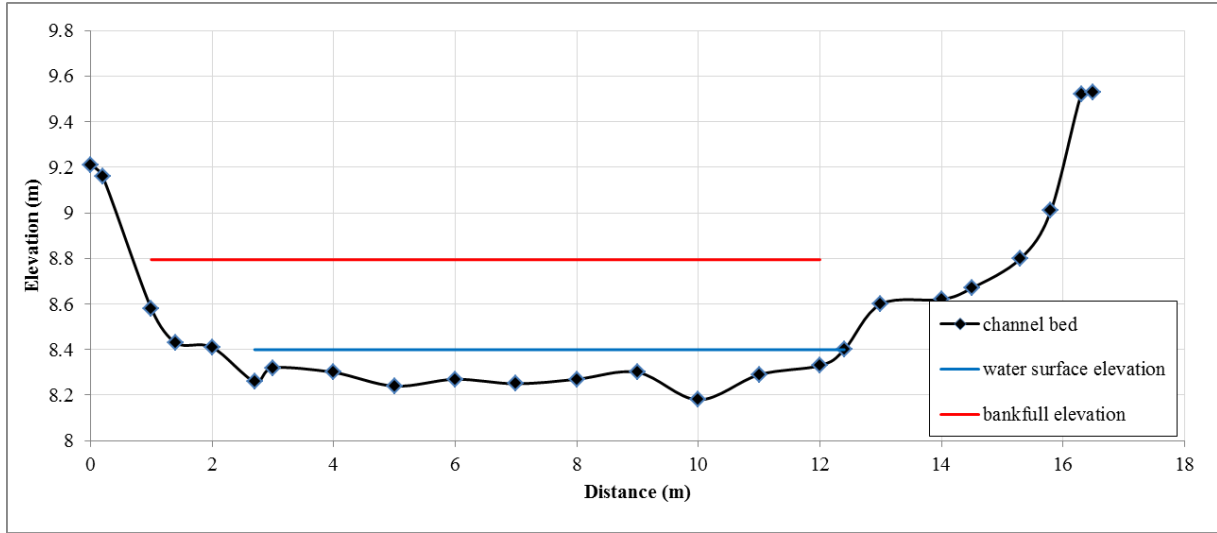
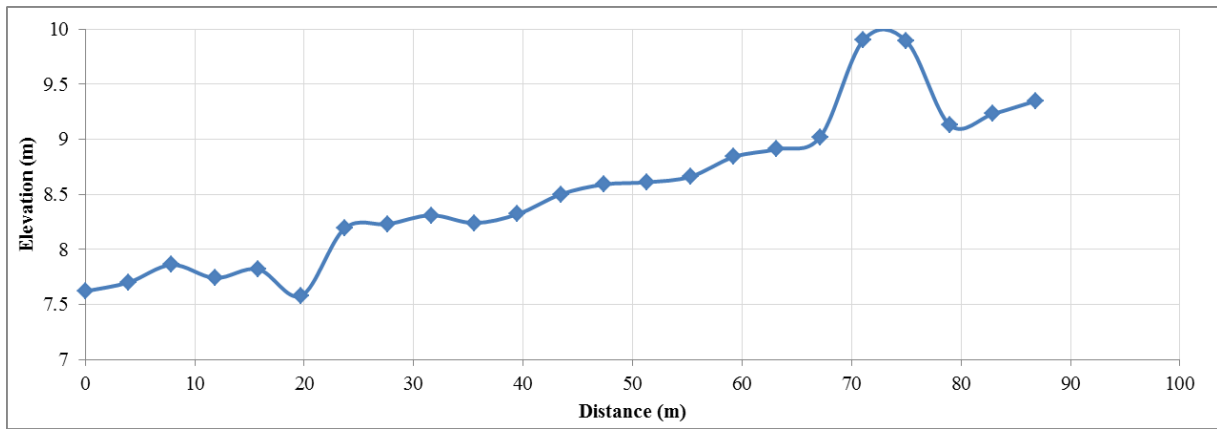
Figure A3. Vertical (a) and longitudinal (b) profiles at representative cross sections of Reach 2.

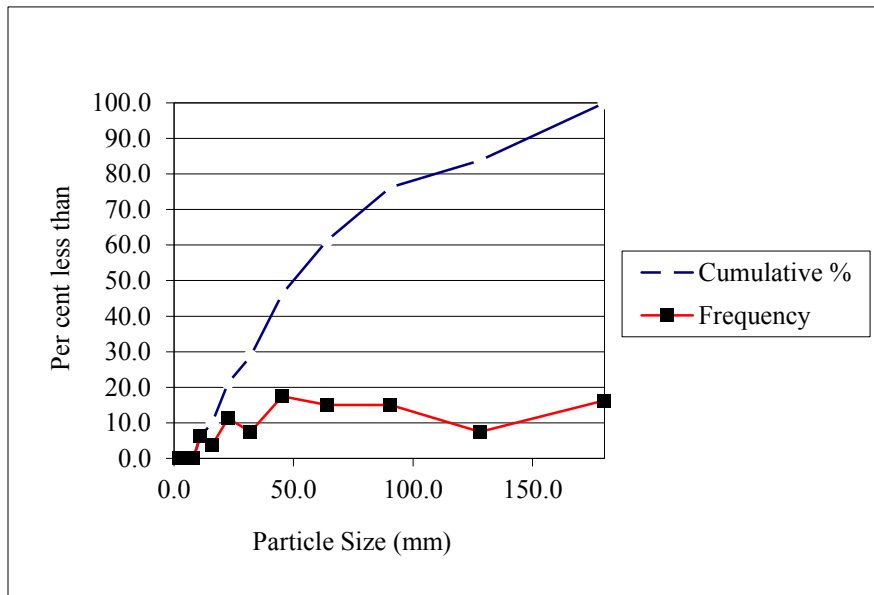
Figure A4. Cumulative size distributions for pebble counts in Reach 1 and Reach 2.
