# Twelvemile Creek

## Mainstem Instream Restoration

### Monitoring Summary

Tongass National Forest, Craig Ranger District

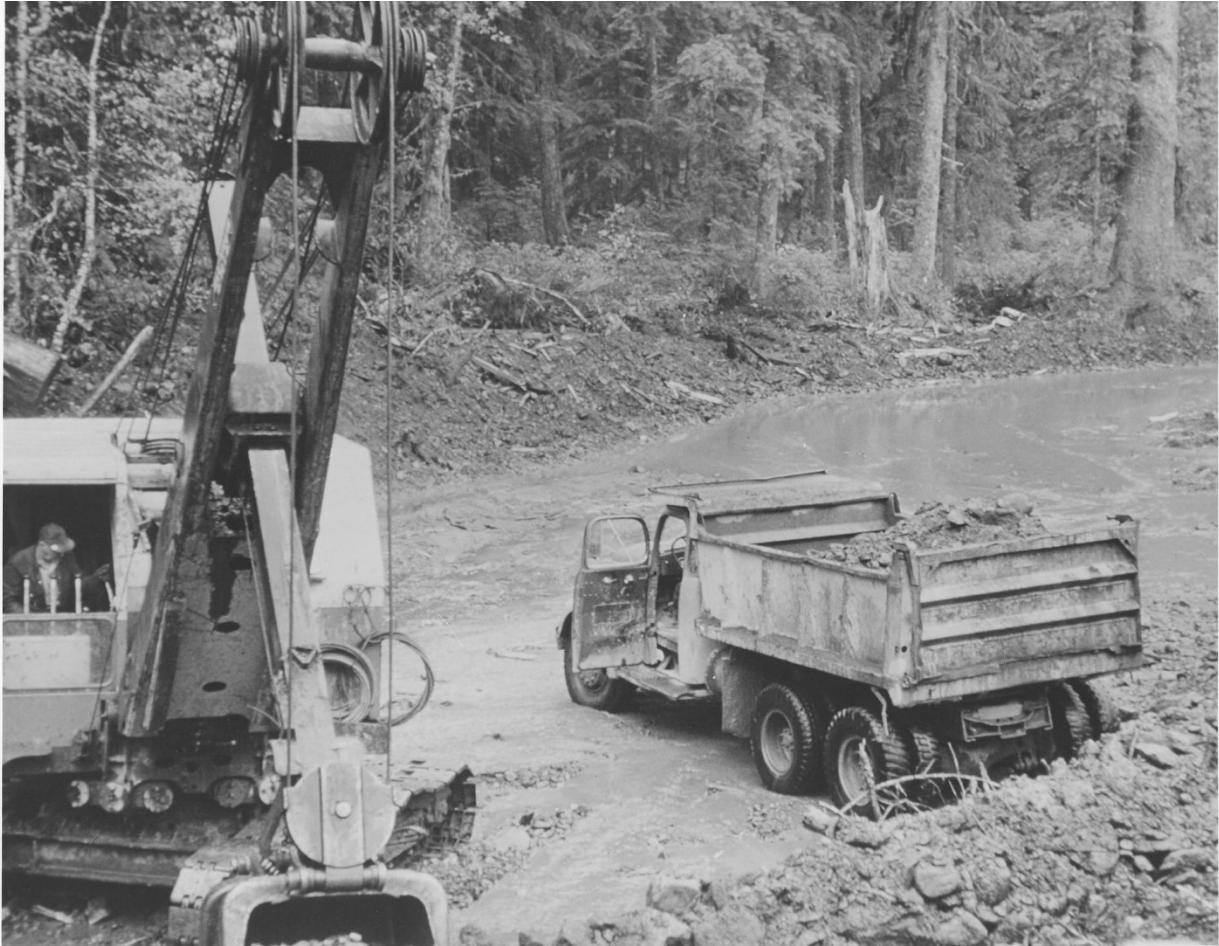
Twelvemile Creek during road building and timber harvest in 1960.

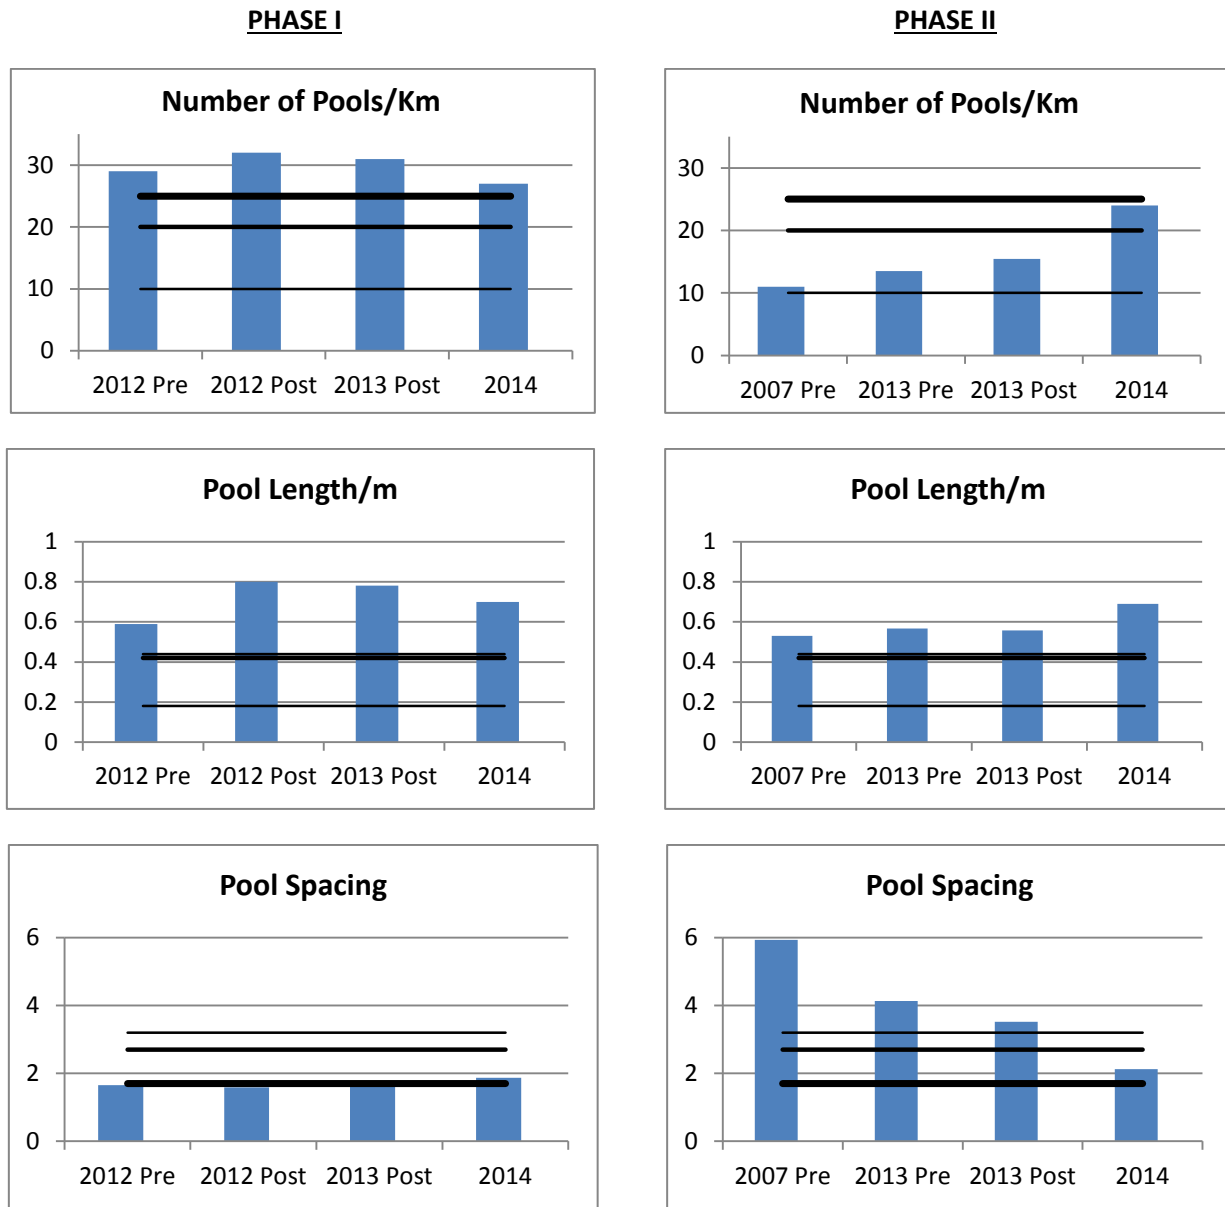
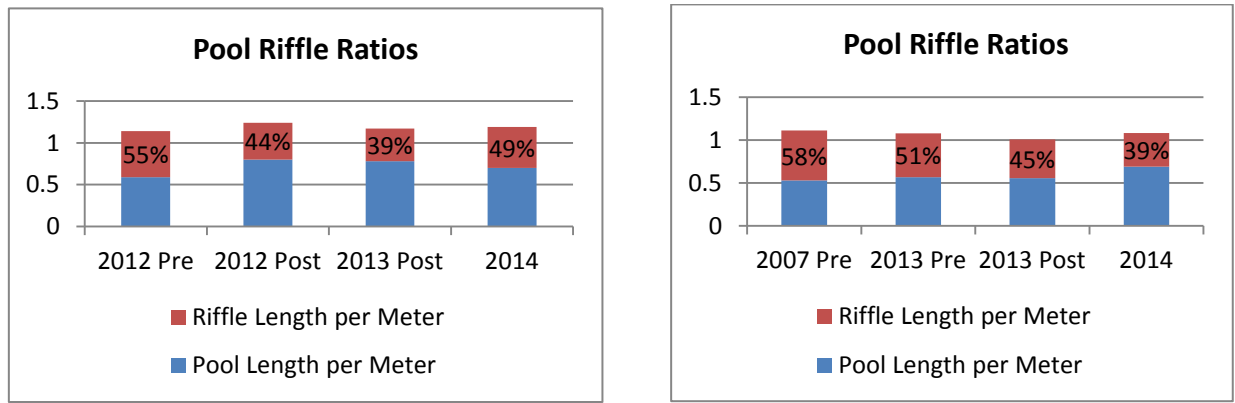
**Figure 3: Pool Habitat Variable Results for Phase I and II by Year.**

**Pool Characteristics:** In **Phase I** the **Number of Pools** per Kilometer and **Pool Spacing** values have been maintained in excellent condition since implementation. The **Pool Length** per meter has remained in fair condition, with more than 50% of the stream length qualifying as pool habitat. This means that the number and spacing of pools along

this part of Twelvemile are meeting the restoration objective levels, except the length of pools exceeds the natural range in variability for the size and channel type. All three habitat values have also been relatively stable over time. As shown in the bottom graph in Figure 3, the **ratio of pools to riffles** along the length of the stream increased after implementation, but the total length of habitat also increased. This reflects rising habitat complexity due to an increase in longitudinally overlapping habitat types (a riffle running parallel to a pool). The decrease in riffle length from 2012 pre-treatment condition to 2014 was 6% (approximately 50meters). Riffle *area* may not have changed, since widths are not measured for each habitat unit. These data suggest that the habitat for adult and juvenile salmonids in Phase I remain in high quality condition, and that the hydrologic functions in the channel appear to be reaching a state of dynamic equilibrium.

In **Phase II**, the **Number of Pools** per kilometer has increased since implementation, and is now just below the target value of 25. The **Pool Length** per meter remains above the target value. The **Pool Spacing** values have been steadily decreasing since 2007 (meaning that there is less distance between the pools) and as of 2014 are near the target value of 1.7. This means the number of pools and the distance between them in the stream is approaching the restoration objective condition. The length of the pools remains above the objective level, which is also reflected in the **ratio of pool to riffle** length. On average, the riffle length has decreased by approximately 12% since implementation. Again, riffle *area* may not have changed, since widths are not measured for each habitat unit. To be clear, loss of riffle length does not necessarily equate to a loss of spawning habitat for adult salmonids because habitat that is measured as a pool according to the survey protocols (e.g. exceeds minimum depth requirement) includes pool tail outs as well as margins of a pool which are utilized by spawning fish. The desired objective, based on the Pool Length per meter values, is to have approximately half of the stream length comprised of riffle and half of pool. Continued monitoring will assess trends pertaining to that metric but spawning habitat will not be directly measured. In general, the habitat conditions in Phase II are trending towards the restoration objective conditions, which will provide high quality areas for adult and juvenile salmonids.

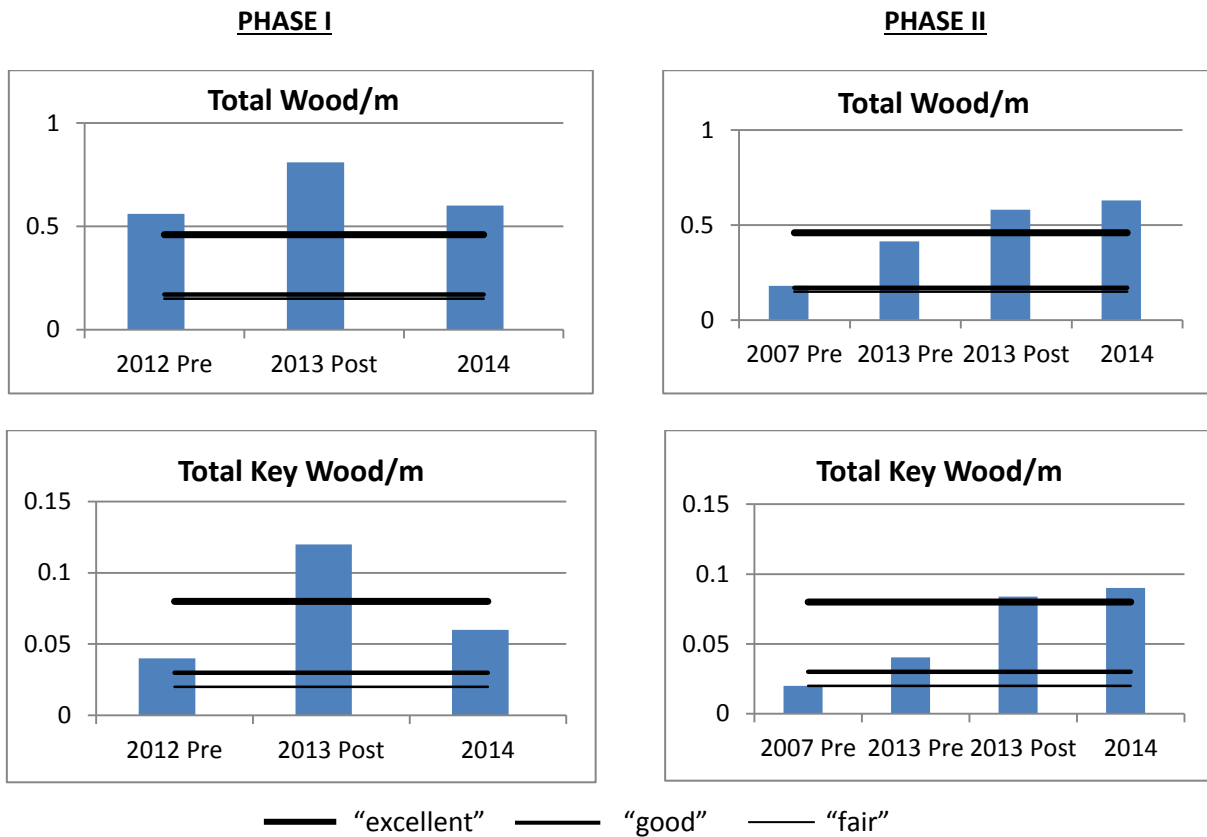
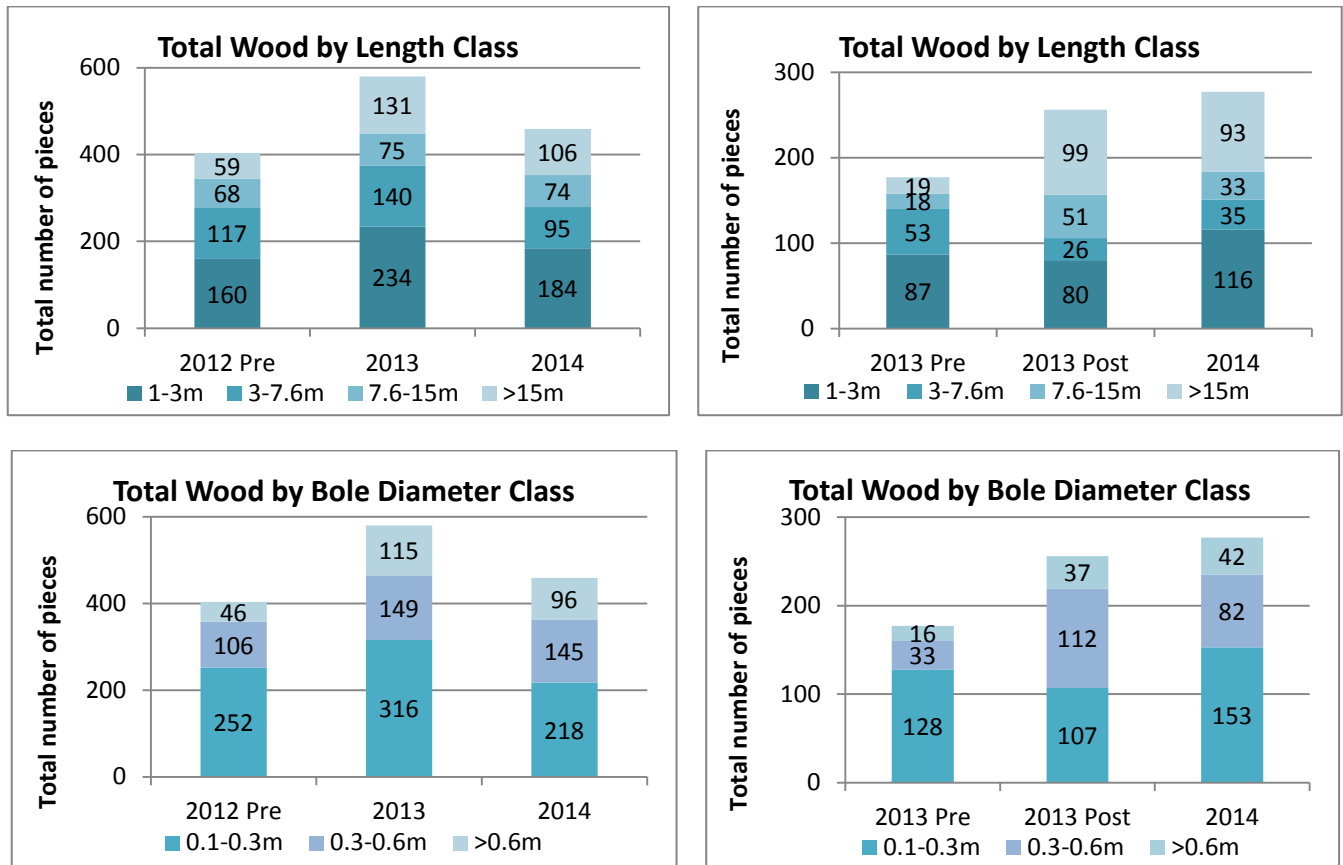
**Figure 4: Woody Debris Habitat Variable Results for Phase I and II by Year.**

Woody Debris: The results of the wood surveys are depicted in Figure 4, again with Phase I on the left and Phase II on the right. In **Phase I**, the **Total Wood** and **Key Wood** counts increase from 2012 to 2013, reflecting the additions of wood during implementation. Both the Total and Key Wood then decline from 2013 to 2014. This could be attributed to a combination of: 1) Movement of wood out of the surveyed reach due to high flow events during January and March of 2014 (prior to survey). Photo documentation of treatment sites does show change in the position and number of pieces at some sites. 2) Deterioration in the size of attached rootwads. Rootwads greater than 3 meters in width, regardless of bole diameter of the attached tree, were counted as key pieces. In the 2014 survey, noticeable wear on the rootwads may have reduced their width to less than 3 meters, lowering the total number of key pieces counted. Of the eighty-eight Key pieces in 2013, twenty-two of them were attached rootwads, while in 2014 only 4 key pieces were included based on attached rootwad diameter. 3) Observer bias. Though not quantified, observer bias is a factor in the repeatability of wood counts and size categorization.

objective value but has improved from pre-project levels, increasing by 66% from 2012 to 2014. The lower graphs in Figure 4 quantify the wood pieces by total length and bole diameter. The increases from 2012 to 2013 include both small and large dimension pieces, reflecting both the large size of the material placed during implementation and an increase in the retention of smaller pieces racking up on the new structures. Conversely, much of the reduction in Total Wood from 2013 to 2014 can be attributed to the smaller sized pieces. From 2013 to 2014 the total number of pieces dropped by 121 pieces, and 98 of them were less than 0.3 meters in diameter (the smallest diameter category). Any wood moving out of Phase I may be moving downstream and getting lodged in structures within Phase II.

In **Phase II**, the **Total and Key Wood** numbers attained the objective target value after implementation in 2013 and remained there through the 2014 survey. The increase in the number of pieces over 15 meters long and over 0.3 meters in diameter post implementation is also reflected strongly in the lower graphs. This highlights the size of the young growth material used during implementation. The differences between Phase I and Phase II in the total number of pieces is due to the length of the surveyed reach (Phase I is about 40% longer).

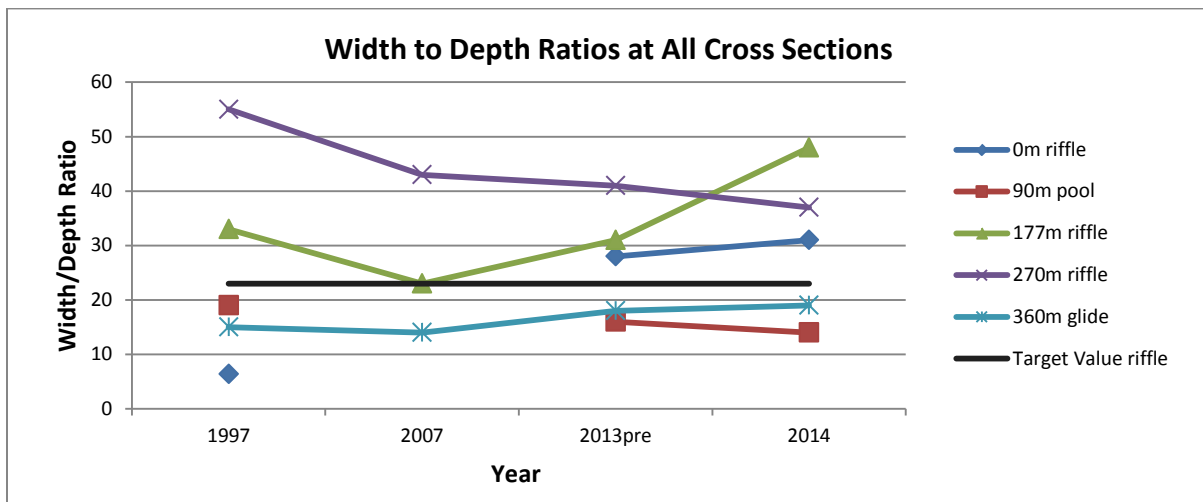
Figure 10. Width-to-depth ratio at 5 cross-sections in Phase II and the target Habitat Value.

There are varying trends in the width-to-depth ratio at these cross sections relative to the target value (Figure 10). The 270m riffle and 360m glide both show trends towards the target habitat value for floodplain channels (23). The 177m riffle shows a departure from the target value. The 0m riffle and 90m pool show minor departure, but have fewer data points. The clustered distribution of pre-project cross-sections in Phase I (all centered around one treatment site) makes them unsuited to monitoring width/depth ratios at the reach scale, so monitoring of this metric is currently limited to Phase II. Continued monitoring may show long term trends relative to restoration. Future monitoring will look also at large wood and channel constrictions relative to the cross section locations. These additional data may explain the varying results of channel response (relative to width/depth ratio) and provide insight into channel function and habitat.

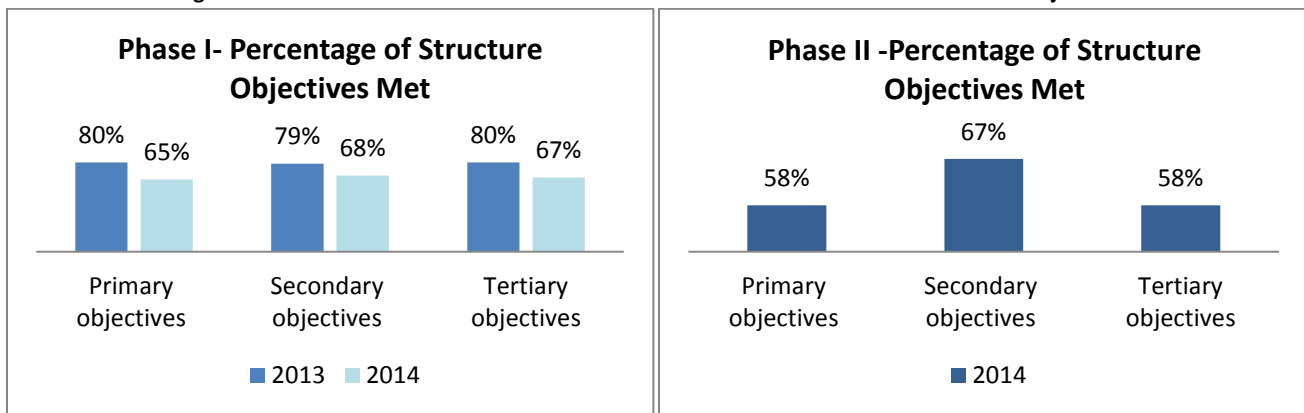
**Figure 12. Relative effectiveness of structures at treatment sites for the Twelvemile Project Area**

The short term results of the structure objective monitoring are shown below in Figure 12. No threshold of acceptability has been established, but the goal is to learn from effective and ineffective structures. After the series of flood events in 2014 three of the 32 sites were completely displaced, while others were either partially displaced or accumulated wood and gained complexity. Structures that were the least effective in meeting objectives were structures designed to Develop/Maintain Gravel Bars (22% success), Improve Off Channel Access (17% success), and Reduce Cross Sectional Area (38%). Structures that had the most success meeting objectives include Protect Bank (78%), Enhance/Create cover (78%), and Develop/Enhance Pool (76%). For further evaluation of structure types and there relative effectiveness, please refer to the Flood Report (USFS, 2015). The effectiveness and relative stability of the placed structures (and those that have formed in other locations) will

respond to future flow events, and will be better evaluated over a longer time period. Since only two years have passed since implementation, continued assessment will indicate future levels of success and durability. The decrease in site objective achievement from 2013 to 2014 in Phase I is likely related to the magnitude of the winter and spring flows of 2014. The decrease in wood levels observed in the habitat surveys are also related to these events. The lower treatment site-specific success in Phase II necessitated further investigation by those involved in the design and implementation of the project (see Flood Report, USFS 2015). Nevertheless, site-specific structure durability does not necessarily equate to success or failure of project objectives at the reach scale, as reflected in the habitat variable monitoring results to date. During the monitoring process it was observed that while a specific site may not be meeting an objective, the wood was often fulfilling the same or different objective where it had migrated. Future project designs may want to consider this aspect; do we continue with the design of site specific targets with rigid structures or would a more loosely dispersed addition of wood into a floodplain channel –with the expectation that the wood would move- be just as likely to meet reach-scale objectives?
