**Restoration and Enhancement of Aquatic Habitats in Alaska:
Project Inventory, Case Study Selection, and Bibliography**

Technical Report No. 93-8

**Alaska Department of Fish and Game
Habitat and Restoration Division**

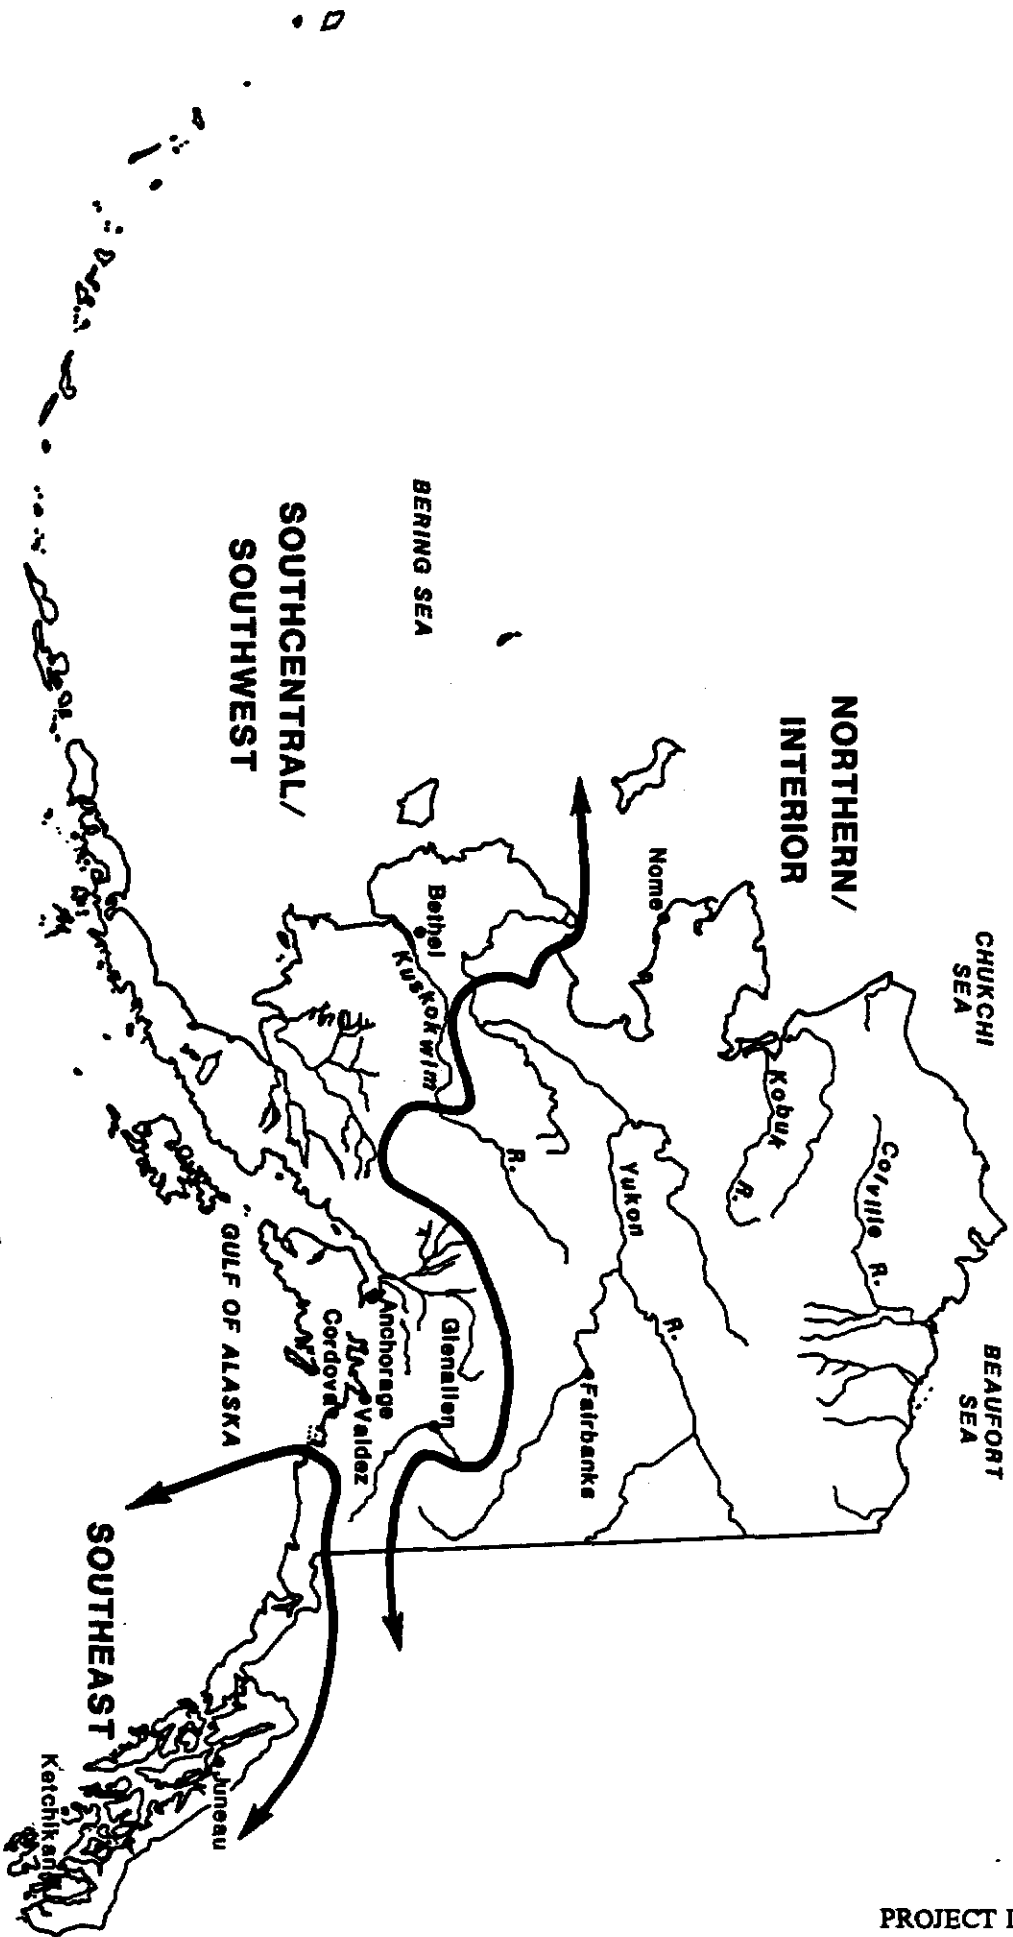
Figure 1. Boundaries of the Three State Regions Used To Sort the Project Inventory Data.

The project records are divided into three regions of the state in the accompanying reports. Approximately half those recorded were from the most populous region (Southcentral/Southwest, 48%) with the remainder divided more or less equally between the Northern/Interior (25%) and the Southeastern regions (27%). The areas represented by these projects are more specifically delineated in Figure 3, where the number and percent of total project records is listed within "ecoregion boundaries" of the state (adapted from those proposed by Cowardin et al. 1979 and Bailey 1976). Once again, the most populated areas contain the highest number of reported projects--the Southcentral Forest area (containing Anchorage, Prince William Sound, and the Kenai Peninsula, at 42%), followed by the Southeastern portion of the state (26%). The only region which does not follow this trend is the Arctic Tundra, where the amount of restoration and enhancement projects (12%) reflects work by the oil field industry rather than the amount of population activity.

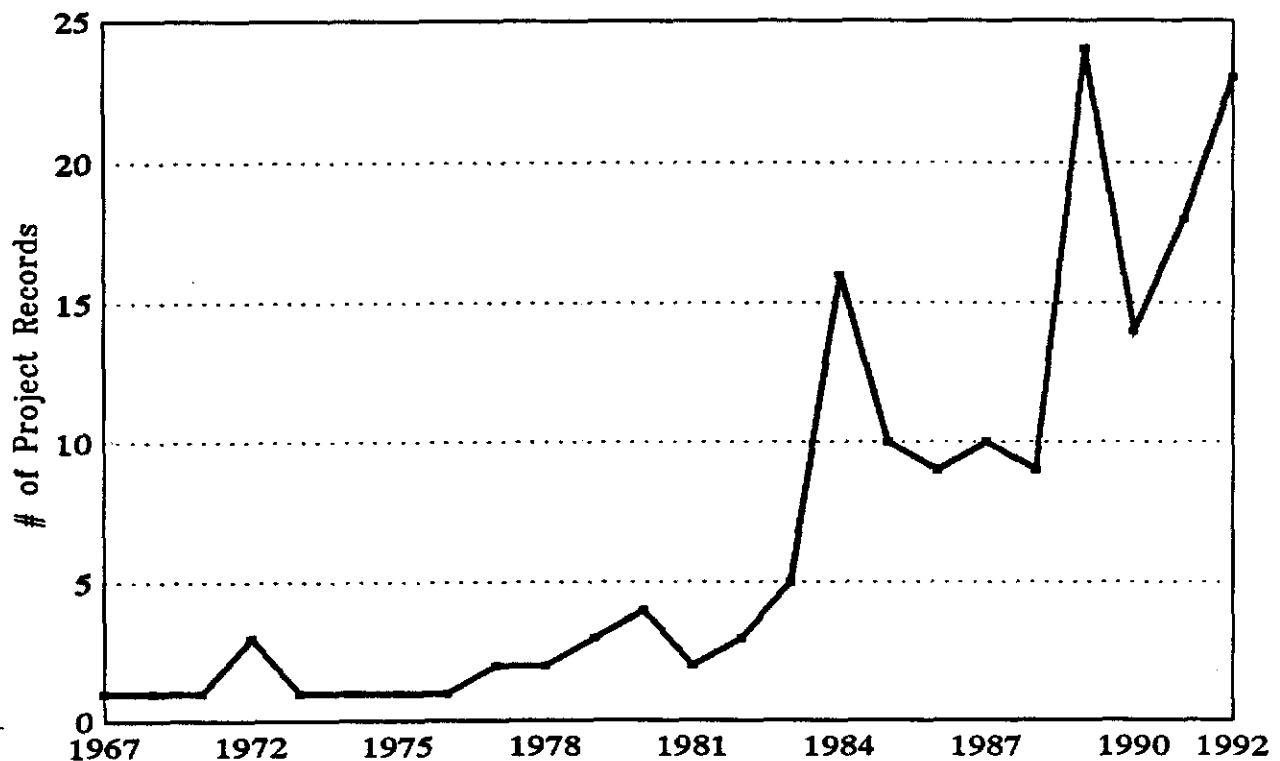
Figure 2: Years in which Restoration/Enhancement Projects were Begun

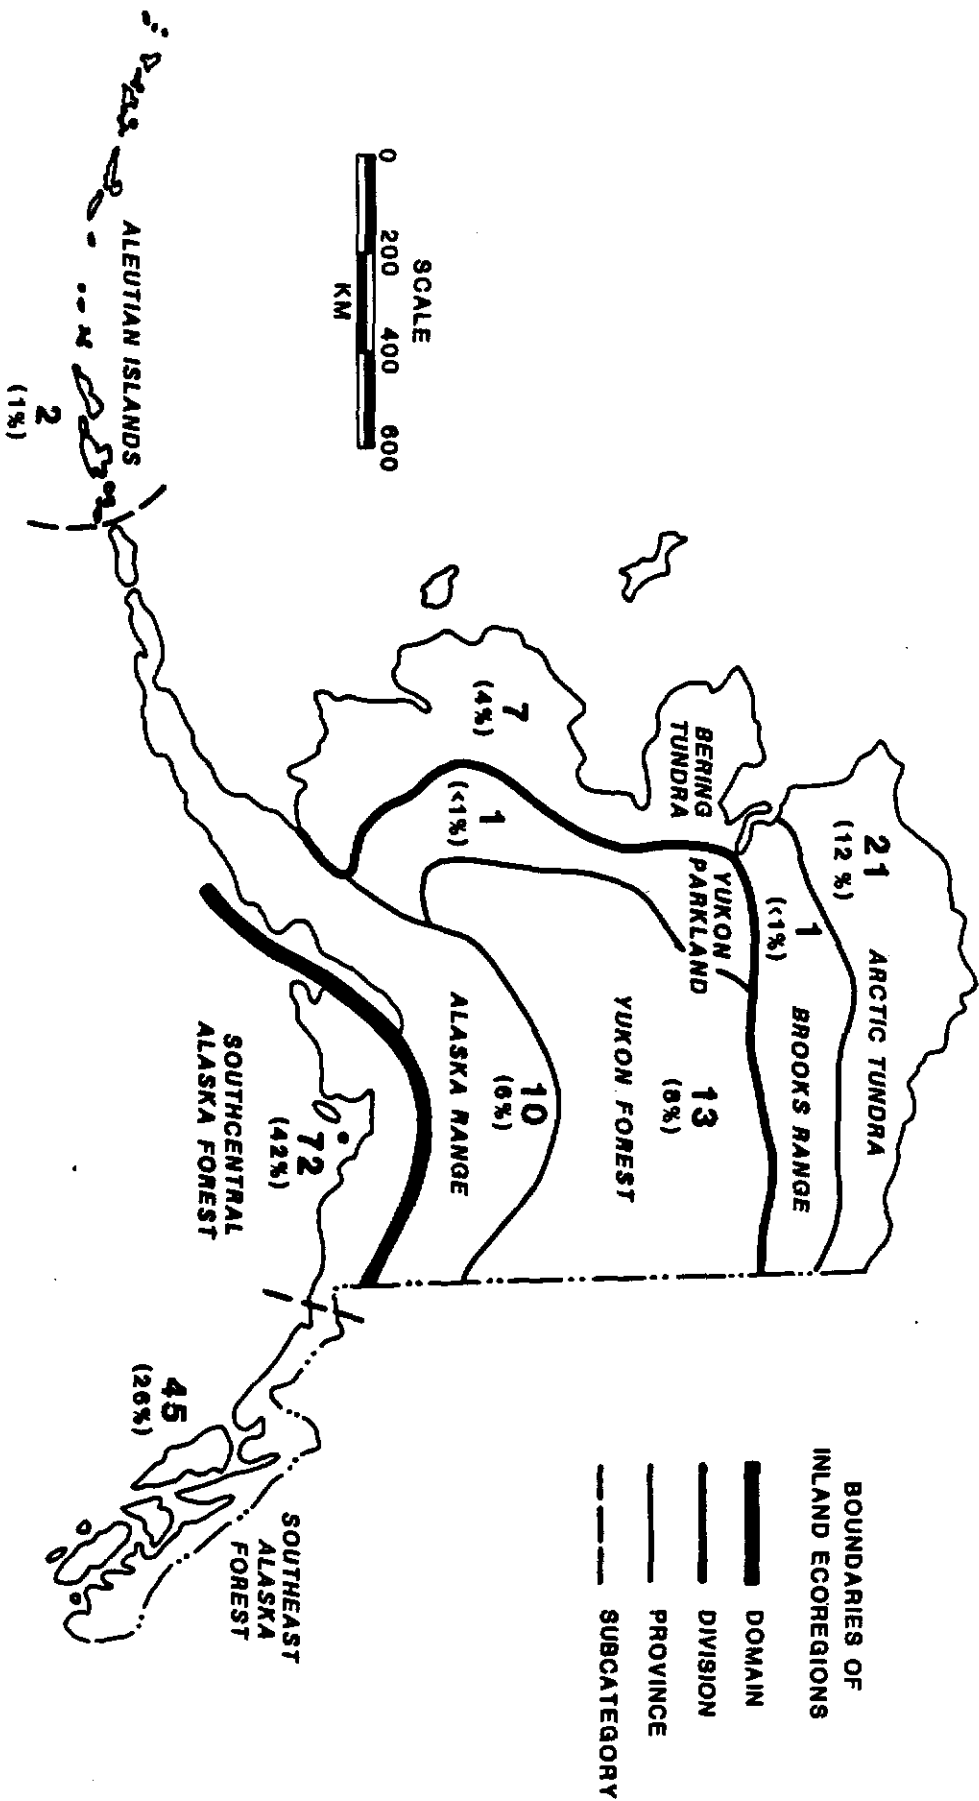
Figure 3. Geographic Distribution of Aquatic Habitat Restoration or Enhancement Projects on Database, Number and Percent of Total Project Records Per Area (Ecoregion Boundaries Adapted from Cowardin et al., 1979)

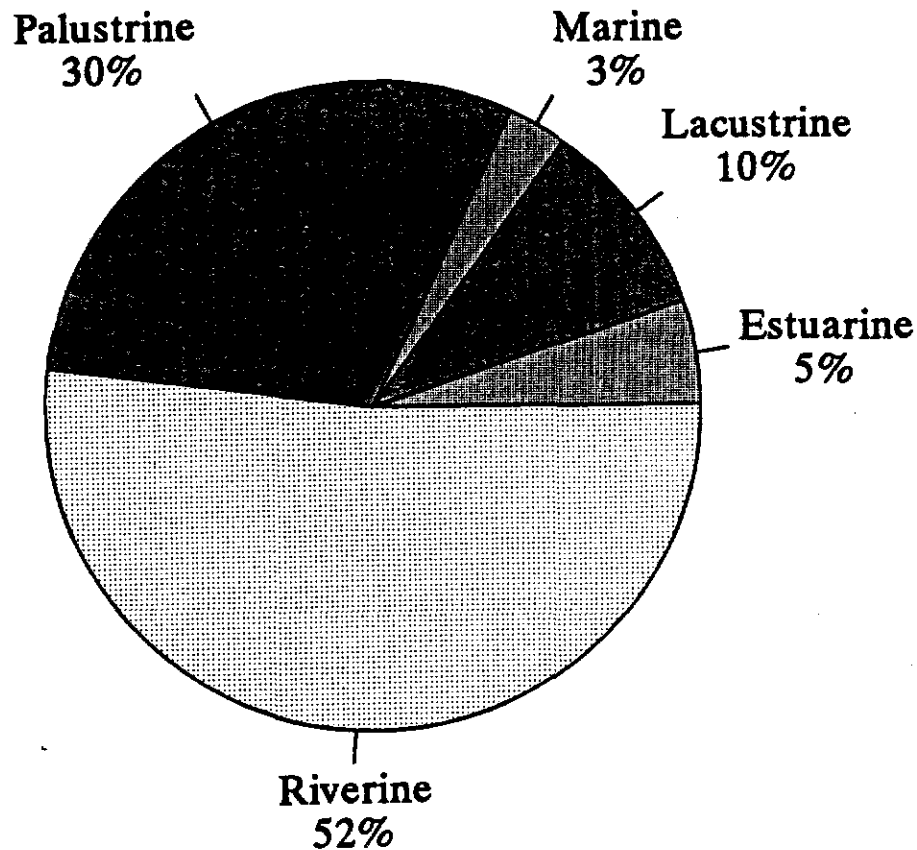
Figure 4: Types of Aquatic Habitat Being Restored or Enhanced (Percent of Project Records)

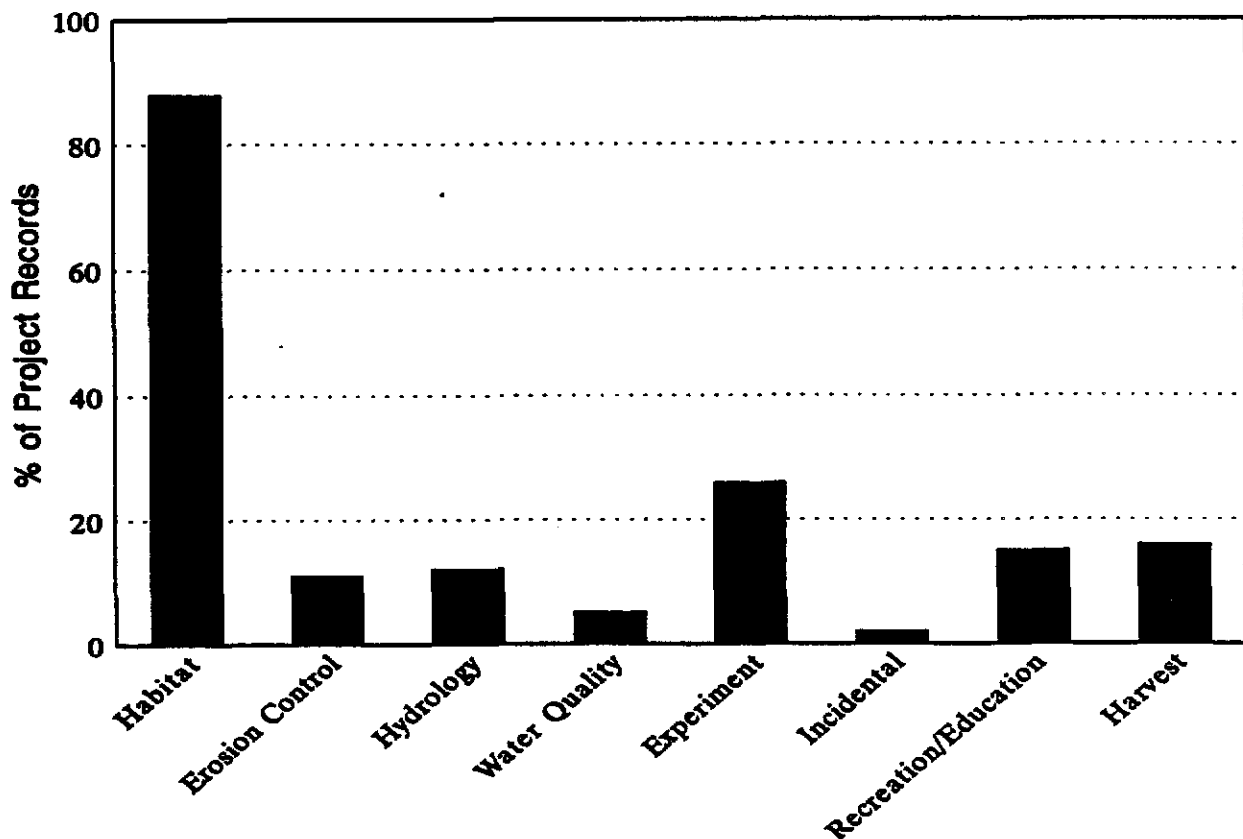
Figure 5: Objectives of Restoration/Enhancement Projects (Percent of Project Records)

enhancement (See Figure 5, terms defined in Table 1). Several objectives could be listed per project record. As is not surprising within an inventory of "aquatic habitat" projects, the "habitat" objective appeared most consistently within the stated objectives (88% of the time); it would seem that most every project documented within this particular inventory should be undertaken with habitat concerns in mind. The next most common objective stated was "experiment" (i.e. experimental attempts at habitat restoration and enhancement, 26%), which is also reasonable considering that efforts at restoration and enhancement are a new field in general, and very new in Alaska. In fact, many of the projects in the inventory could be considered experiments, whether or not they were identified as such by those involved. Harvest objectives (16%, usually for commercial or recreational fishing) was the next most frequently stated objective, which is much higher than nationwide percentages, followed by recreation/educational use (15%), hydrological objectives (12%), and erosion control (11%). Only nine projects (5%) mentioned improving water quality as an objective for undertaking the aquatic habitat work.

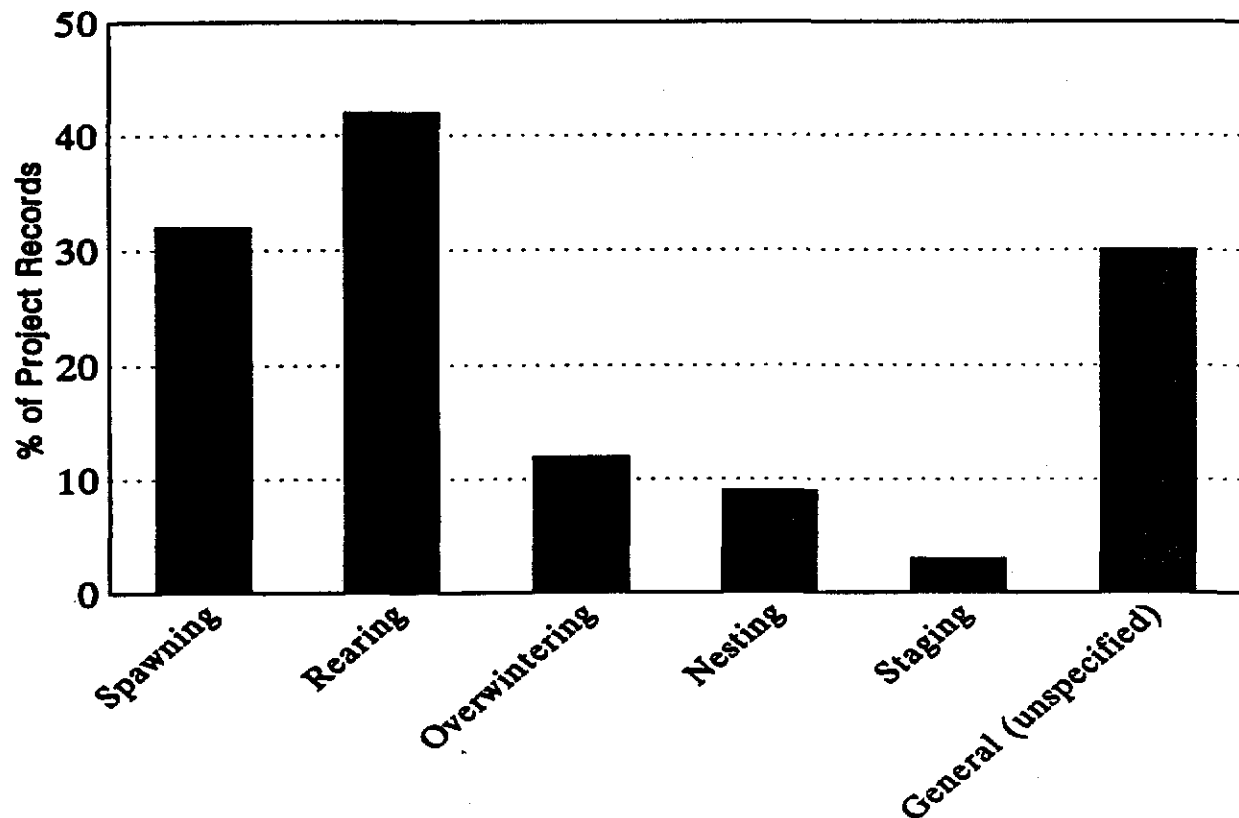
Figure 6: Target Habitat Use of Restoration/Enhancement Projects (Percent of Project Records)

When broken down into the intended uses of the restored or enhanced habitat, the most commonly cited use was rearing and spawning habitats for fish (42% and 32% of project records, respectively), followed by "general" (i.e., not specified uses, 30%), overwintering (12%), and nesting and staging for birds (9% and 3%, respectively, See Figure 6). More than one intended habitat use could be listed per project. A "migrating" category of habitat use (e.g., allowing fish to migrate upstream to spawning grounds) also appears in 9% of the project records in the Summary Table (Section D), but this category was removed from analysis and from the inventory index because it was not applied consistently to all project records. However, even the usage in the remaining categories could be confusing because in some cases where the overall intention was to open up additional spawning or rearing areas (via a fish ladder, for instance), those were sometimes listed as the target habitat use even though no work was conducted in intended "spawning" or "rearing" habitat areas. The true use at the exact project site in that example would have been "migration".

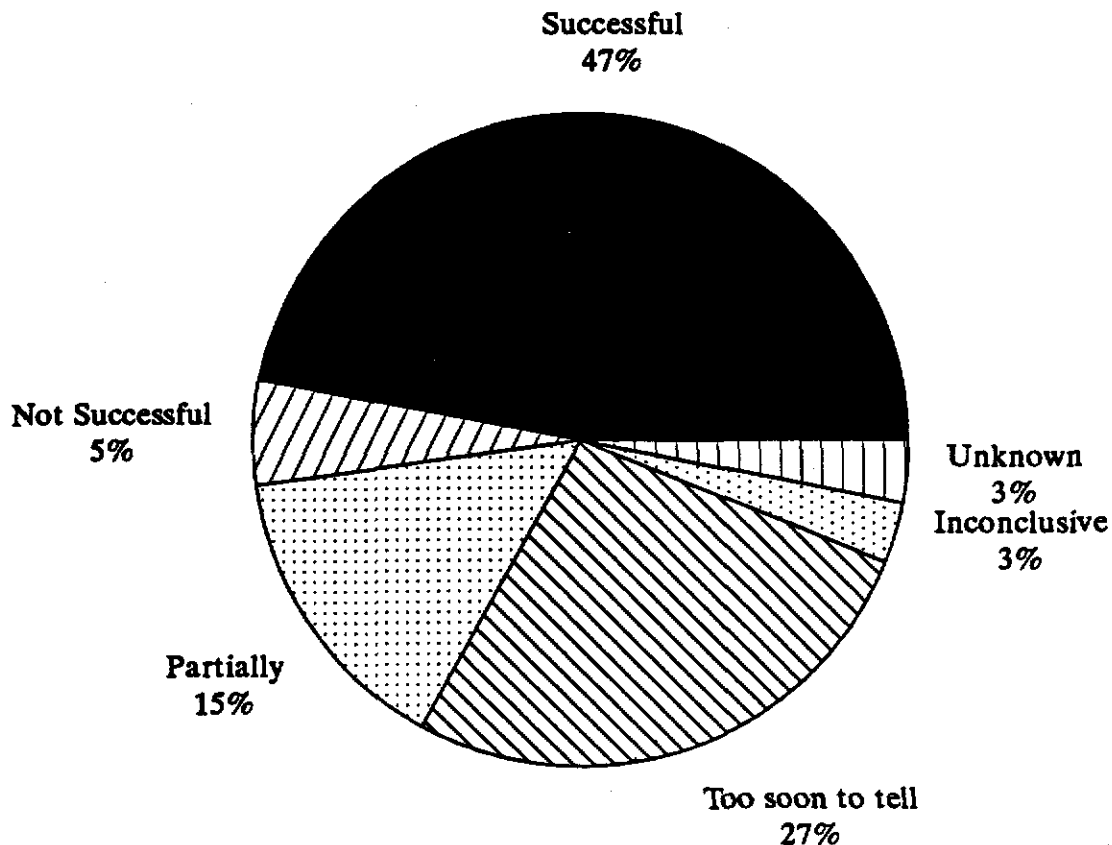
Figure 7: Assessment of Success at Meeting Restoration/Enhancement Objectives
(Percent of Project Records)

Almost half of the database projects stated that they were "successful" (defined as over 50% effective) at improving aquatic habitat to meet the objectives (Figure 7). Not surprisingly, many of these are the simplest actions, such as reseeded native plants on disturbed tundra, or modifying a stream barrier to allow fish to pass. The more complicated tasks, such as creating new spawning habitat, have had less reliable results. These attempts (e.g., spawning channel projects) illustrate the fact that although a project may appear successful in the first few seasons
